Approaching Near Zero Energy in Historic Buildings

Title: Refurbishment and Change of Use at the Rectors' House, Raahe: Art Residence Plans and Co-Design Process

Refurbishment and Change of Use at the Rectors' House, Raahel.

Art Residence Plans and Co-Design Process

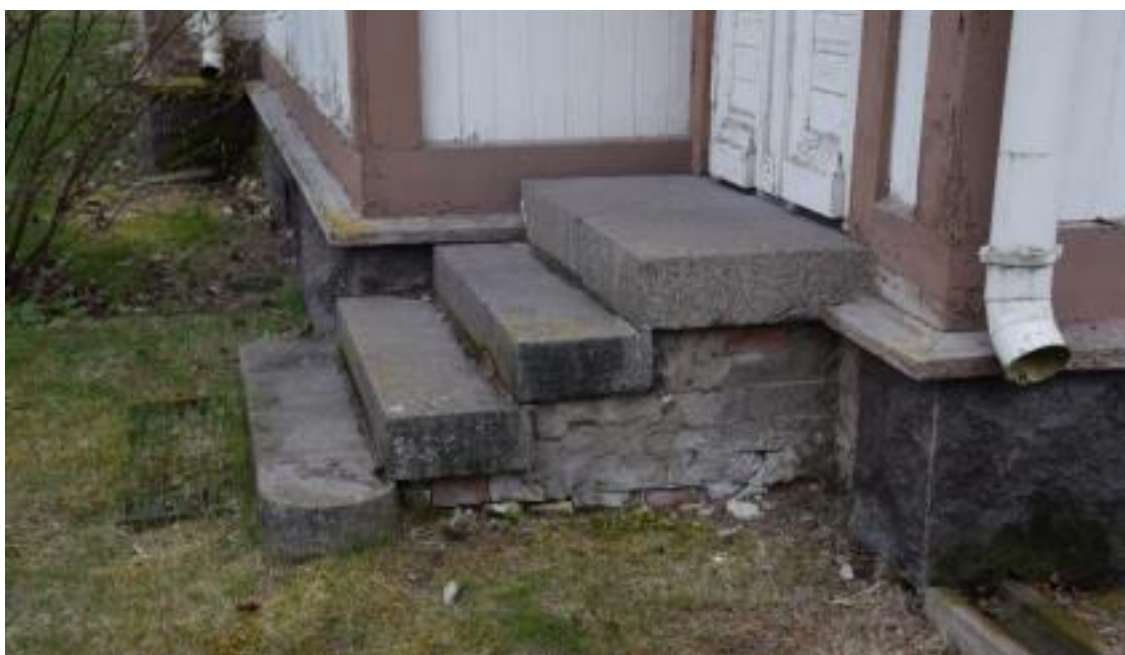
Damage was noticed in the stairs leading to the entrance to the building. Damage to the brick structure of the stairs appeared as packaging damage or possible brick cancer (Fig. 10). Damage to the structure in the future would be repaired by lowering the terrain around the building and treating the mudflats properly next to the building.

FIGURE 10. Damage to the structures of the stairs leading to the external doors (Tolonen 2021)

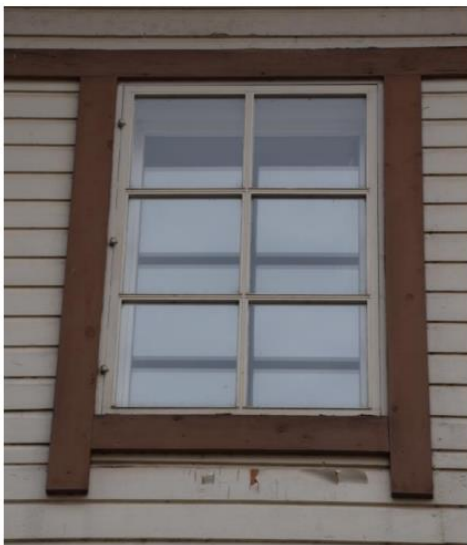
The windows were mostly in good condition. The outer windows of most of the windows were blown glass. However, replacing blown glass with modern window glass would be unnecessary and in addition the old glass surface respects the era of the building and the overall look of the façade. The second floor windows on the entrance side have been replaced at some point (Figure 11). However, the design and hinges of these windows do not fit the style of the façade as well as the older windows mentioned above.

FIGURE 11. Second floor window on the entrance side (Tolonen 2021)

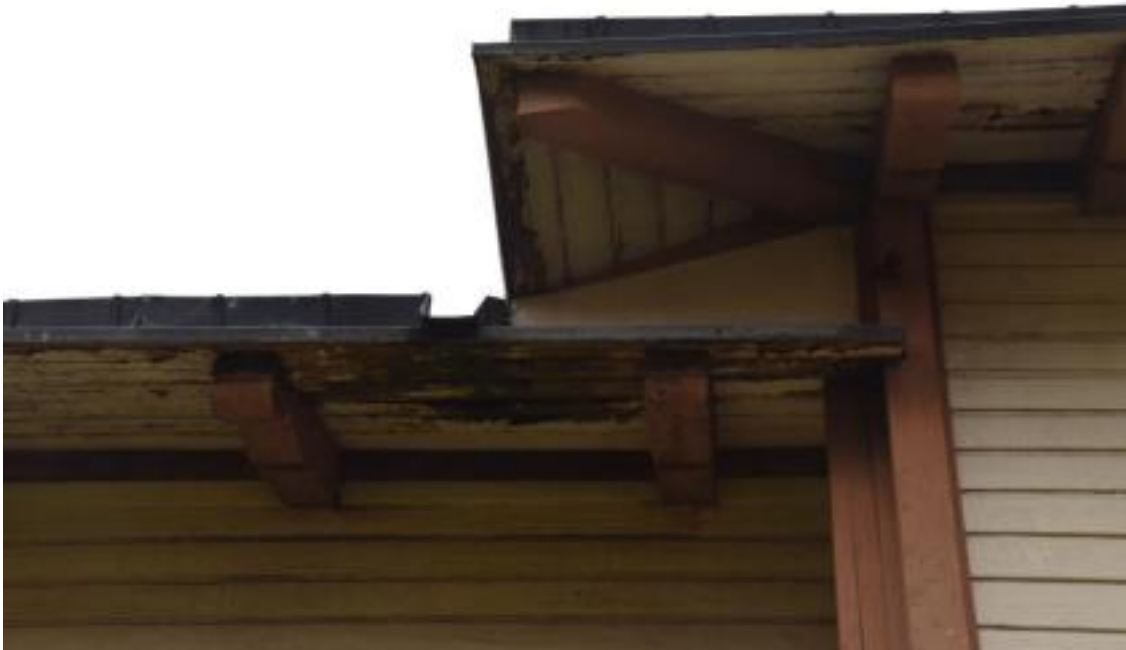
FIGURE 12. Damage to the underside of the eaves of the south-east façade (Tolonen 2021)

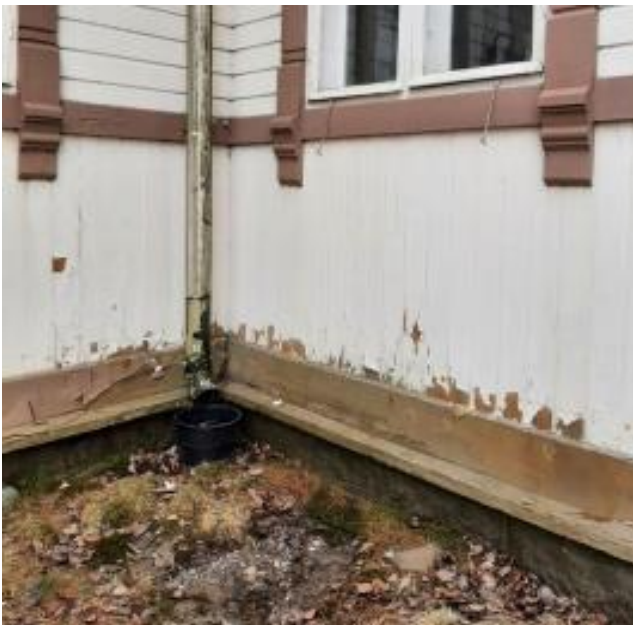
There were considerable damage and deficiencies in the rainwater systems of the building. Gutters and drainpipes were clearly blocked and mossy, with a high risk of rainwater flooding and diverting to façade structures. The location of the drainpipes was slightly too high, allowing water to flow close to the façade (Fig. 13).

FIGURE 13. Damage to the lower part of the façade at the downspout

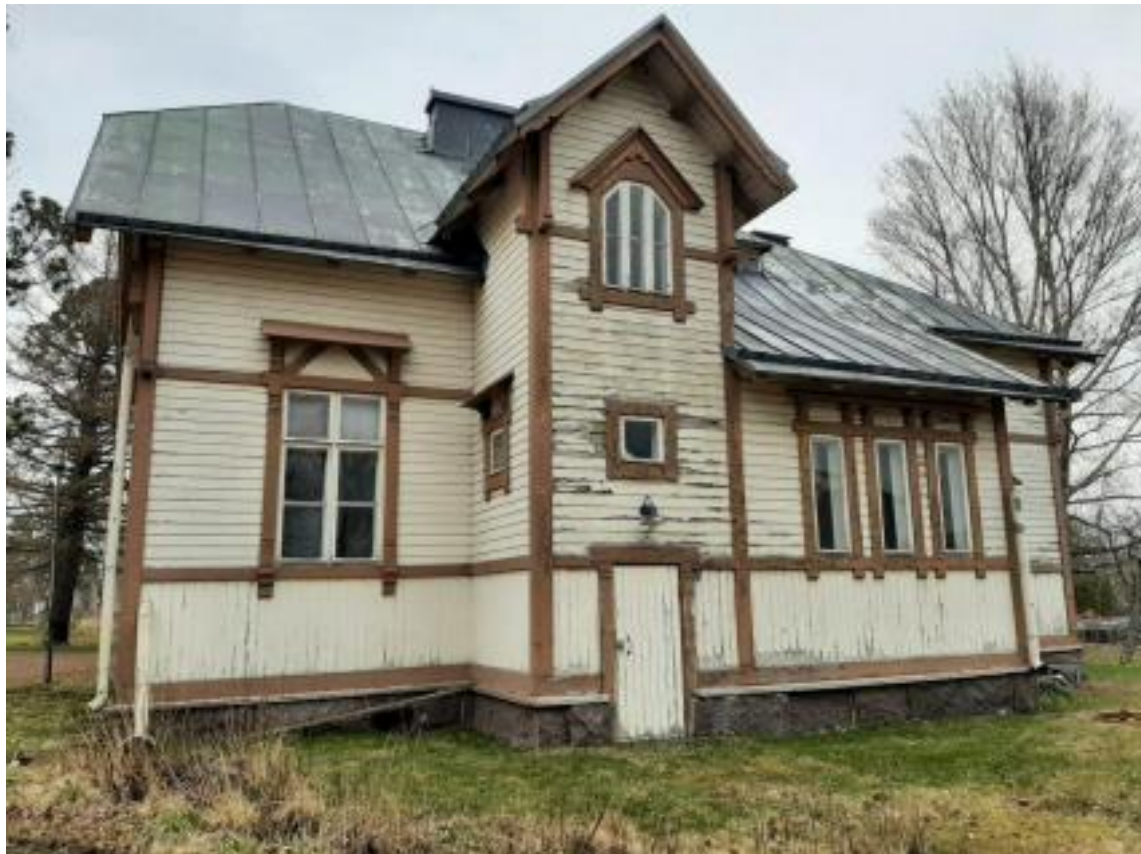
building, which has inevitably caused damage to the façade and eaves structures at these points (Figure 14). The building's rainwater systems should be inspected for any other damage and cleaned of moss, twigs, leaves and other potential debris. The downspouts can be serviced and repainted. Fallen downspouts should also be serviced and re-installed as soon as possible to prevent further damage, and it should also be extended to be at least 100 mm from the underside of the façade.

FIGURE 14. *Significant deterioration of the end façade surface, a door leading to the basement near the ground and a fallen downspout on the left.*

There was considerable deterioration of the paint surface on the façade of the south end of the building. The ground surface of the façade cracked significantly, the paint surface was the so-called crocodile-coated. Exposure to heat and sunlight, as well as a layer of paint that is probably initially too thick, have combined to affect the condition of the façade. (Figure 14.) Repairing the end facade would require painting and possibly air vents in the end structure to increase breathability. The facades of the building were completely worn out and the building would have to be repainted in its entirety.

When planning the renovation of a façade, it is possible to study the colour options and whether, for example, the decor of the exterior doors can be further emphasized with a different colouring. Respecting the style of the building, oil-based paint could be used to paint the façade; above all, the paint must be breathable in order to prevent the accumulation of moisture in the surface structures.

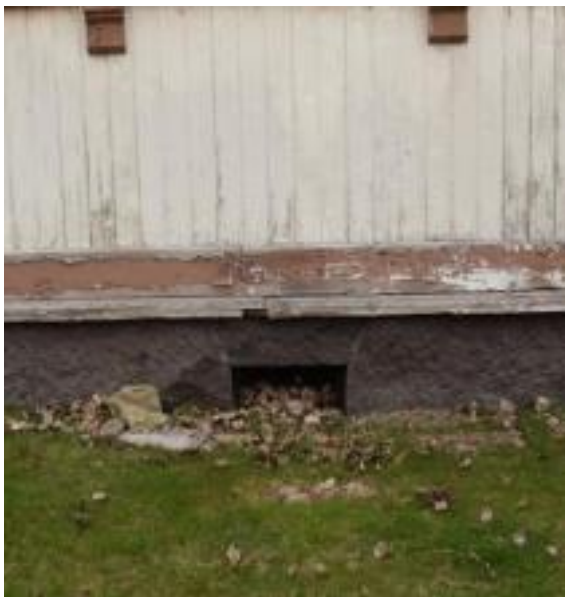
The basement ventilation windows and the outer door leading to the basement at the south end were very close to the ground (Figures 14 and 15). Lowering the terrain around the building and tilting away from the foundations would also help prevent rainwater from entering the basement and its outer wall structures.

FIGURE 15. Basement ventilation hatch (Tolonen 2021)

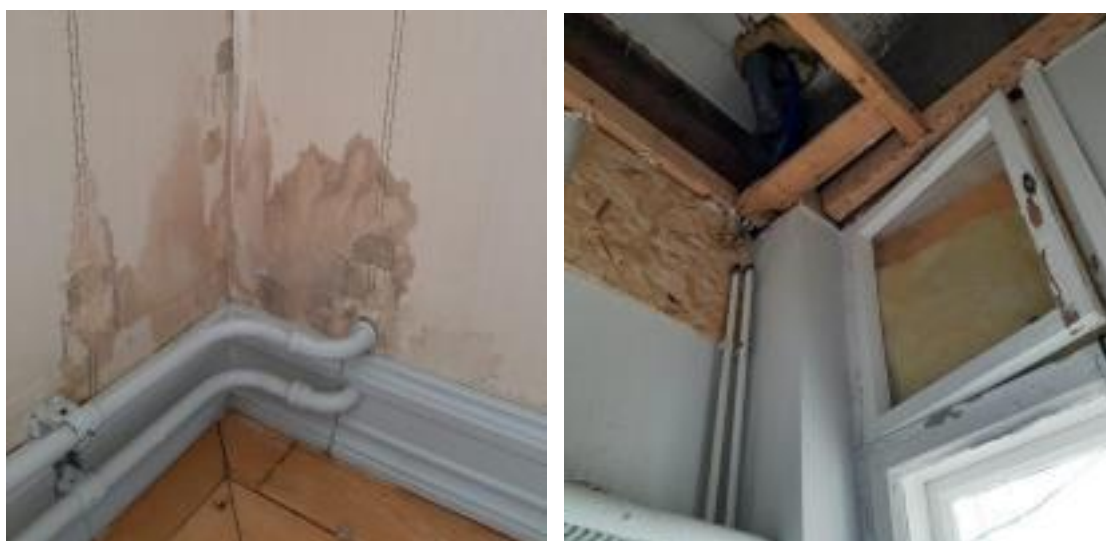
Indoors, moisture damage was observed on the first floor in the structures adjacent to the two toilets. Viewed from the entrance, in the back corner of the small toilet at the left end, there was visible moisture damage to the back on the wall surface. Water has entered the structure from probable leaking water pipes which had apparently already been cut off in the toilet but the piping had not been repaired. In addition, the part above the toilet window was filled with insulating wool when the window glass was broken. (Figure 16.)

FIGURE 16. Moisture damage in the room behind the first floor toilet and toilet water pipes and insulated window

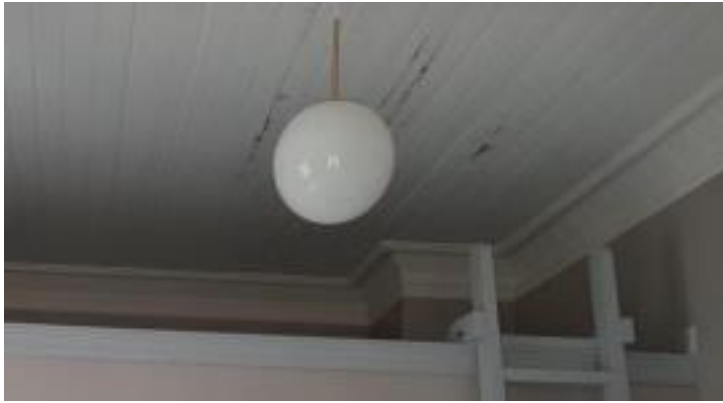
On the first floor, one of the office rooms had moisture damage on the ceiling surface (Figure 17). Above the damage site, there was a heat distribution room on the second floor, so moisture has passed from there through the midsole. Below the area affected by the moisture damage, on the first floor, there were toilets built later in the building during the renovation. The toilet on the premises in the office room had a shallow loft, so moisture has not passed below the ceiling surface.

FIGURE 17. Moisture damage to the ceiling surface below the heat distribution room.

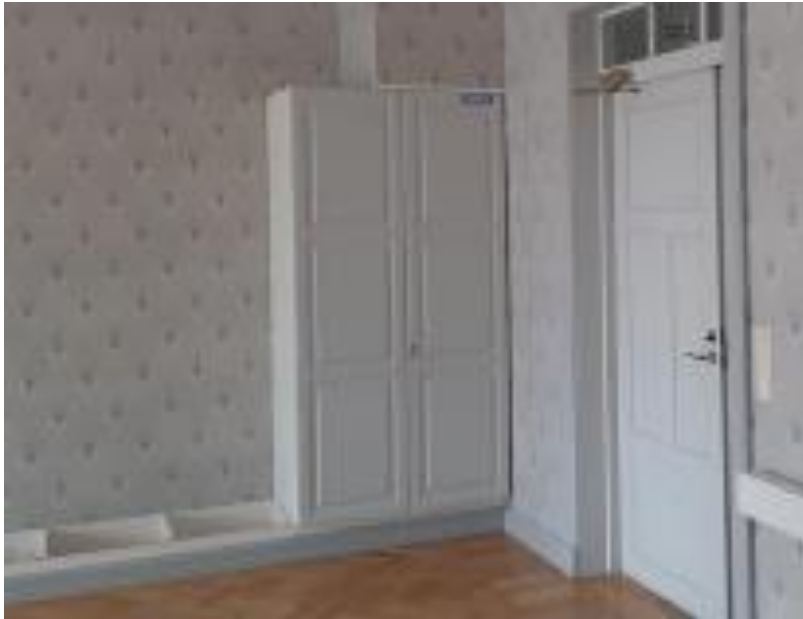
The technology in the building was old-fashioned and their placement was unnecessarily bulky (Figure 19). Indoors, the supply and exhaust air valves were placed too close together, as a result the air cannot circulate enough in the rooms (Fig. 20). When replacing the ventilation equipment, the appropriate placement of the valves may be considered more appropriate.

FIGURE 19. *Technology in a partially dismantled cabinet on the first floor*

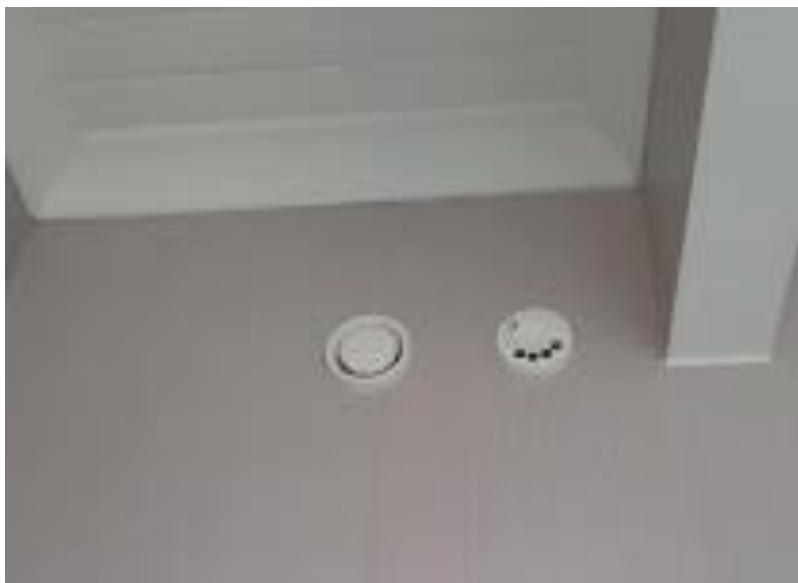
FIGURE 20. *Side-by-side supply and exhaust air valves*

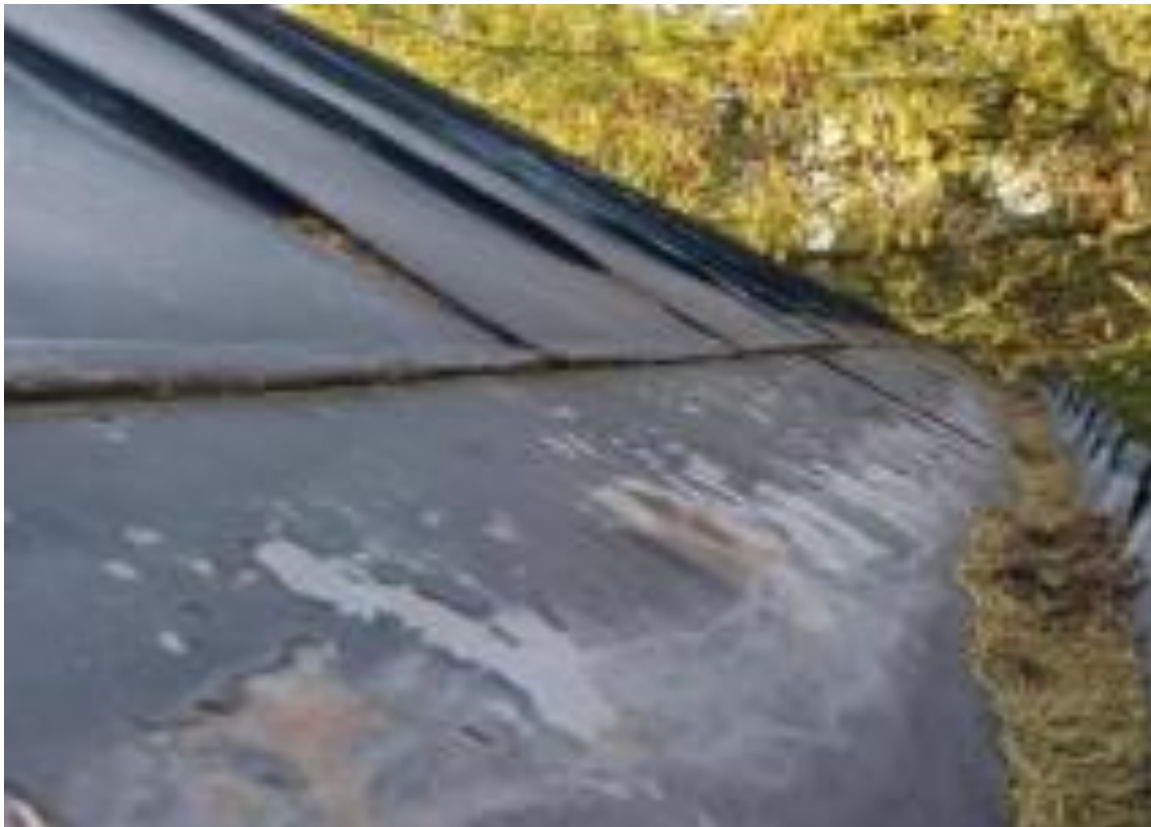
The originally thick sheet metal roof, which was typically thick during its manufacturing period, was visually in good condition, with the exception of occasional paint wear and surface rust, as well as the few leaks and moisture damage to the underside of the eaves mentioned above. On the water roof, the foot girders were loose but intact (Fig. 21). (Riekkı 2021.)

FIGURE 21. Paint and surface rust detached from the sheet metal roof and dirty footstool (Riekkı 2021)

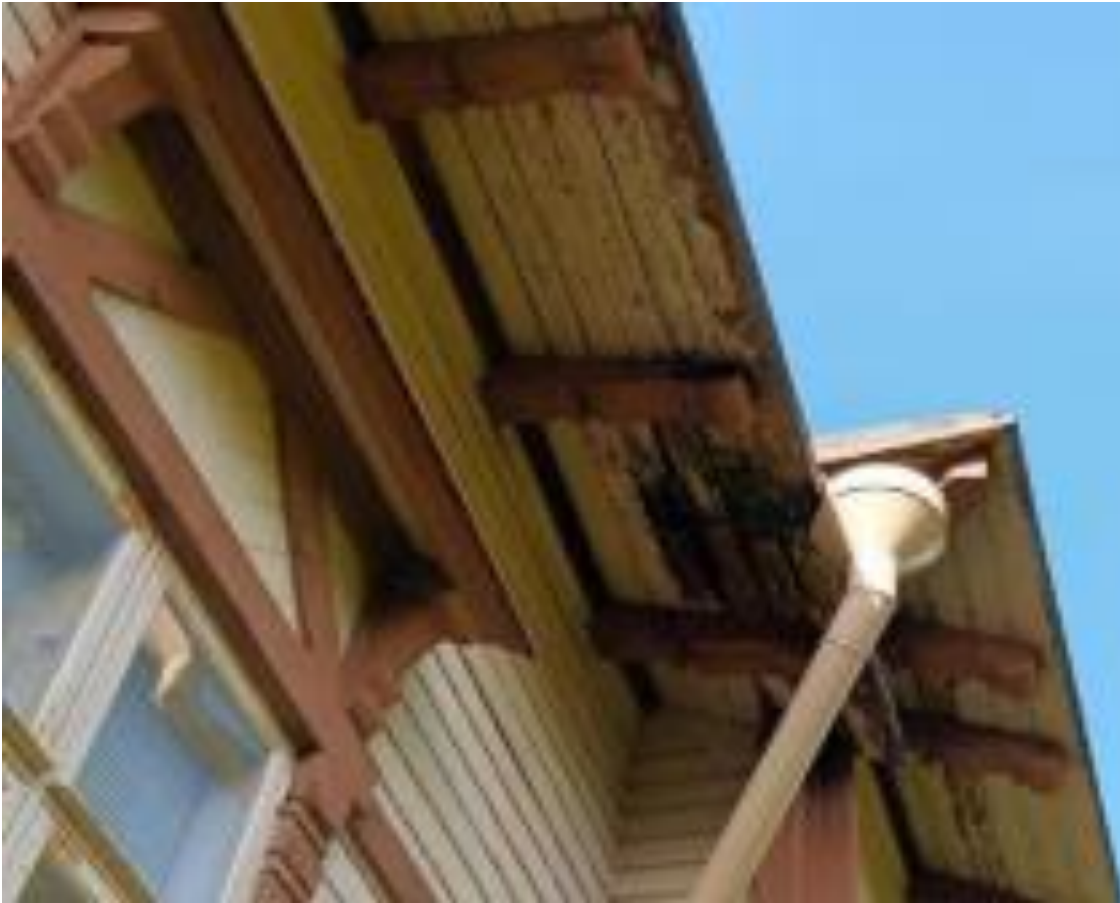
By the inventory visit of this condition assessment, the downspouts of the building had already been renovated (Figure 22). The roofing was not recommended for renovation or complete renewal; painting, patching leaks and adding drops to the eaves are sufficient as corrective measures. There was significant wear on the facade surfaces and damage to the exterior stairs. The façade must be renovated as necessary. (Riekkı 2021.)

FIGURE 22. Leakage from the eaves on the lower surface and a new downspout (Riekki 2021)

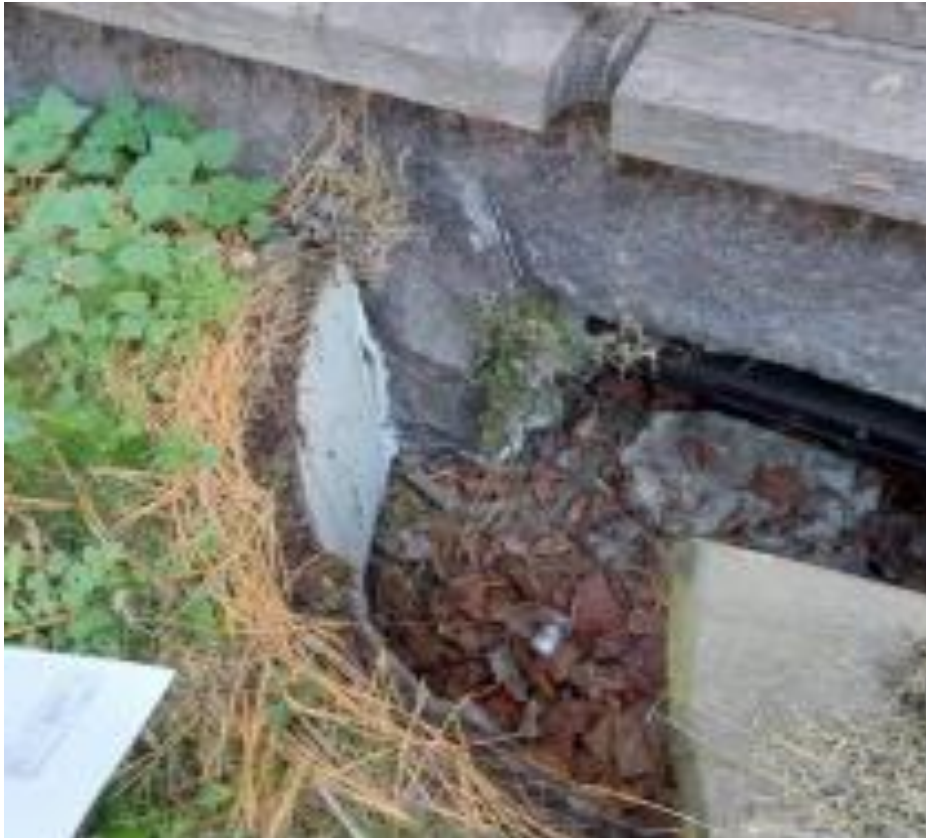
Rainwater control was deficient; some of the downspouts descended into the gutter well and some to the parasitic rocks and ground slopes were inevitable. The ground level had risen around the building, resulting in the basement ventilation hatches being too low (Fig. 23). In addition, the edges of the building had vegetation that increased moisture stress and some harmful alien species. The yard area should be basic repaired. The renovation includes e.g. improving rainwater management with sufficient slopes, determining the bearing capacity of the ground and installing drainage systems where one does not exist. (Riekki 2021.)

FIGURE 23. Basement window on a stone foot (Riekki 2021)

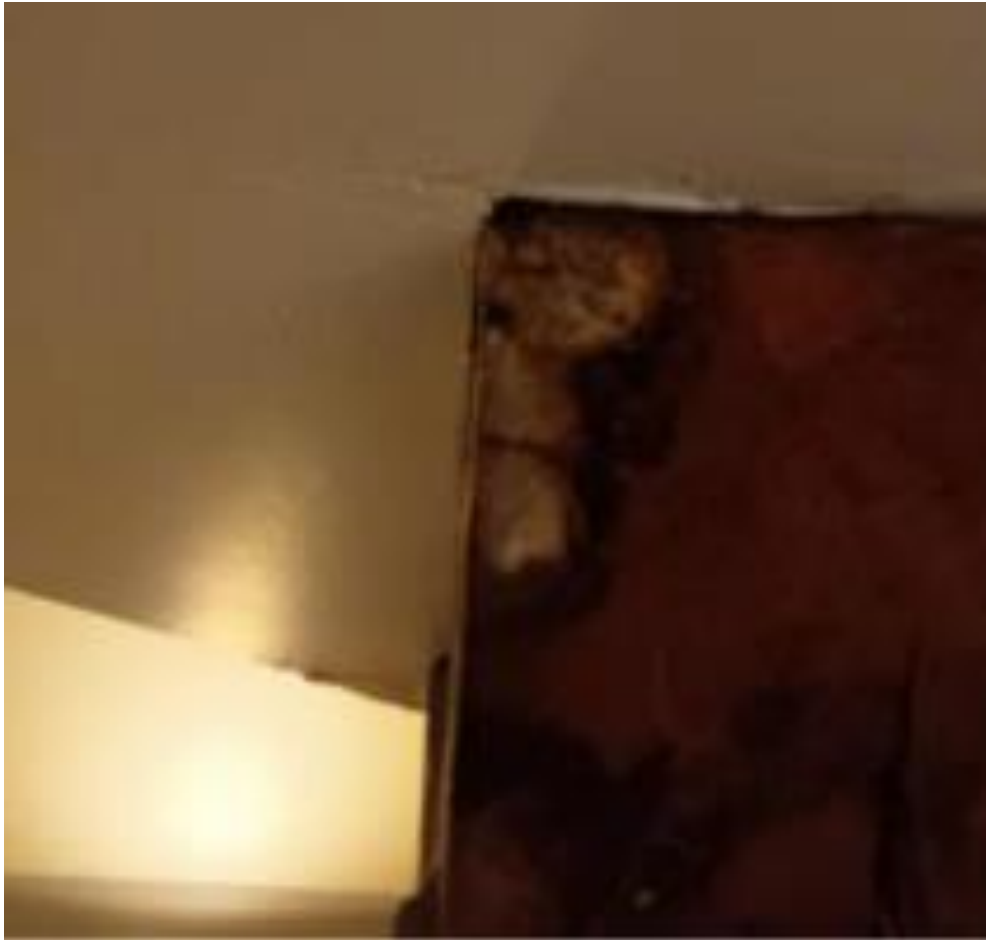
In the building, the structure supporting the upper floor, a log so-called the roof truss of the front house, was partially unventilated. In the upper part of the unventilated sloping roof and the rafters, a trace of moisture-induced leakage was observed (Fig. 24). In the room air, a typical cellar odour was observed, which may indicate microbial growth. The condition of the components of the upper sole should be checked and the ventilation of the upper sole improved. (Riekki 2021.)

FIGURE 24. Leakage trace and signs of microbial growth at the base of the lattice (Riekki 2021)

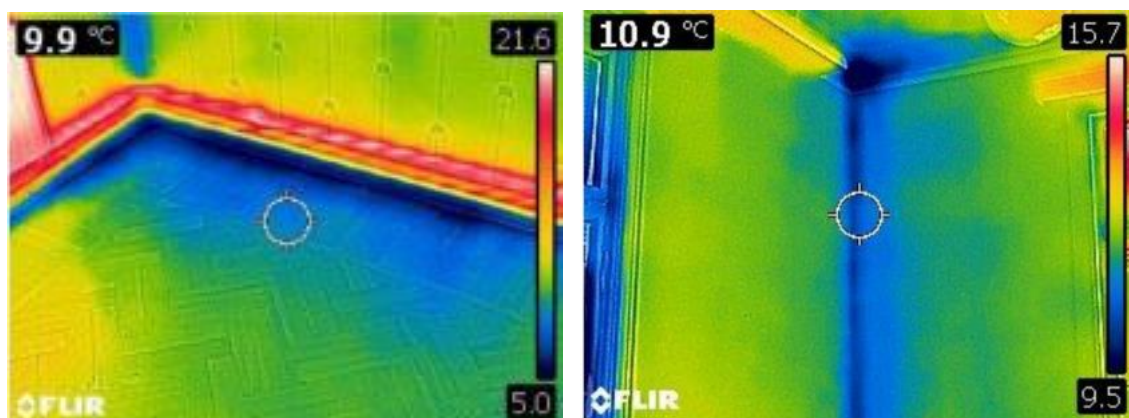
FIGURE 25. Heat leakage at the bottom and at the junction of the walls (Hukka & Korpi 2022)

During the renovation in the 1990s, the building was further insulated, so further insulation is no longer necessary. Repairing components, improving ventilation and airtightness, and improving the energy consumption during the use of a building are the most cost-effective repair methods in this case.
