MYROSS WOOD HOUSE, LEAP, COUNTY CORK

Retrofit Strategy

March 2020

Job Number: 020006

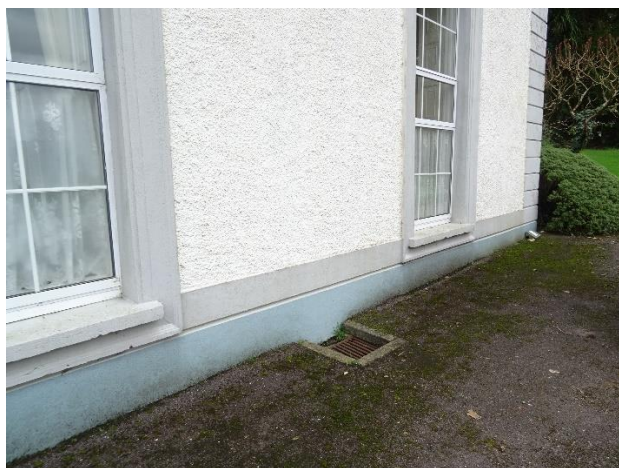
Figure 6. Opening to underfloor vent on the eastern elevation.

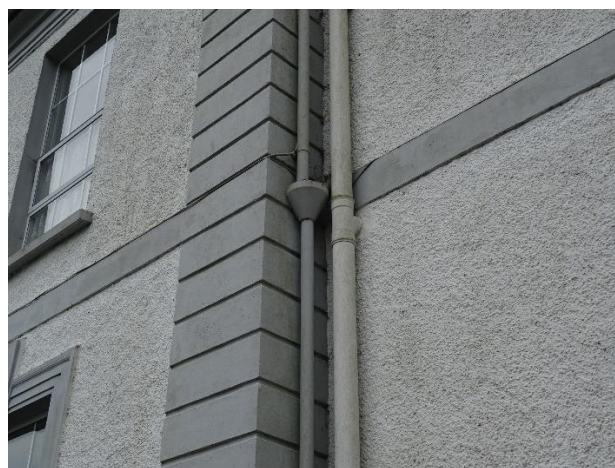
The external walls of the original house appear to have been re-rendered with a hard concrete pebbledash, which will be inhibiting the natural evaporation of excess moisture (Figure 7).

Figure 7. Cement based render and finishes on the eastern elevation of the original house.

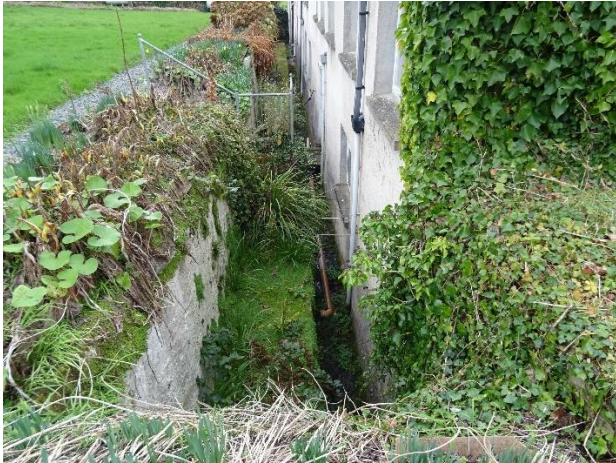
The concrete surfaces and walls in the trench around the northern and western wings of the building are particularly damp and are covered with biological growth (Figure 9 and Figure 9).

Figure 8. Biological growth in the trench around the northern elevation.

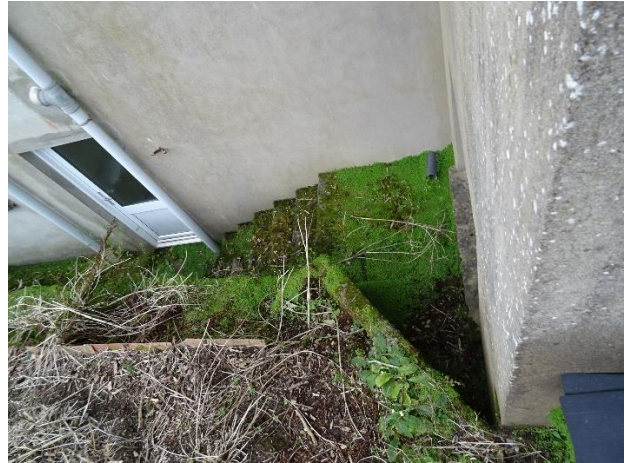
Figure 9. Biological growth in the trench around the western elevation.

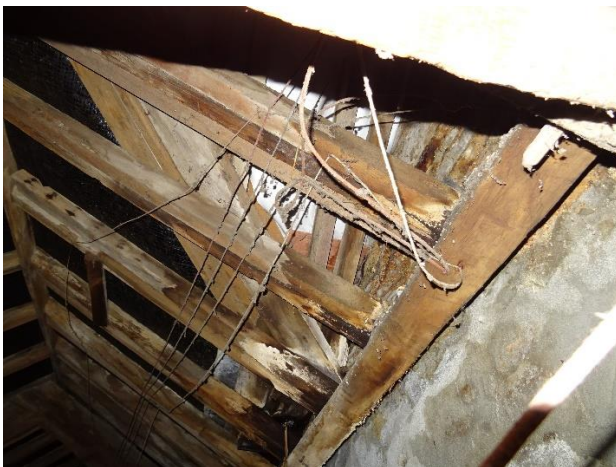
Signs of localised water ingress were found in the attic above the original house with rafters showing decay (Figure 10). White staining on the rafters may be a symptom of condensation build up caused by a non-vapour permeable membrane (Figure 11). Water ingress has also been noted in the eastern wall of the Chapel, so a close inspection of slates and flashings around this chimney stack should be undertaken (see Section 6.1.9, Figure 44).

Figure 10. Evidence of localised water ingress in the rafters above the original house.

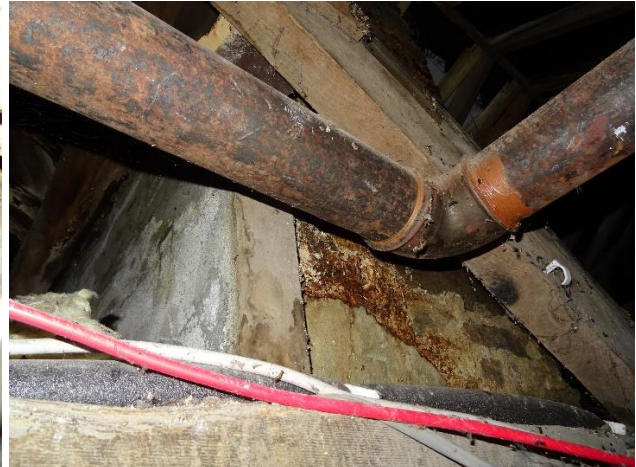
Previous concrete repairs have been made to the chimney stack in the attic above the original house (Figure 11).

Figure 11. Concrete repair to the chimney stack in the attic above the original house.

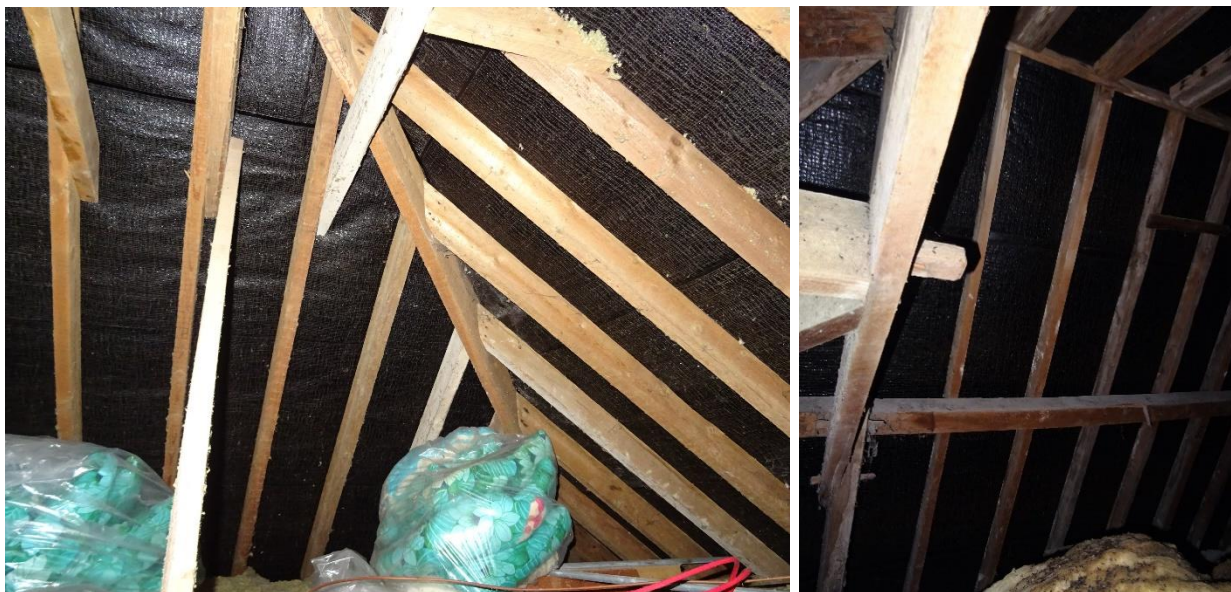
A black roofing felt membrane has been installed above the rafters in the eastern and southern wings of the building (Figure 12 and Figure 13). This membrane is not breathable and is likely trapping moisture, as is evident by the white residue on the roofing timbers in Figure 13.

Figure 12. Non-breathable roofing felt membrane used in the attic space above the southern wing.

Figure 13. The white residue on the rafters above the eastern wing may be a symptom of condensation caused by the non-vapour permeable membrane.

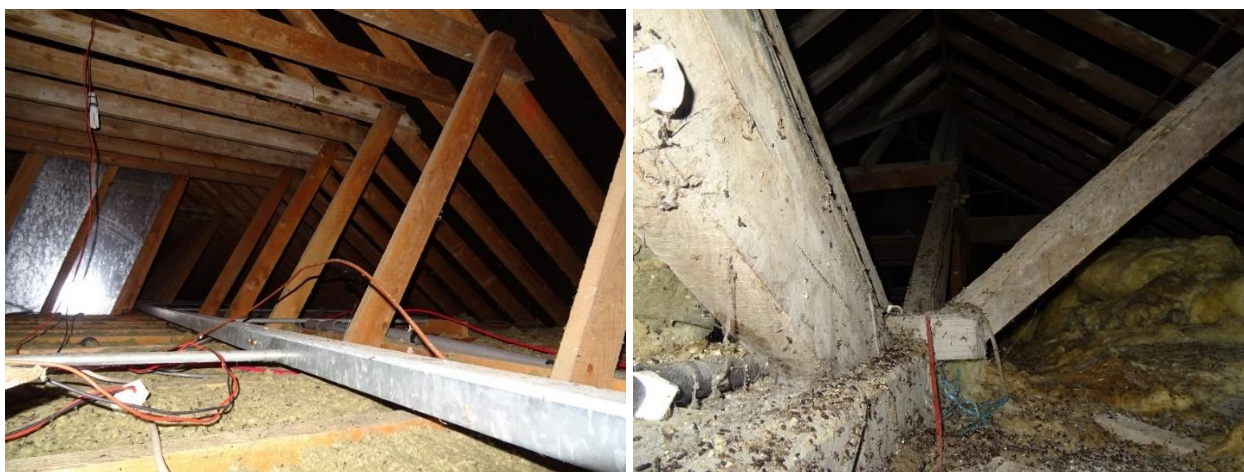
A loose-fill mineral wool insulation has been blown on the flat over the southern wing (Figure 14) and a rolled mineral wool insulation has been laid on the flat over the eastern original wing of the building (Figure 15), both at a depth of approximately 100 mm. The blown insulation appears to be in better condition than the rolled insulation, but both will need to be checked for moisture content and condition before any further insulation is added.

Figure 14. Loose-fill mineral wool insulation over the southern wing.

Figure 15. Mineral wool roll insulation over the eastern wing.

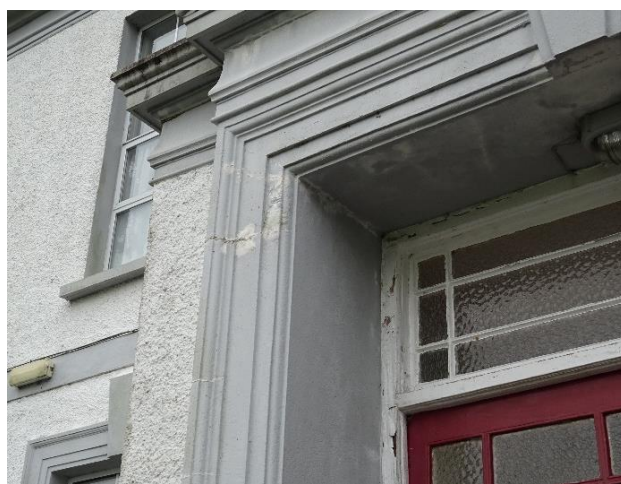
Figure 17. Deterioration around the portico door frame and window frames.

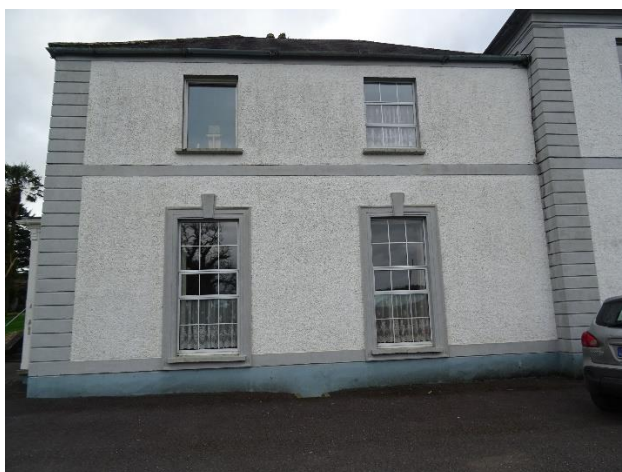
Figure 18. Replacement uPVC windows on the southern wing of the eastern elevation. Most but not all replacement windows are stylistically sensitive with the age of the building.

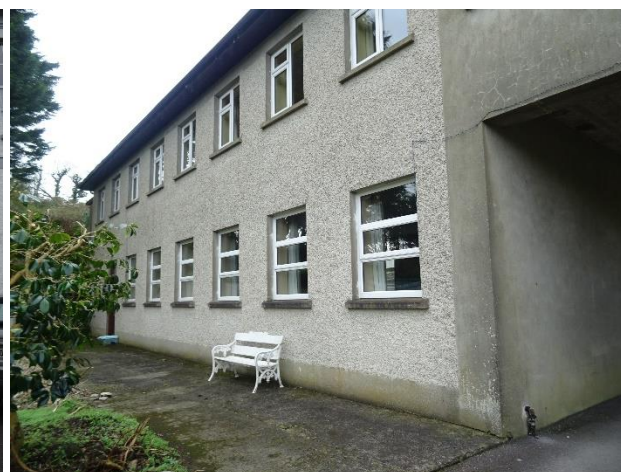
Figure 19. uPVC windows on the southern elevation. All appear to be in acceptable condition.

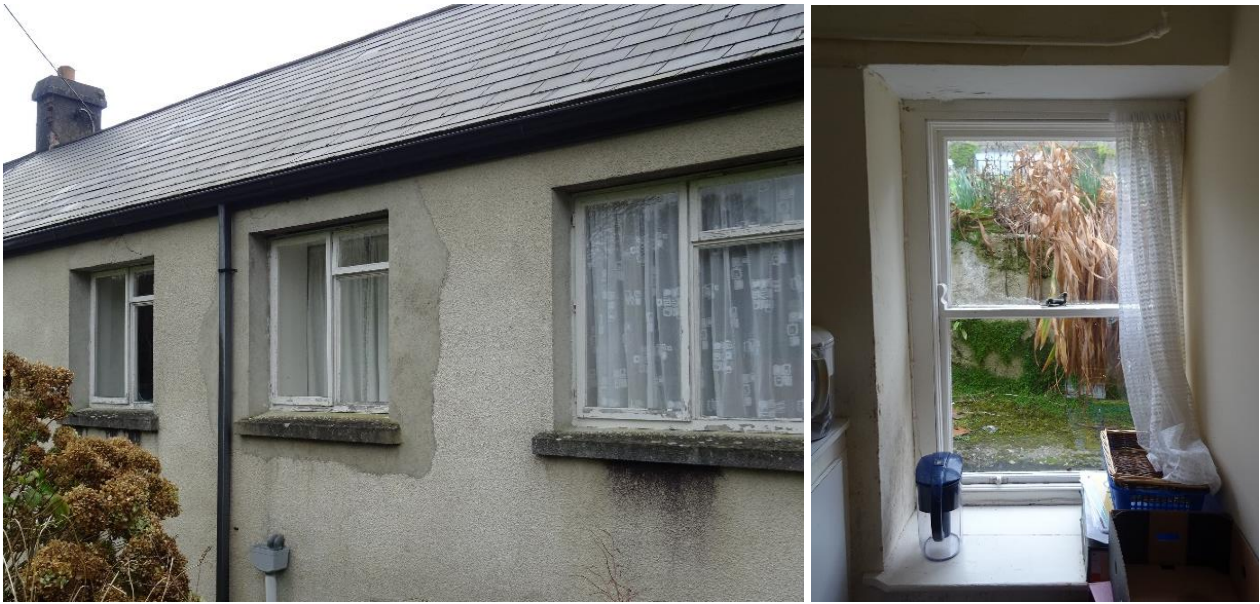
A few older timber framed single-glazed windows remain in the building (Figure 20 & Figure 21). Most of these are in need of repair.

Figure 20. Timber framed single-glazed windows on the northern elevation.
 Figure 21. Timber framed single-glazed window in the Foyer of the North Wing.

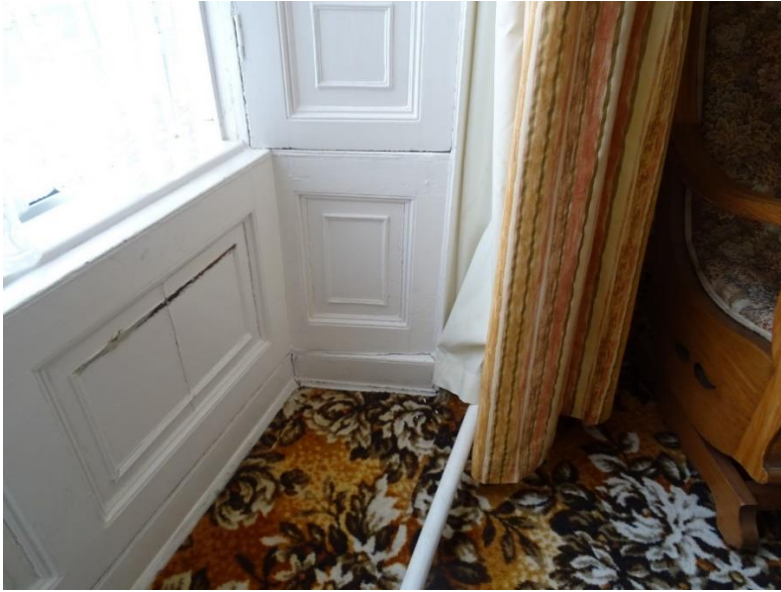
Figure 24. Panelling and shutters around a window in the Parlour need general repair.

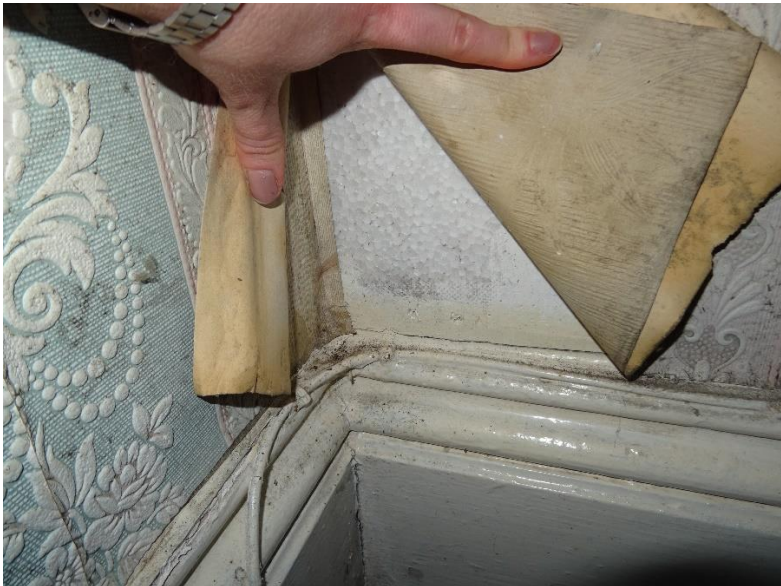
The interior face of the exterior walls of the Community Room and Dining Room to the north of the entrance hall have been internally insulated with a non-vapour permeable polystyrene insulation layer at least 10 mm thick (Figure 26). This has caused a large amount of interstitial moisture to build up in the walls, which has led to mould growth on the wallpaper from floor to ceiling (Figure 27). Condensation and mould were also found behind the shutters as this area is colder than surrounding surfaces (Figure 28). An internal leak in the southwest corner of the Dining Room has damaged the historic ornamental cornicing.

Figure 26. Thin polystyrene 'insulating wallpaper' found behind the wallpaper.

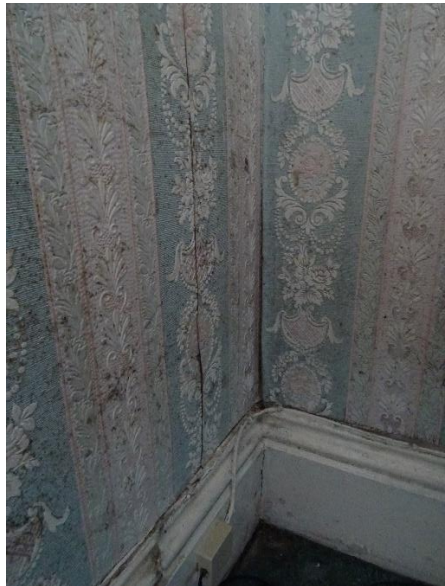
Figure 27. Surface mould on the wallpaper over the polystyrene wall insulation.

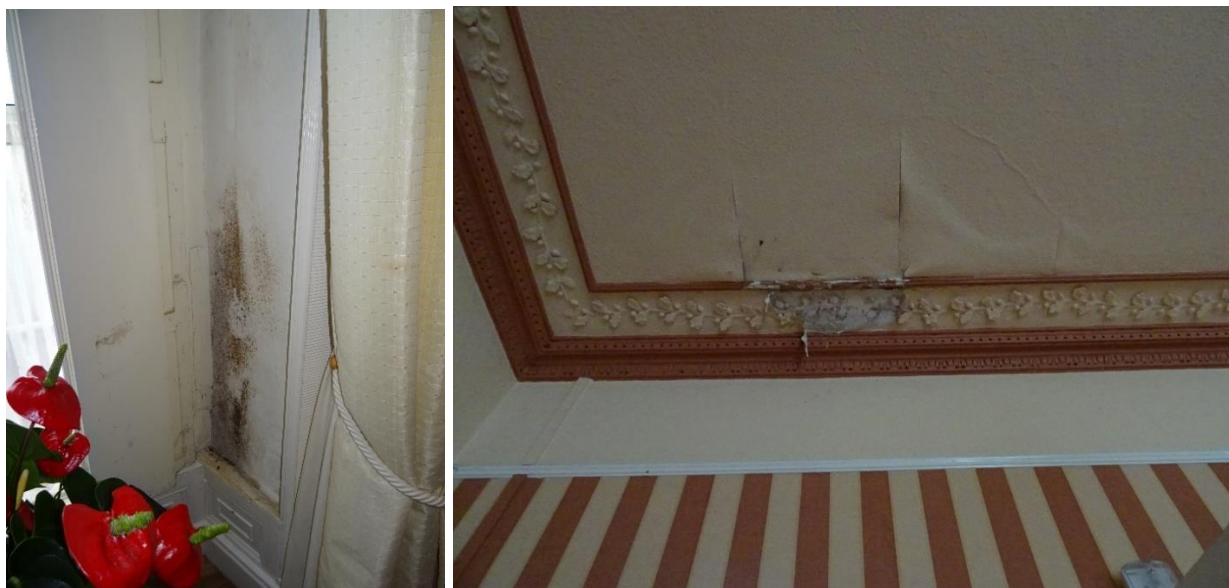
Figure 28. Mould caused by condensation on a cold spot behind the shutters in the Dining Room.

Figure 29. Damage caused by an internal leak above the Dining Room.

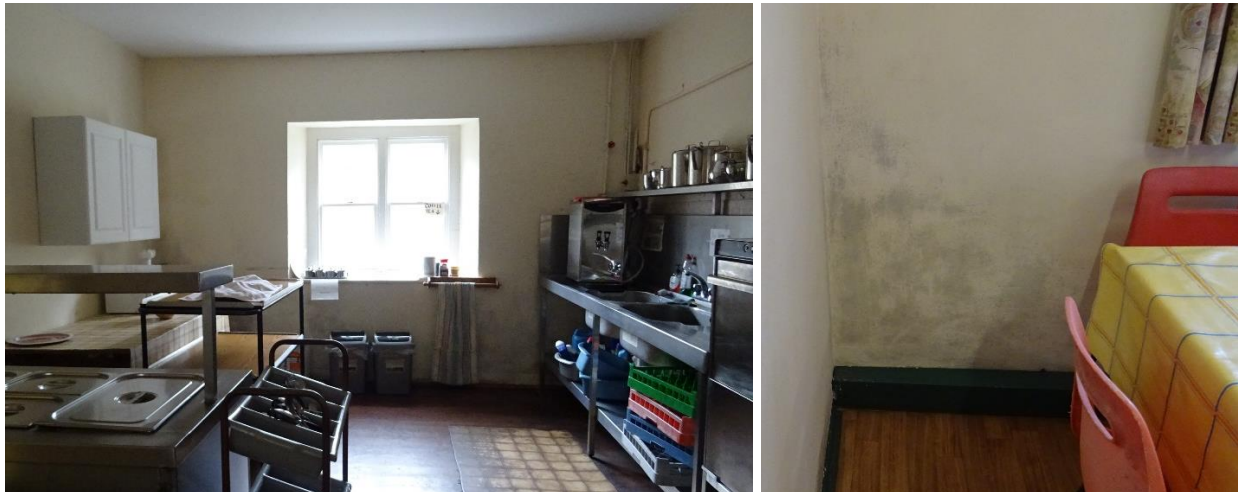
The exterior walls of the Retreat Lounge, Dining Hall, Washing Up Room and Foyer are all showing signs of damp (Figure 32, Figure 33). The carpet over the southwest corner of the Retreat Lounge is wet and a dehumidifier is being used in the room to remove the excess moisture (Figure 34, Figure 35). The ground level outside this room is above the ceiling level, but a retaining wall the width of a walkway separates the soil from the exterior of the building. The base of the trench is covered with concrete, which causing rainwater to be absorbed by the walls rather than the ground. Ivy growth up to the roof of the northwest corner may also be blocking gutters and causing rainwater overflow (Figure 36).

Figure 32. Staining along the lower level of the external wall in the Washing Up Room indicates persistent issues with rising damp.

Figure 33. Damp in the northwest corner of the Dining Hall.

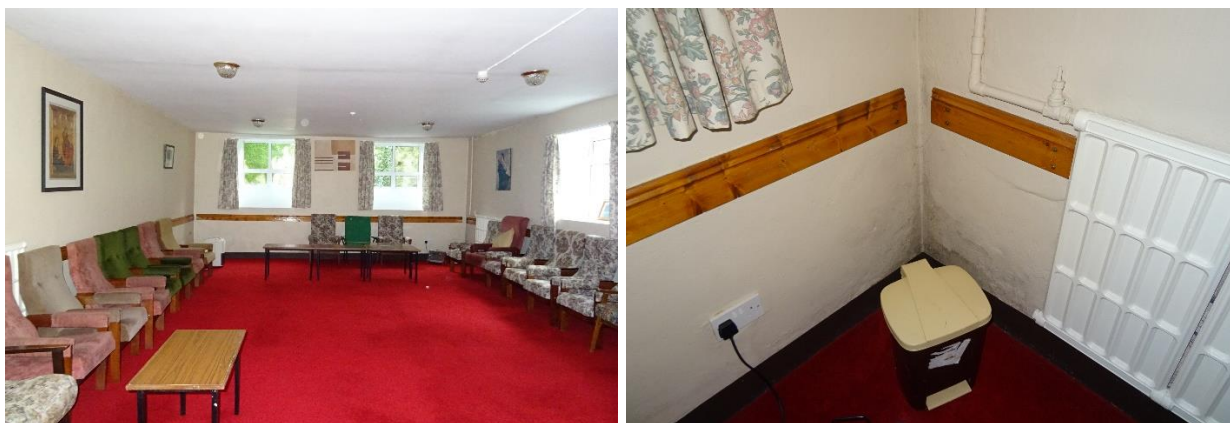
Figure 34. Retreat Room - both the northwest and southwest corners are showing signs of persistent damp.

Figure 35. Damp in the northwest corner of the Retreat Room

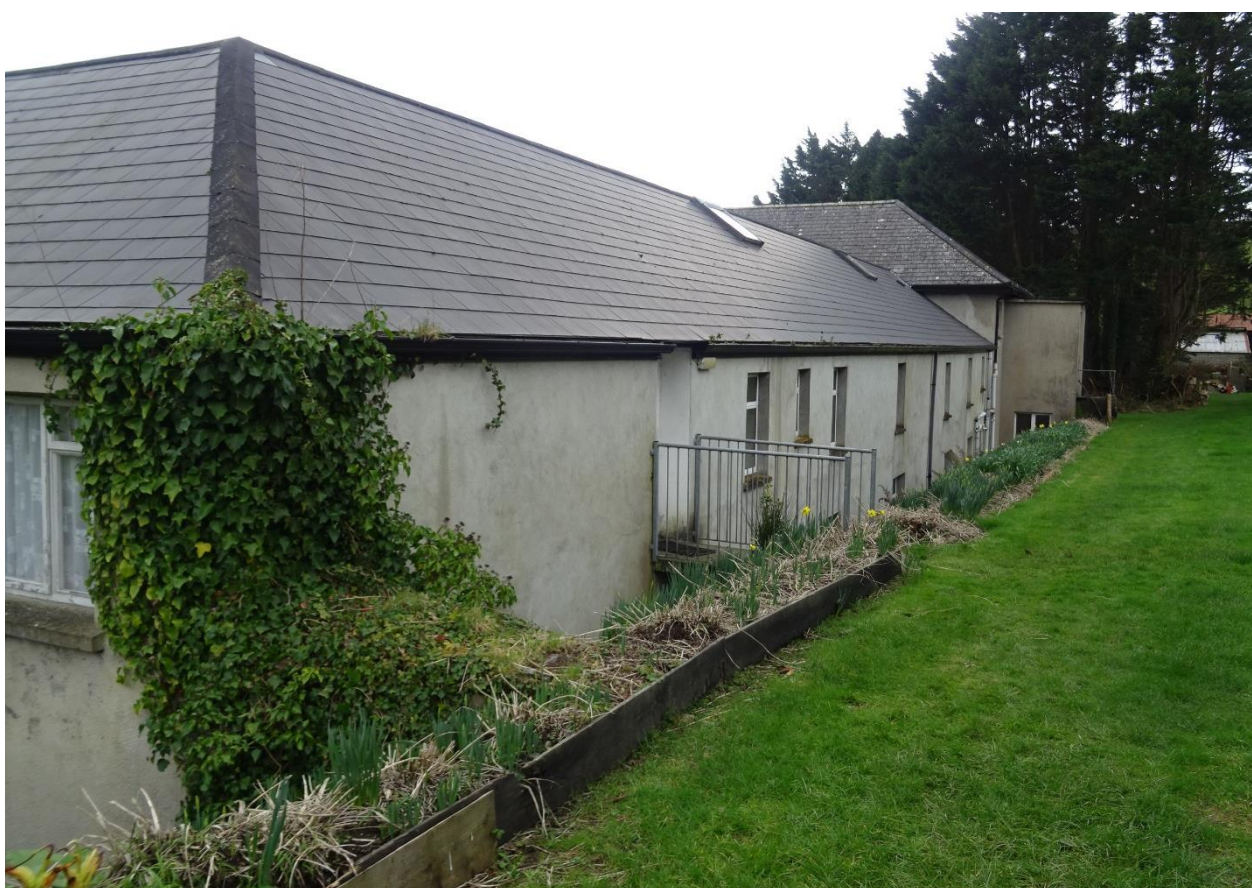
Figure 36. Ivy growth on northwest corner of the building. Note that the Retreat Lounge level is fully below ground.

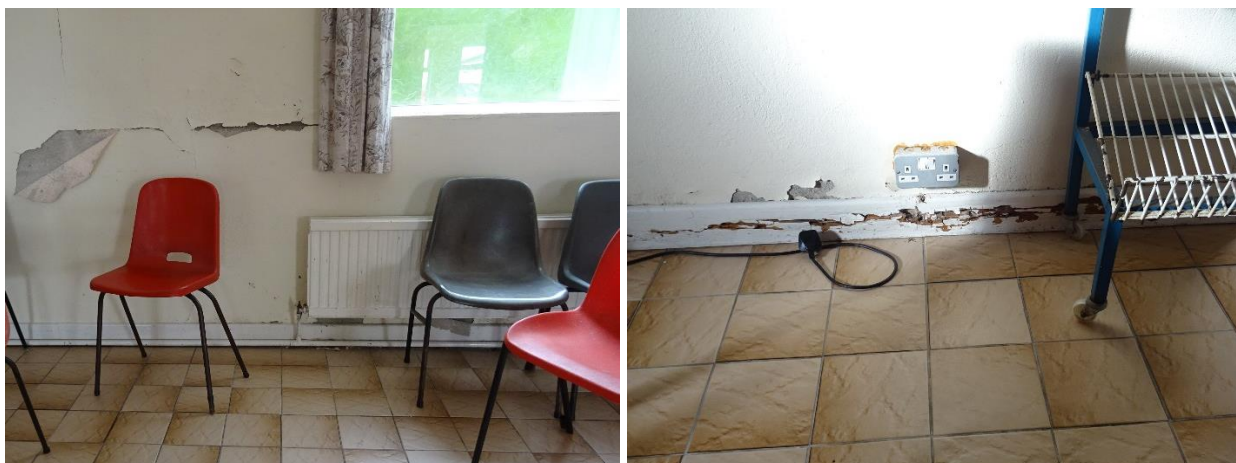
The Lounge and Hall in the western wing are constructed of concrete walls (650 mm) and floors. These rooms are also showing significant signs of damp in the external walls to the west where the external trench is lined with concrete (Figure 37). The timber floorboards in these rooms were also rotting in places due to excess moisture (Figure 38).

Figure 37. Damp conditions found within the external wall of the Lounge and Hall of the West Wing.

Figure 38. Rotting timber floorboards were found throughout the West Wing.

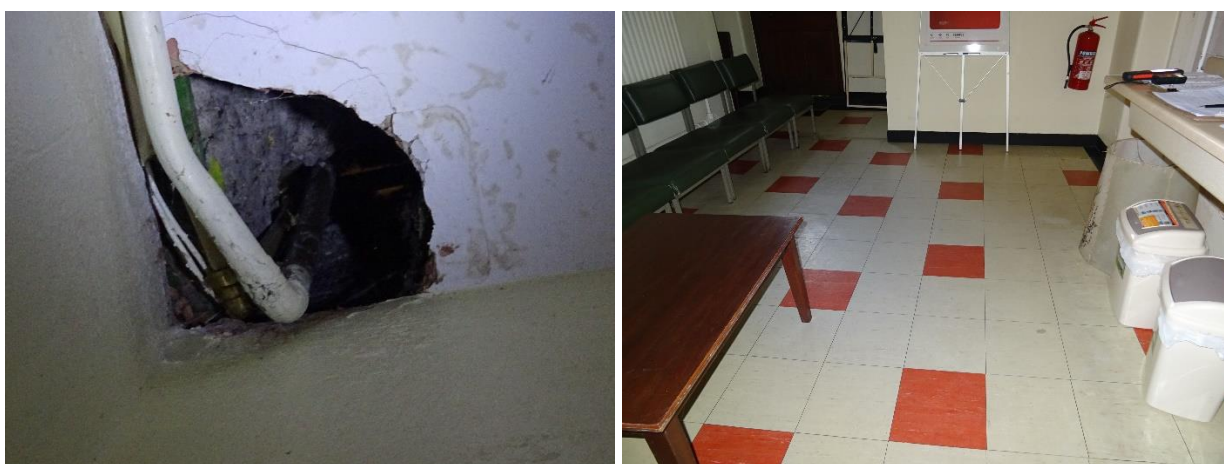
Figure 39. Internal leak within NW corner of the Tearoom.

Figure 40. Vinyl (potentially asbestos) tiles in the Tearoom and Store.

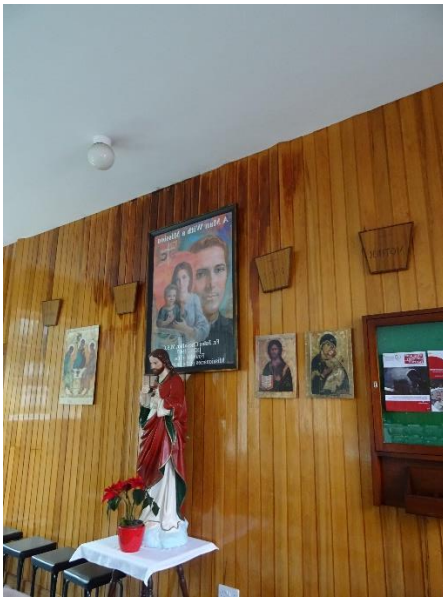
Figure 42. Rainwater ingress around the defunct chimney stack in the east wall of the Chapel in the South Wing.
Figure 43. Conference Room in the South Wing.

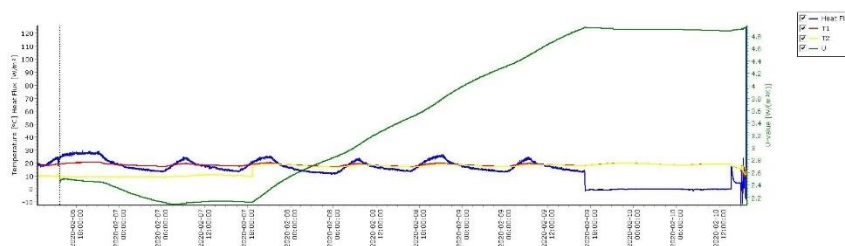
Figure 44. Output from the in-situ u-value measurement undertaken at Myross Wood House.

Figure 44 shows the output from the in-situ u-value measurement undertaken on the northern corner of the east wall of the office above the dining room at Myross Wood House from 15:42 on Thursday, 6 February 2020 until approximately 18:00 on Friday, 7 February 2020 (see Figure 49 for exact location).

Please Note: This data requires some interpretation due to the onset of Storm Ciara on Friday, 7 February. As one can see, the measured u-value (green line) takes a dramatic leap from approximately 18:00 onward on Friday, 7 February. This corresponds to when the external sensors were removed from the external face of the wall and brought inside to protect them from rain damage. This intervention has skewed the readings in the overall output as the sensor was not turned off until Monday, 10 February when Carrig was able to retrieve it. However, we can see from the diagram at the bottom that the u-value had essentially flat-lined for 12 hours from 06:00 to 18:00 on 7 February at approximately 2.1 W/(m²K).

This u-value corresponds with the default value provided for solid walls in the Dwelling Energy Assessment Procedure (DEAP) used to calculate dwelling Building Energy Ratings (BERs). Although we were hoping to find a lower u-value given the thickness of the wall (700mm), this higher u-value may be due the material qualities of the concrete render which is a poor insulator and can trap moisture due to its impermeable nature. As water is a conductor, damp walls typically increase the transmission rate of internal heat through the walls by approximately 30%.
