Approaching Near Zero Energy in Historic Buildings

Deliverable No: T3.2.1

Deliverable Title: Initial Energy Performance Assessments

Deliverable Coordinator: Historic Environment Scotland

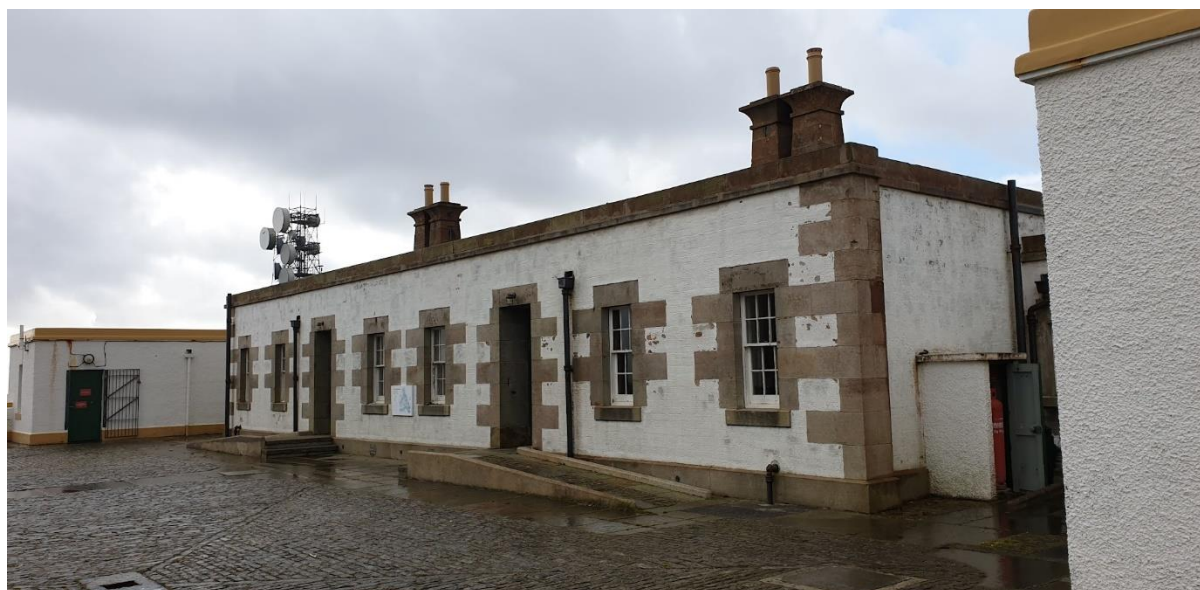
Figure 3: The south-eastern block – Image © Historic Environment Scotland – Photographer: Carsten Hermann

The earlier south-eastern block is unusual for a domestic structure of its time in Scotland, in that the external walls are constructed of brick rather than stone. These are also unusual for being 600mm in depth, typically a solid brick external wall in 19th century Scotland or elsewhere in the UK would be approximately 200 to 300mm, this is likely to be a design adaptation to the building's northerly location, high exposure, and comparatively extreme local environment.

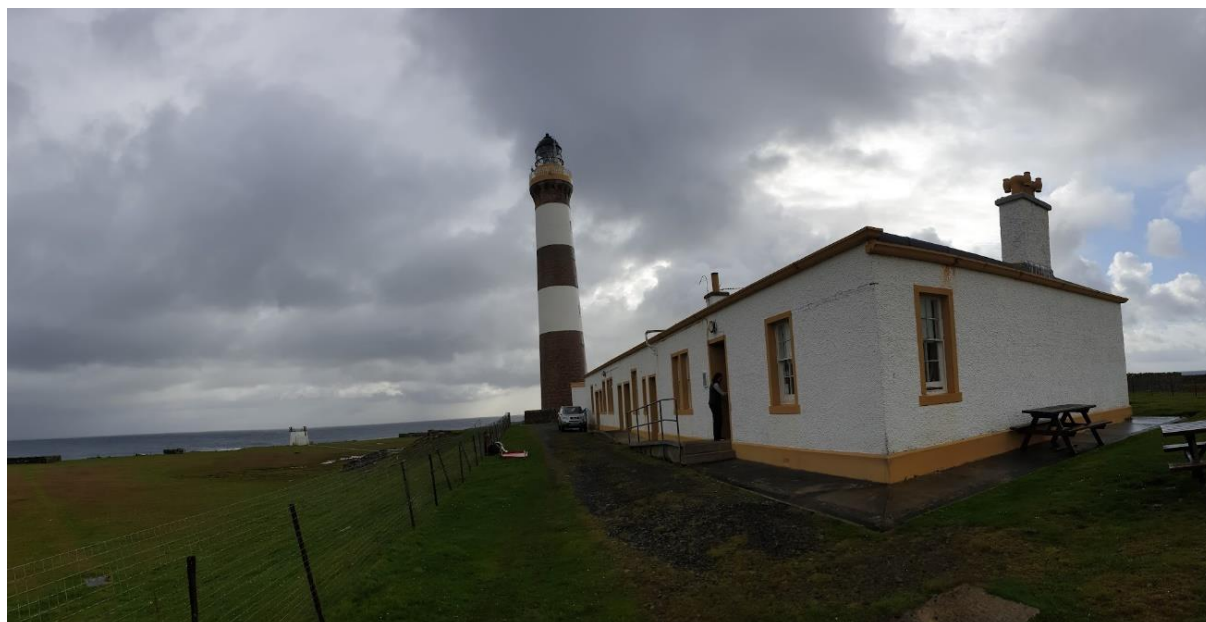
Figure 4: The north-western block – Image © Historic Environment Scotland – Photographer: Carsten Hermann

The exact construction date for the north-western block is unknown, conceivably it may have been original (1850s) or could be as late as the early 20th century. Some sources do suggest it is original however this is somewhat counter-indicated by its very different construction technique which would have been highly unusual, though not unknown, in mid-19th century Scotland.

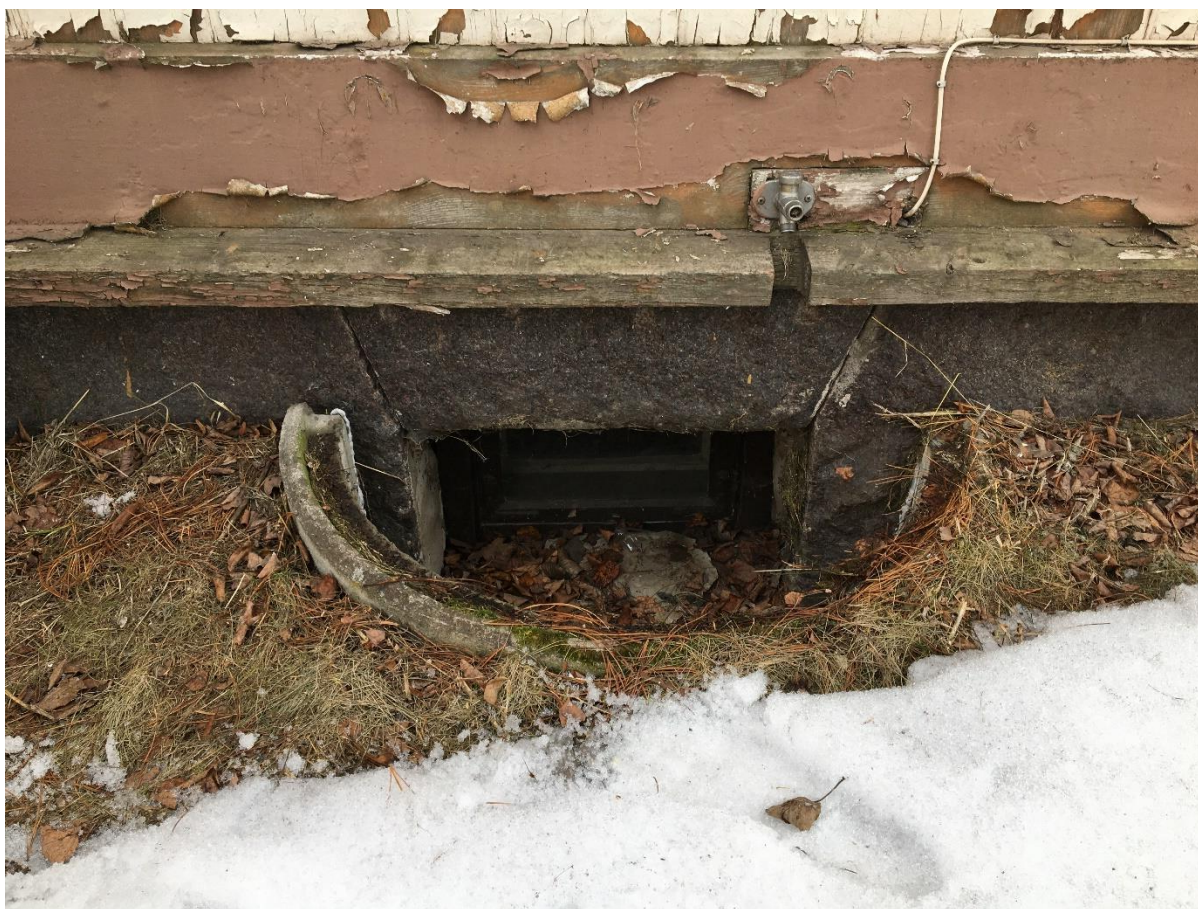
Figure 9: Modern semi-circular concrete ring added to protect an original ventilation opening, which has itself been modified to serve as a basement window – Image © Historic Environment Scotland – photographer: Kenneth Easson

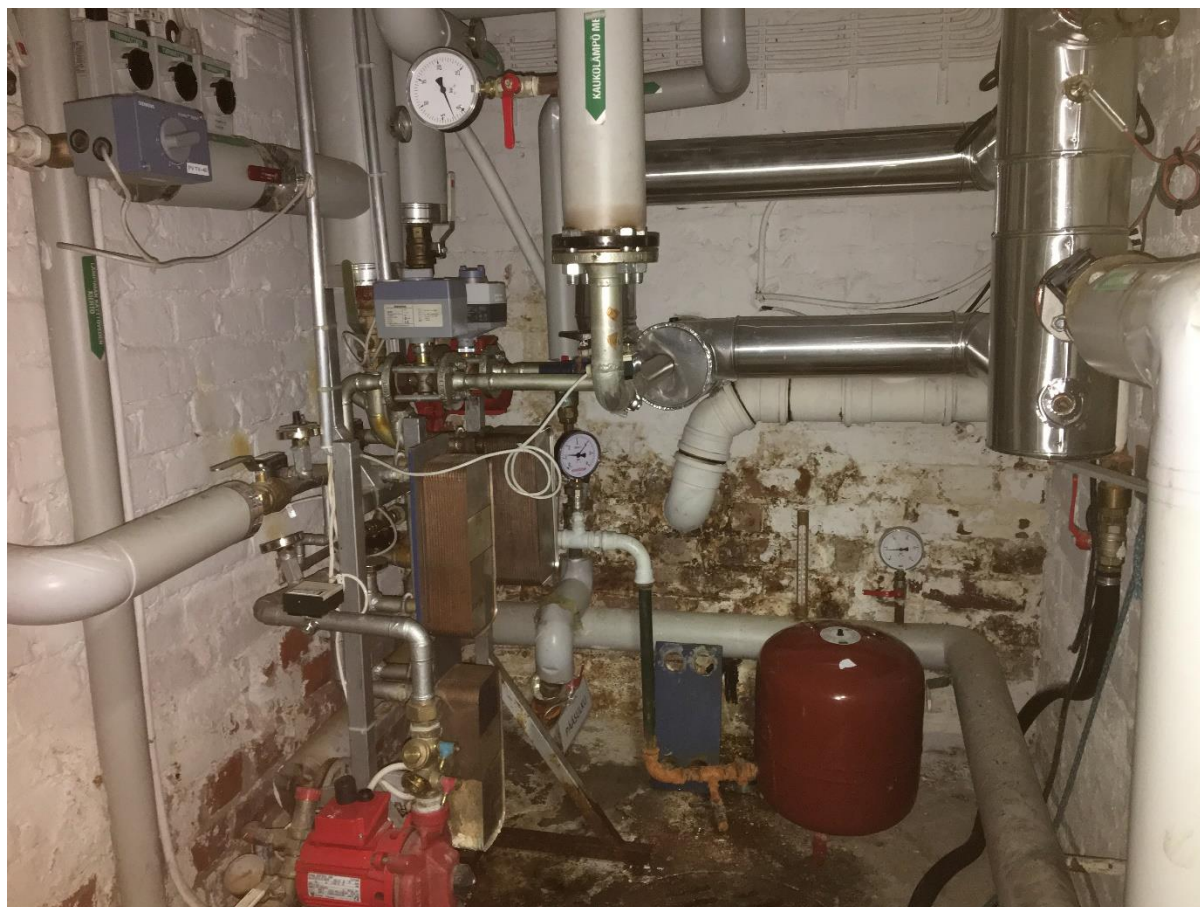
Figure 10: Basement room housing district heating plant equipment, note in particular the heat exchangers (three rounded metal cuboids to left of centre showing visible corrosion) – Image © Historic Environment Scotland – photographer: Kenneth Easson

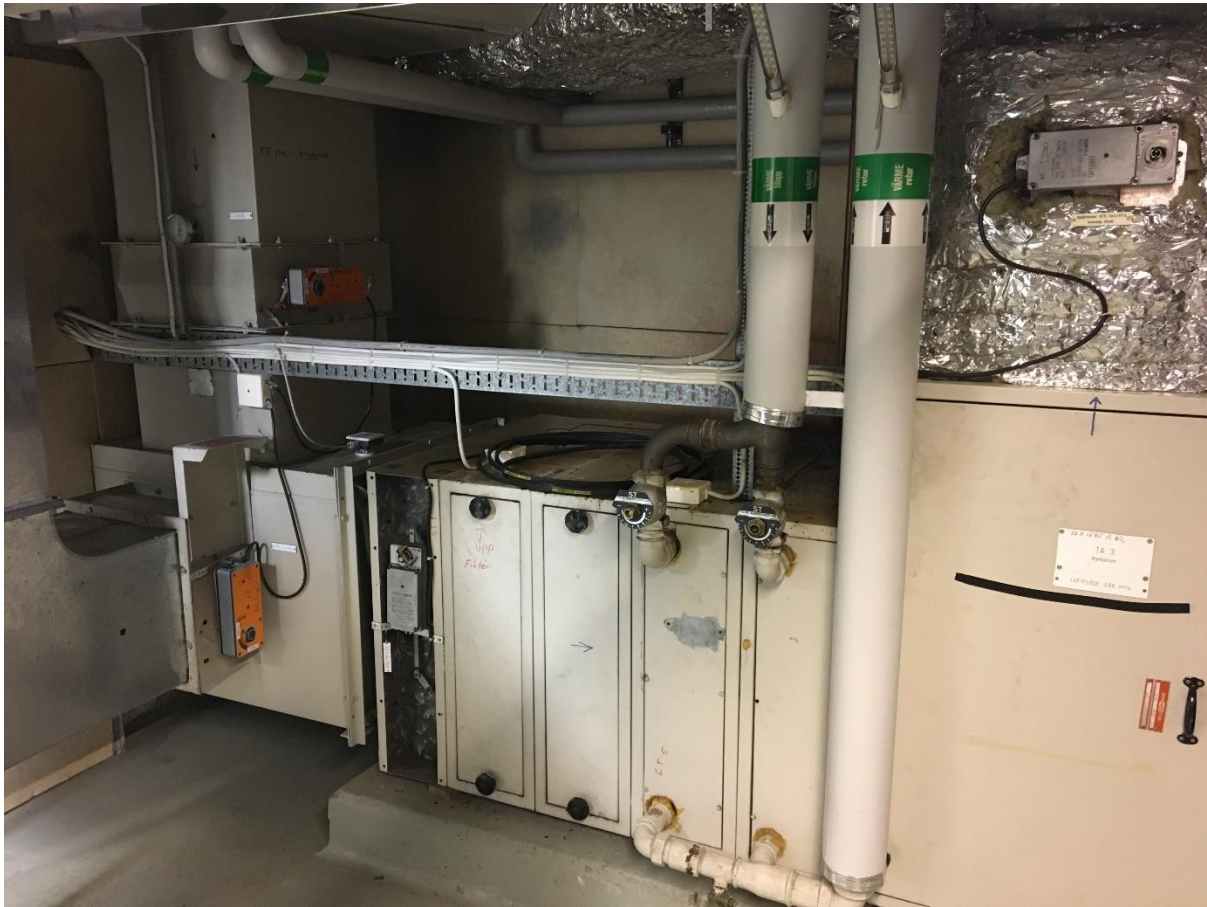
Figure 14: Heat recovery ventilation unit in the plant room at Tegn Church – Image © Historic Environment Scotland – Photographer: Kenneth Easson

The church has a mechanical ventilation system that works on the basis of a heat recovery system. A significant issue for the church is the presence of asbestos in the lining of the system's ductwork. Ventilation of the church has not proven to be an issue because the nave has a very large internal volume and it is only generally occupied for short periods. There is likely to be some degree of passive ventilation via the doorways, and there is also intermittent air extraction in the WCs. Air tightness of the building is unknown.
