Approaching Near Zero Energy in Historic Buildings

Deliverable No: T3.3.1/T4.2.1

Deliverable Title: Energy Assessment Results and Retrofit Outcomes

Deliverable Coordinator: Historic Environment Scotland

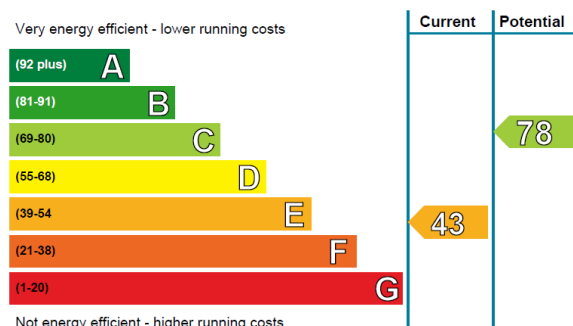
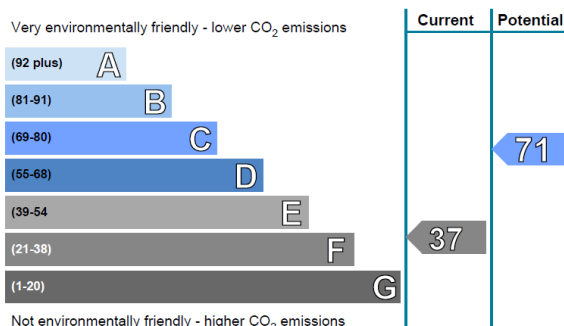
Figure 6: Bayview, pre-retrofit SAP rating for the whole building, assessment by a local domestic energy assessor 07/08/2017.

Figure 7: Bayview, pre-retrofit carbon rating for the whole building, assessment by a local domestic energy assessor 07/08/2017.

The above images, Figure 6 and Figure 7, show the SAP and carbon rating for Bayview as a whole building prior to the conversion project undertaken by the WDT. For context, the average Scottish dwelling in 2019 had a SAP rating of C65 and a carbon rating of D61 (Scottish Government, 2020). It should also be noted that the average SAP rating for a Scottish property not on the mains gas network was D58, the average rating for a rural property was D56, and the average rating for a pre-1919 property was also D56 (Scottish Government, 2020). At a glance, in its baseline condition Bayview was underperforming the Scottish average across its various categories by a considerable margin.

This assessment is likely to be a relatively true reflection of the building's pre-retrofit performance and may even overestimate the true energy performance by omitting the volume of the habitable attic rooms. RdSAP surveys are governed by a set of conventions and omission of the attic may have been a correct application of these, it is impossible to determine this as HES staff were unable to inspect the interior of the building in its pre-retrofit condition. Alternatively the omission may have been in error which would be reflective of an additional issue known to impact EPC assessments in Scotland, and which has been documented in a study by Heriot-Watt University; specifically, inconsistent quality of surveys and application of the RdSAP conventions (Jenkins, Simpson and Peacock, 2017).

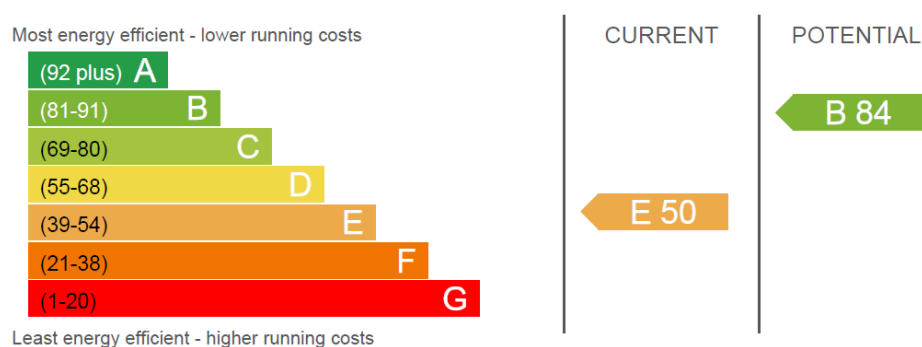
Figure 13: Cottage 1, estimated SAP rating at time of survey assuming a functional main heating system. Assessment by HES member of staff 15/03/2022.

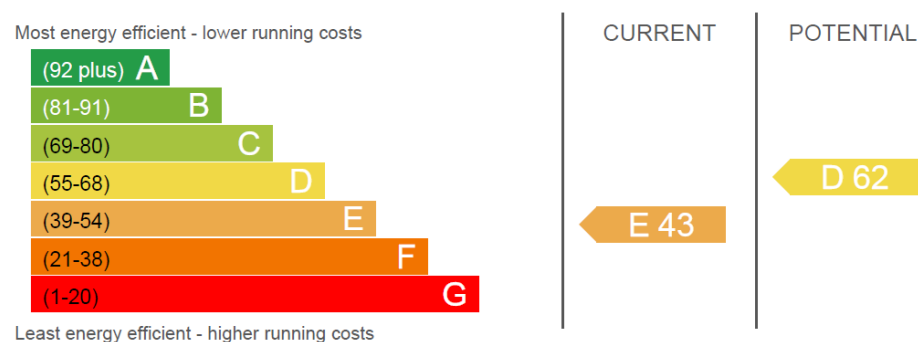
Figure 15: Cottage 3, estimated SAP rating at time of survey assuming a functional main heating system. Assessment by HES member of staff 15/03/2022.

A further quirk of the RdSAP methodology is identified by considering the lower “potential” rating for Cottage 3 (Figure 15 above). This lower potential is calculated based on the incorrect assumption that the walls of that property are unsuitable for insulation. This is reflective of the ongoing issues faced by the methodology and which are discussed in greater detail in the preceding chapter covering the Bayview demonstrator on Westray.

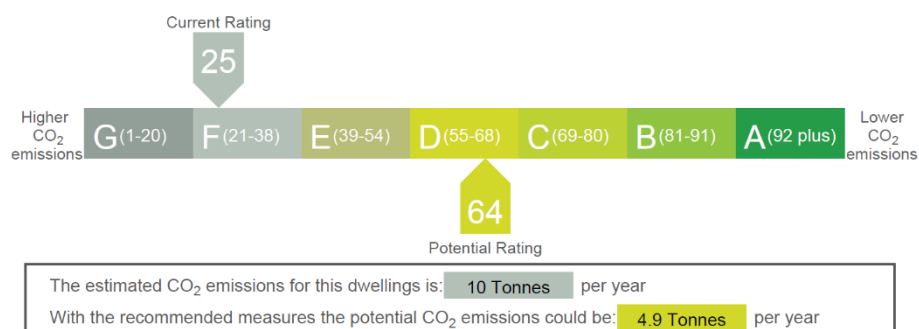
Figure 16: Cottage 1, estimated environmental rating at time of survey assuming a functional main heating system. Assessment by HES member of staff 16/03/2022.

Low environmental scores for the Keepers' Cottages accurately reflect the fact that the modelled energy use is dominated by space heating which in the modelled scenario is provided by a functioning communal oil boiler. Again, the suggested potential rating falls well short of reality because the software is not equipped to consider a change of fuel type as a possible option.

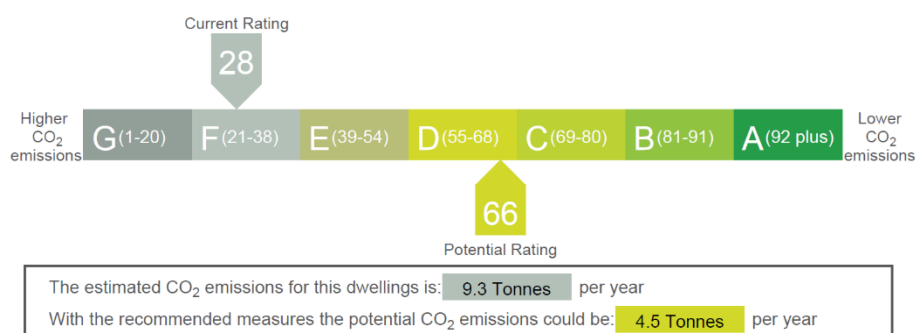
Figure 17: Cottage 2, estimated environmental rating at time of survey assuming a functional main heating system. Assessment by HES member of staff 16/03/2022.

Cottage 2 is nearly identical to Cottage 1 with the slightly higher actual and potential environmental ratings attributable to the same factors identified as responsible for variation in the SAP ratings.

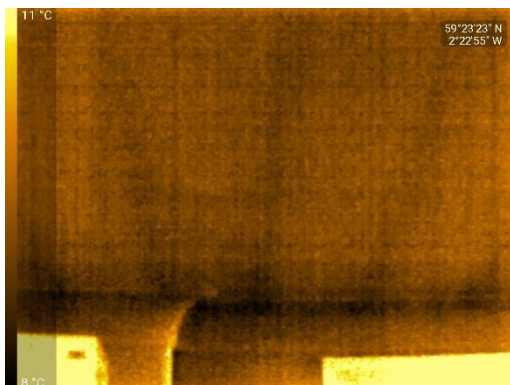
Figure 22: Infrared image showing the thermal trace of concealed joists supporting a false ceiling – Image © Historic Environment Scotland – Thermographer: Kenneth Easson

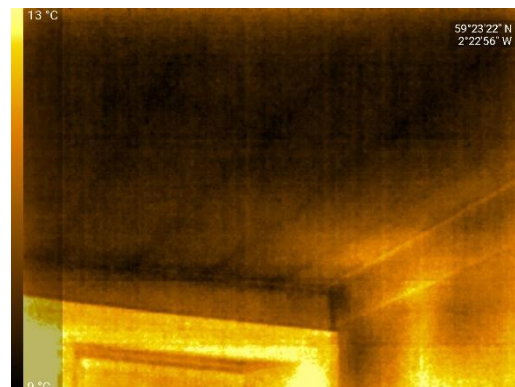
Figure 23: Infrared image showing the thermal trace of concealed joists supporting a false ceiling – Image © Historic Environment Scotland – Thermographer: Kenneth Easson

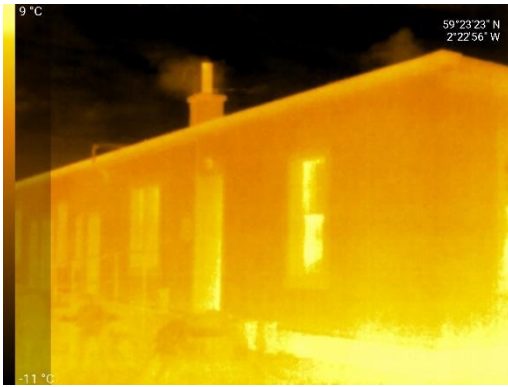
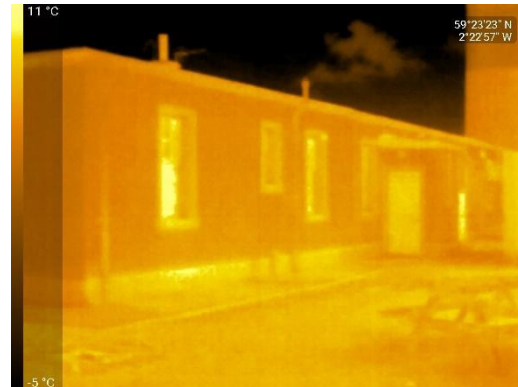
Figure 24: Cottage 3 (aka the Café/Visitor Centre) viewed from the northwest – Image © Historic Environment Scotland – Thermographer: Kenneth Easson

Figure 25: Cottage 3 (aka the Café/Visitor Centre) viewed from the southwest – Image © Historic Environment Scotland – Thermographer: Kenneth Easson

External images of the café/visitor centre showed no visible infrared anomalies in the building fabric which concurred with the results of the visual survey and tests using a pinless moisture meter. It was also in line with anecdotal evidence suggesting that the overall condition of the building fabric is good and that the building remains dry and weathertight in spite of less than ideal conditions created by the defunct heating system and ongoing fabric maintenance challenges.

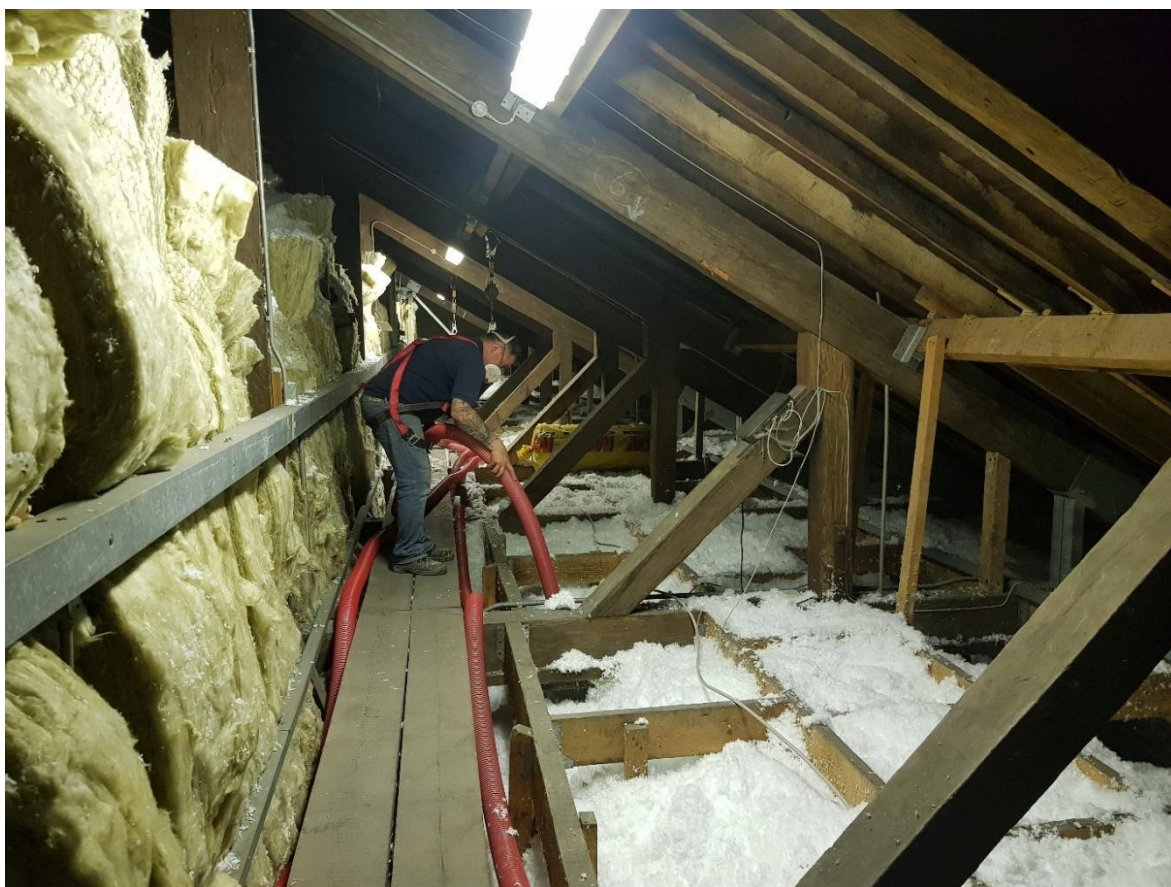
Figure 28: Insulation installation in the cathedral pitched roof during 2021 – Image © NCE Insulation

Attic spaces within the main pitched roof structure were insulated during summer of 2021 using a combination of blown cellulose fibre installed over horizontal ceilings and mineral wool batts installed against vertical stud walls. This was supported by grant funding issued by the Sustainable Energy Authority of Ireland (SEAI). Draught-sealing of windows in the cathedral was noted by JCA Architects (2020) as a sensible option for further work but (at this time) NCE Insulation has elected, noting the significance of the building, not to proceed with this until an appropriately qualified conservation professional can be appointed to support the work.

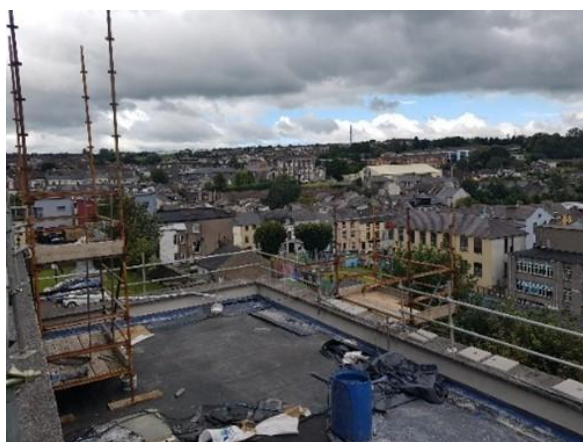
Figure 29: Maintenance work in progress, refelting on one of the principal flat roof sections over the altar – Image © NCE Insulation

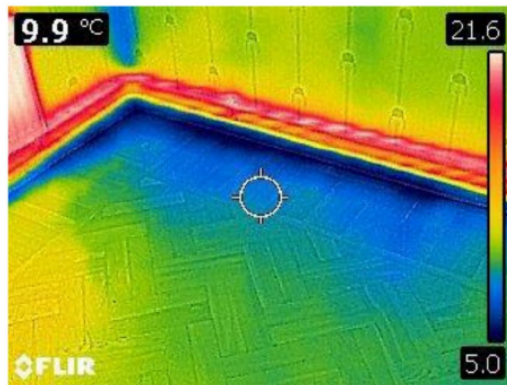
Figure 36: Heat loss at the wall-floor junction on the ground floor – Image © OAMK

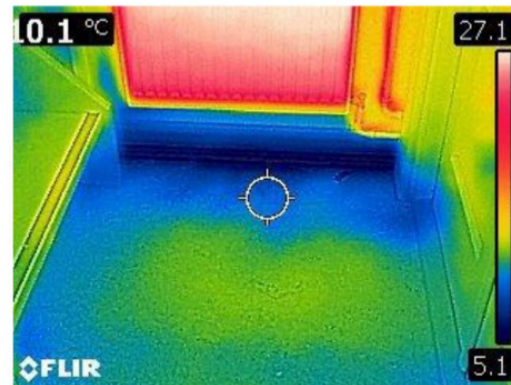
Figure 37: Heat loss below a radiator at the wall-floor junction on the ground floor – Image © OAMK

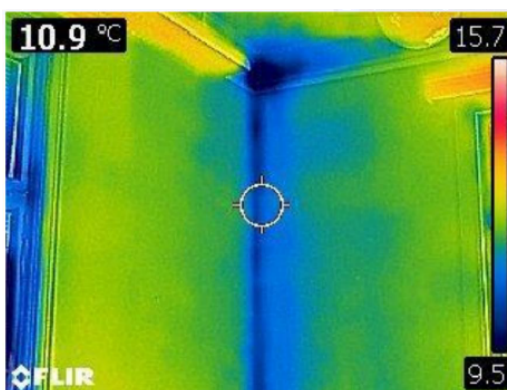
Figure 38: Heat loss at and above the wall junction at a corner of the ground floor – Image © OAMK

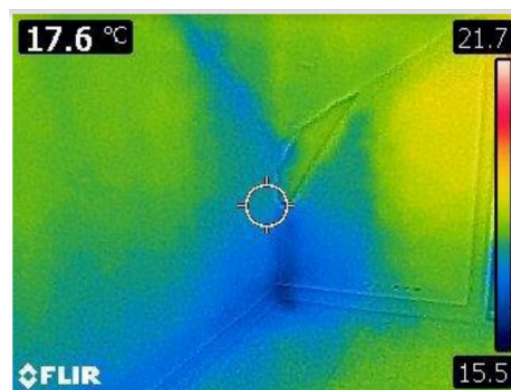
Figure 39: Heat loss at the junction of stud walls and floor in the 1st floor room-in roof – Image © OAMK

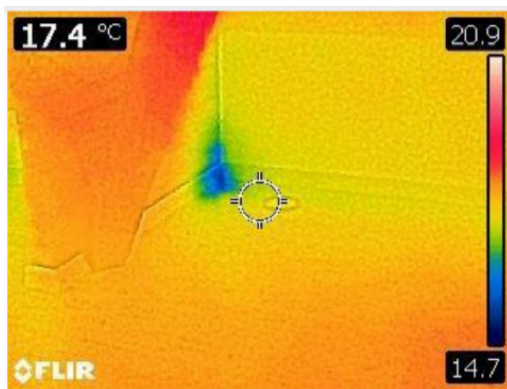
Figure 40: Heat loss at the junction of stud walls and floor in the 1st floor room-in-roof – Image © OAMK

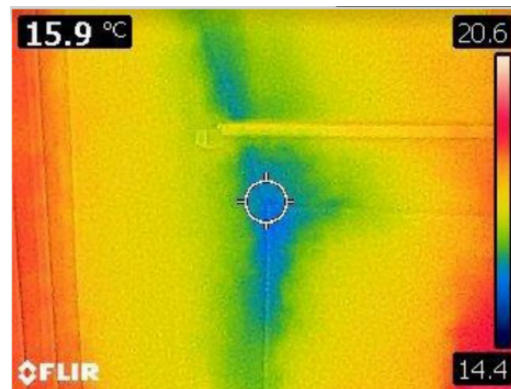
Figure 41: Heat loss via a stud wall junction in a 1st floor cupboard – Image © OAMK

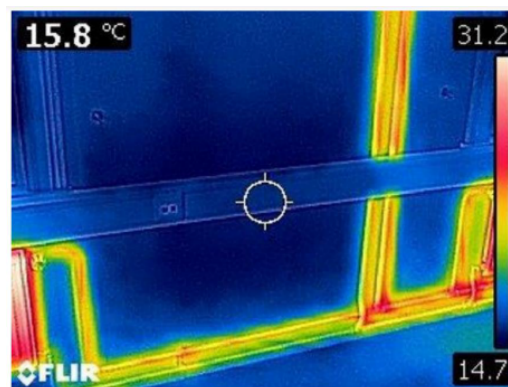
Figure 42: Heat loss in the middle of an external wall on the ground floor – Image © OAMK

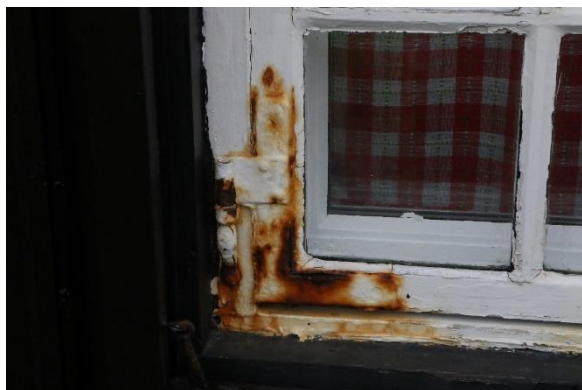
Figure 51: Pre-retrofit, deterioration of existing window frames – Image © Landsverk

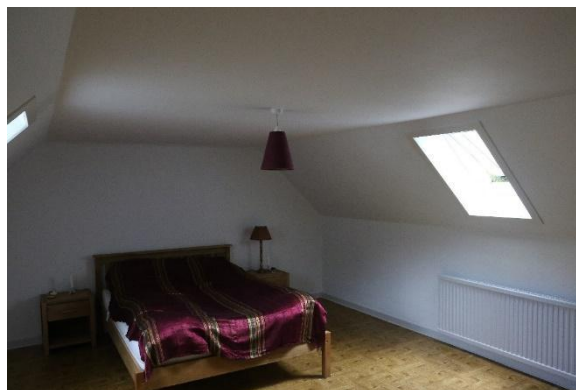
Figure 52: Pre-retrofit, internal spaces were noted as being cold and poorly lit – Image © Landsverk

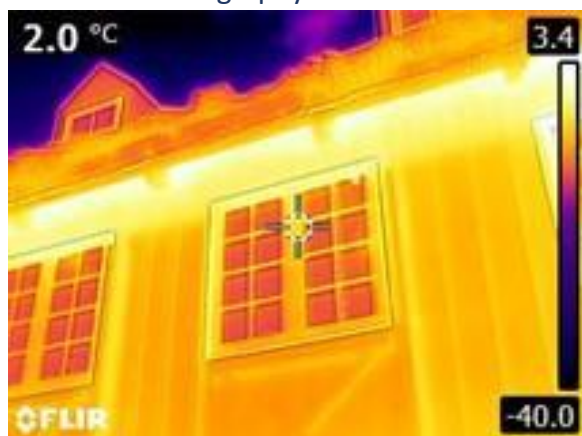
Figure 57: Heat loss at eaves below fascia boards and via timber joints – Image © Landsverk

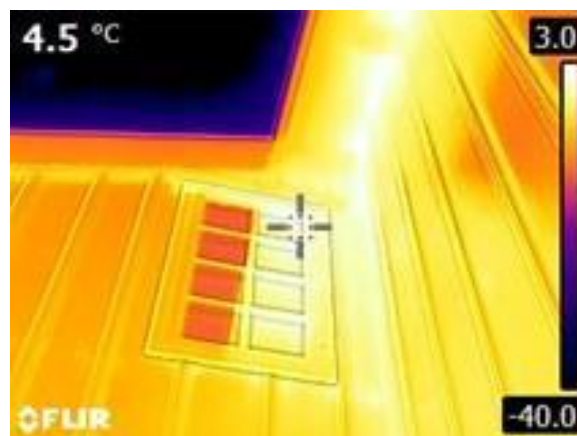
Figure 58: A replacement window, note the infrared reflection of the soffit above – Image © Landsverk

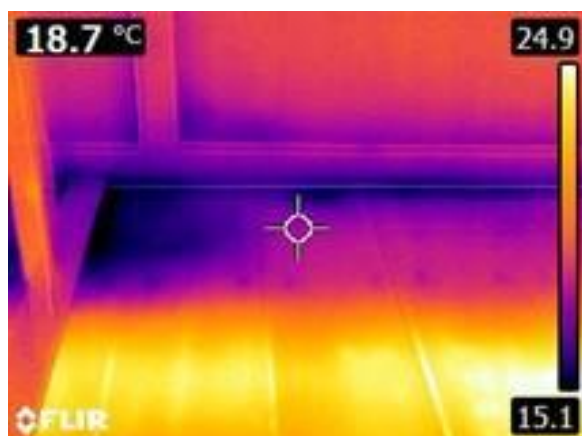
Figure 59: Heat loss via thermal bridging through the wide stone foundation – Image © Landsverk

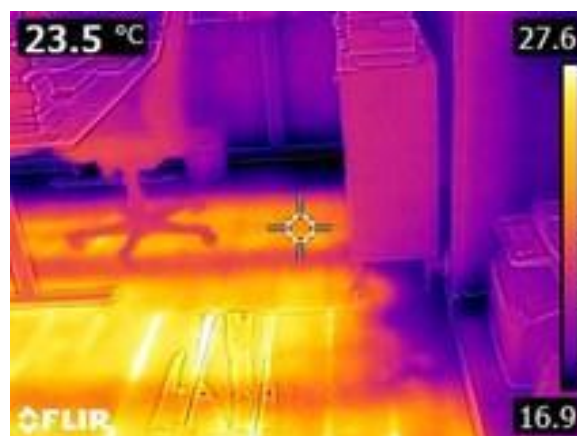
Figure 60: Heat radiating through floorboards from distribution pipework below – Image © Landsverk
