Approaching Near Zero Energy in Historic Buildings

Title: Thermal Imaging Report: Raahe Seminary Rector's House

THERMAL IMAGING REPORT

Raahe Seminary Rector's House

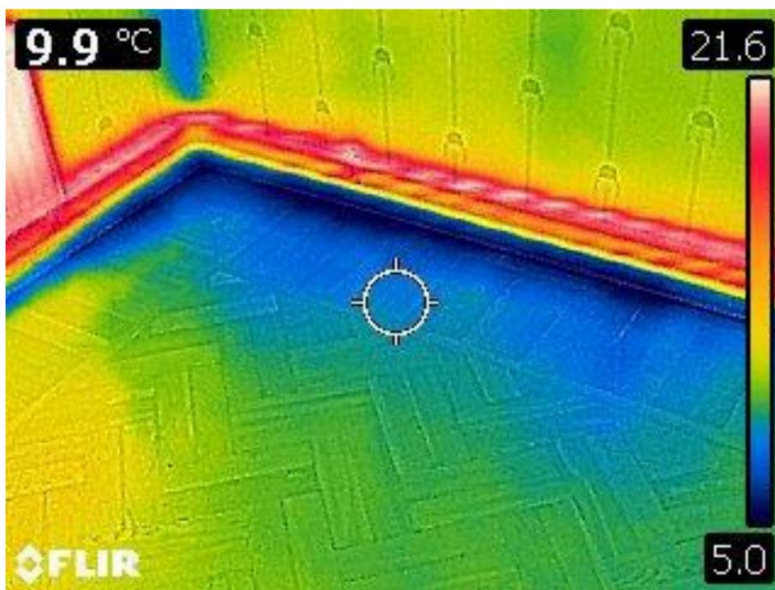
Status 1st floor Rector's room

Comments: Heat leakage can be observed in the room through the lower floor. **Point temperature** 9.9 °C

Range min. 5 °C

Temperature index TI 39%

Pressure: overpressure 0.3-3Pa

In the first two figures, the temperature index is less than 61% (39%), ie corrective action is required at those points. The alternative is, for example, additional thermal insulation or the replacement of damaged structures with new ones, if possible.

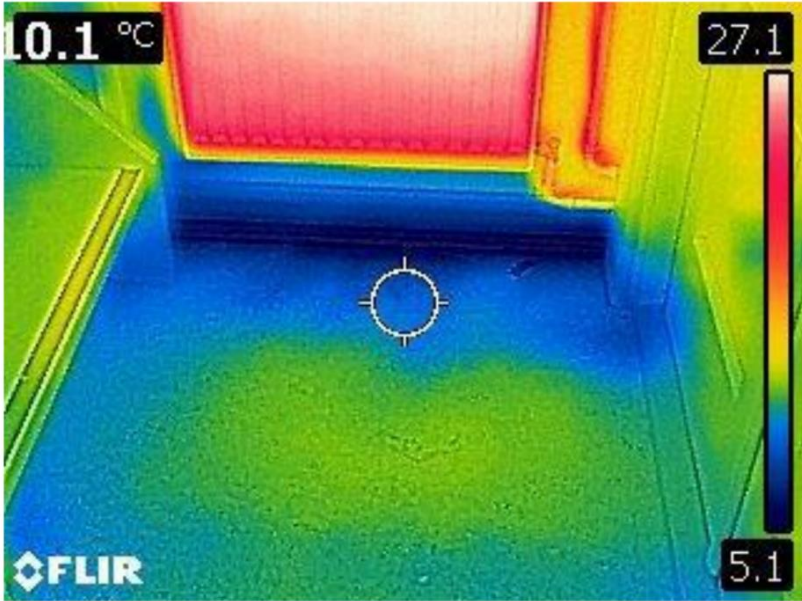
Volume: 1st floor, staircase/second entrance

Comments: Heat leakage in the room through the lower floor.

Point temperature 10.1 °C

Range min. 5 °C

Temperature index TI 39%

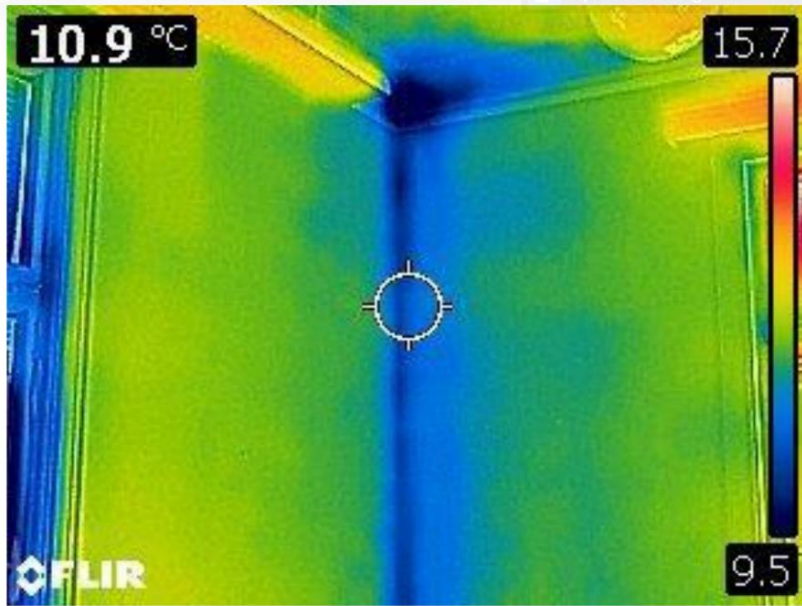
Status 1st floor Room

Comments: Heat leakage can be observed in the room through the junction of the walls. Point temperature 10.9 ° C Range min. 9.5 ° C Temperature index TI 69%

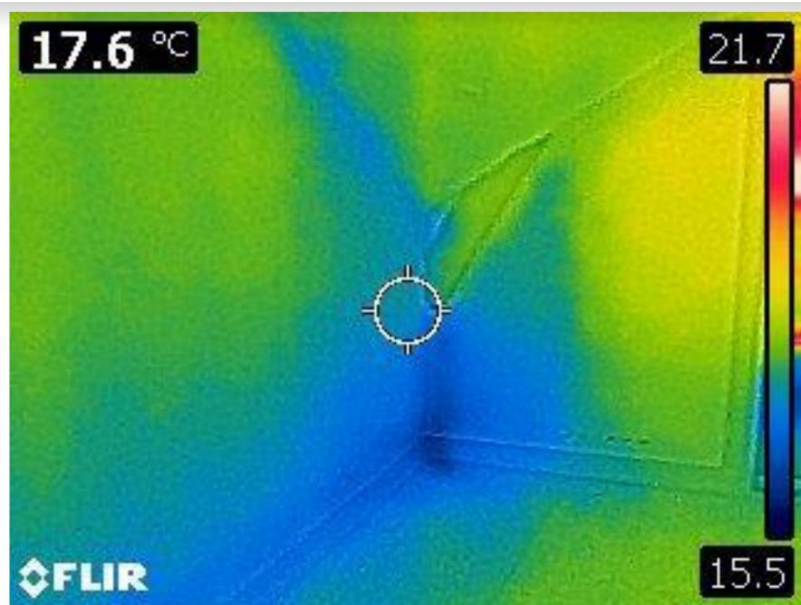
Status 2nd Floor large conference

Comments: Some heat leakage can be observed in the room through the junction of the walls and the midsole. Point temperature 17.9 ° C Range min. 15.5 ° C Temperature index TI 109%

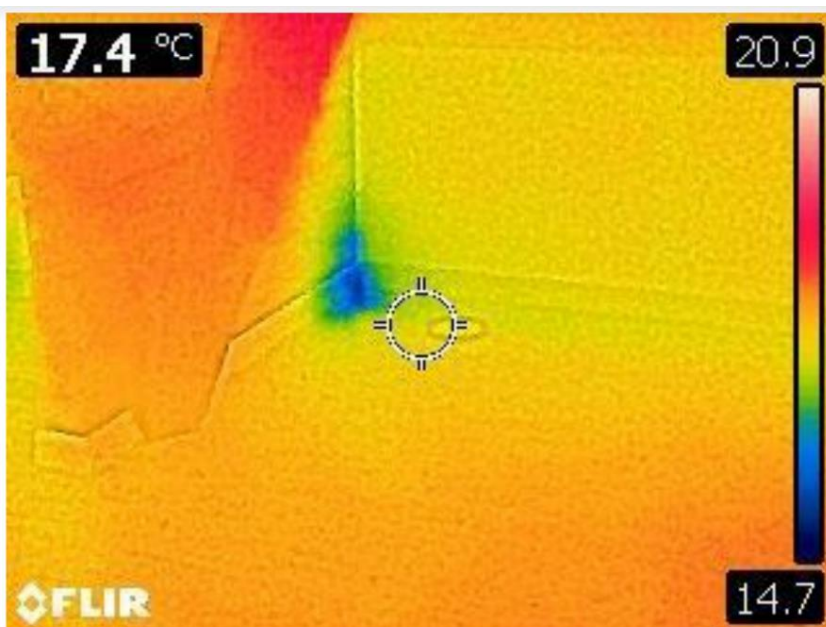
Status 2nd floor Large conference

Comments: Heat leakage in the room through the midsole.

Point temperature 17.4 ° C

Range min. 14.7 ° C

Temperature index TI 104%

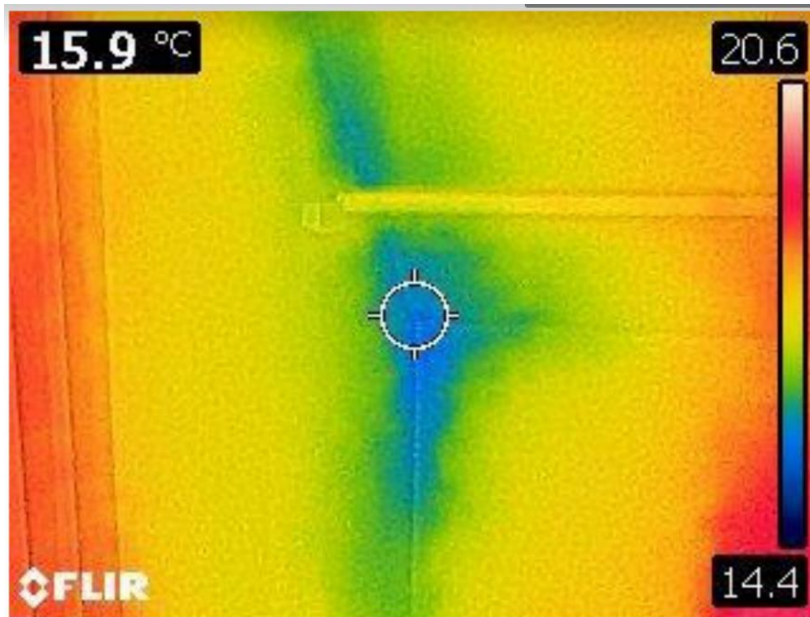
Status: 2nd floor room

Comments: Slight heat leakage in the room through the upper floor.

Point temperature 15.9 ° C

Range min. 14.4 ° C

Temperature index TI 102%

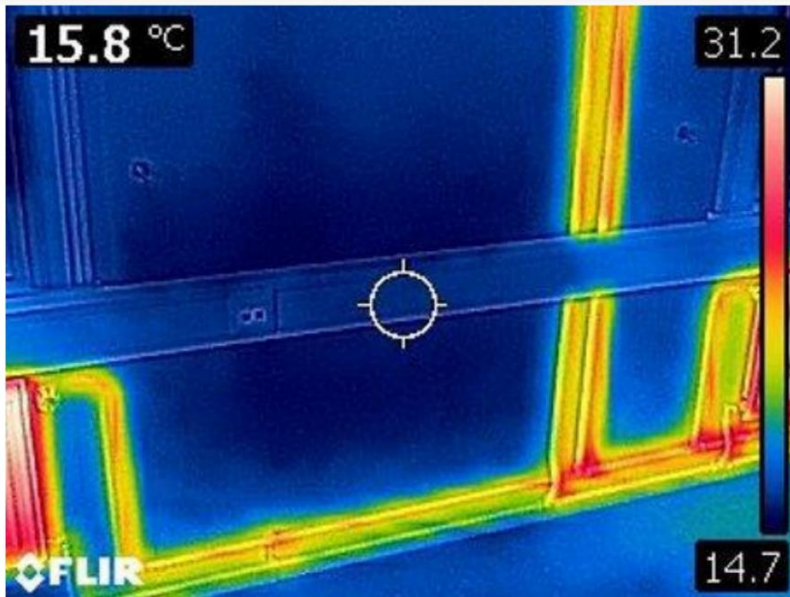
Status 1st floor Room

Comments: There is heat leakage in the room in the middle of the wall.

Point temperature 15.8 ° C

Range min. 14.7 ° C

Temperature index TI 105%

Pressure vacuum 2.5-6 Pa
