Approaching Near Zero Energy In Historic Buildings

Deliverable No.: WP1_DT1.5.1

Deliverable Title: Summary report on baseline of demonstration projects

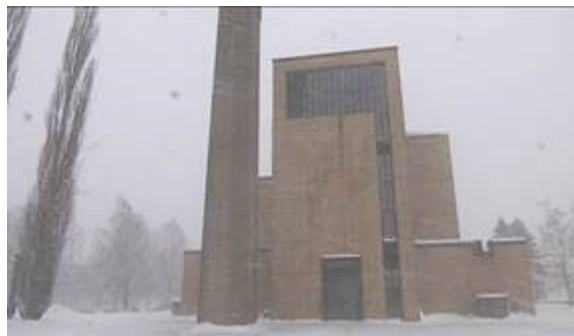
Figure 1: Teg's church

The management do not have any plan to make alteration to the building in the near future. An energy audit of the building was done in 2012 and the building does not have any major problems such as dampness or mold.

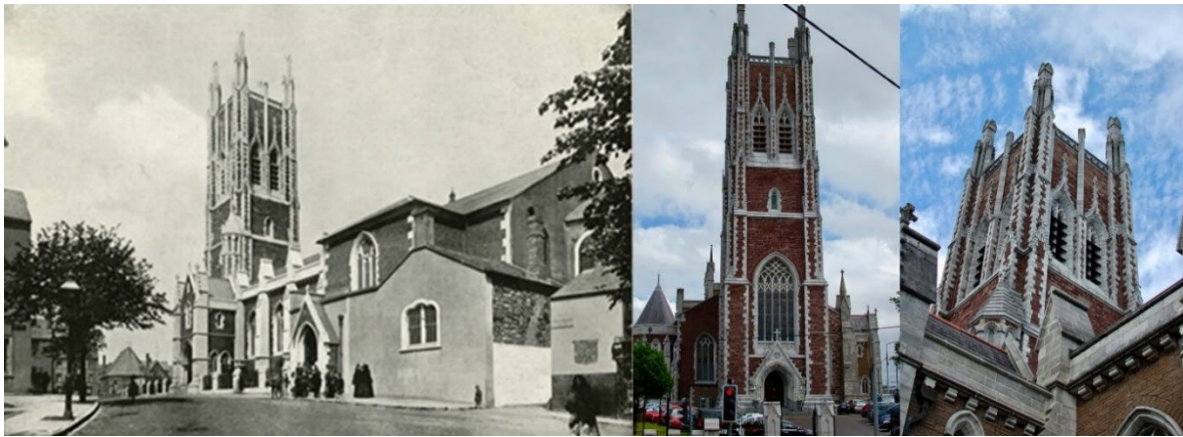
Figure 5.: The Cathedral of St Mary & St Anne, Cork, Ireland

Windows have historical features and cannot be altered. Cost is the biggest barrier for alteration of the building. The flat roof membranes had deteriorated in several locations and had served beyond their life time. There were some leaks in the roof and presumably heat was also escaping at a quicker rate due to the reduced thermal resistance. In summer 2021 it is planned to install a combination of blown cellulose and rolled mineral wool insulation over the main nave of the church. It is proposed to install an energy monitoring system in Autumn 2021.

- In 2018 an Air to Air heat pump was installed as a secondary heating source and 2 electric vehicle Chargers which the community can use free of charge.
- 2020 - flat roof membranes were replaced as well as repairs to upstands, flashings, parapet render, and some minor repointing
- 2021 - Attic insulation will be installed over the main body of the Cathedral

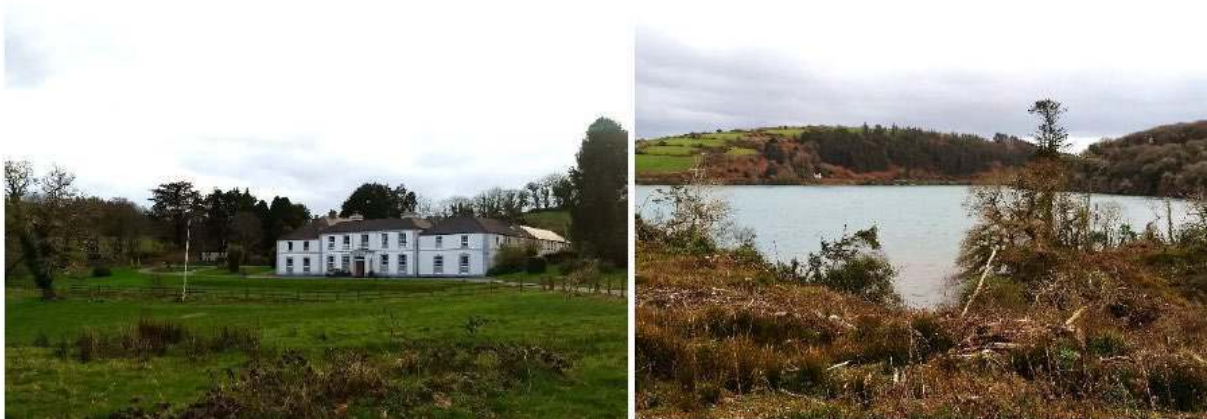
The east wing is mostly in original condition and is on National Inventory of Heritage. The house is considered historic but not protected. It has 52 bedrooms most of which are for single occupancy. More recently the residence used as seminary and for religious gatherings. The building has been found to have increased dampness.

Figure 6: Myross Wood House is overlooking an inlet from the Celtic Sea

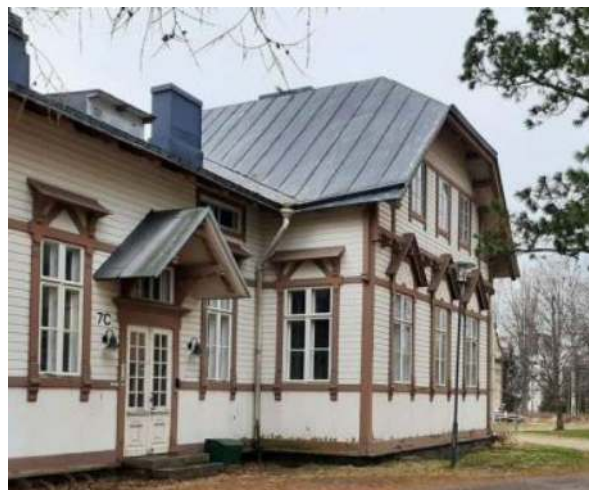
Figure 7: Entrance of the building

wooden doors at the entrance are thick and there is no need to replace them for energy efficiency, However, the doors could be sealed. There was considerable deterioration of the paint on the façade on the south end of the building. The whole building façade requires repainting. The attic has insulation with 350 mm wool.
