Approaching Near Zero Energy in Historic Buildings

Title: Refurbishment and Change of Use at the Rectors' House, Raahe: Art Residence Plans and Co-Design Process

Refurbishment and Change of Use at the Rectors' House, Raahel.

Art Residence Plans and Co-Design Process

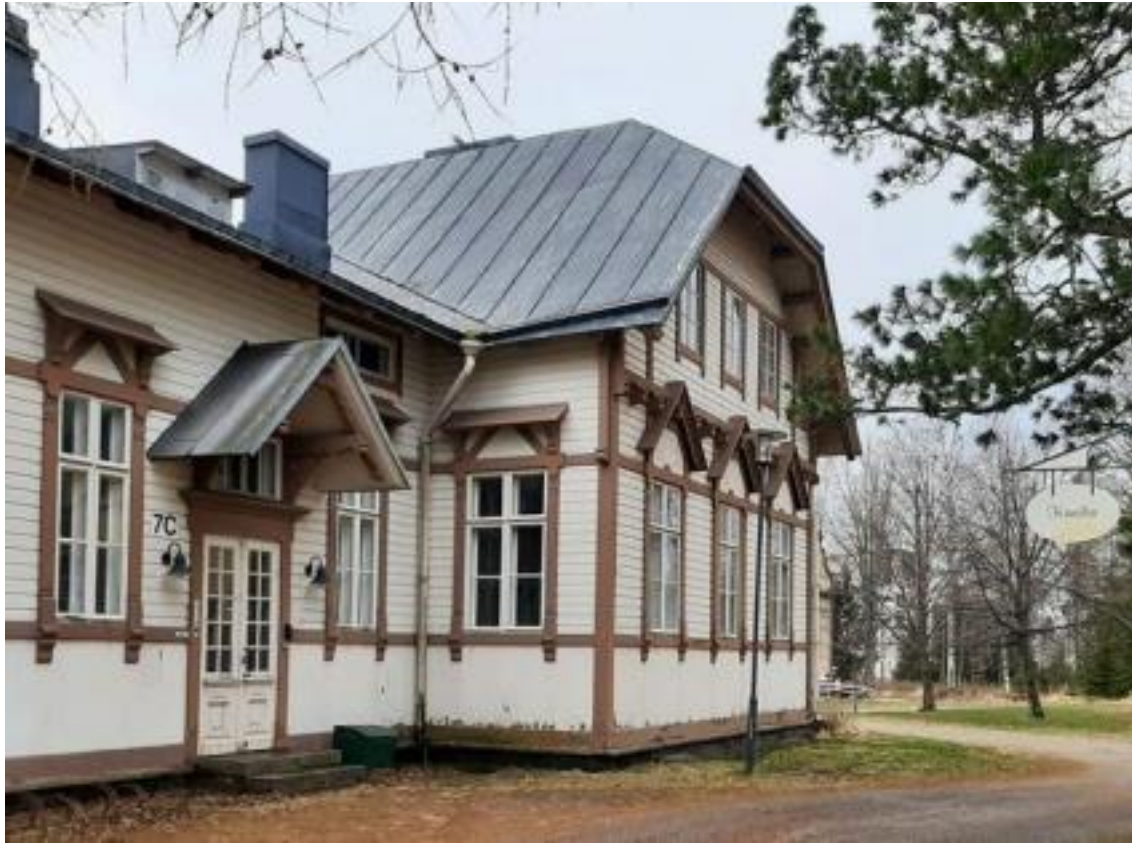
The ornamentation and diversity of the building's facades were emphasized. The decorations on the façade have been enhanced with a darker shade of brown than the exterior cladding (Fig. 9). The decorativeness makes the facades impressive and their preservation is a requirement of the site's building protection decision.

FIGURE 9. View of the entrance to the building and the decoration of the façade

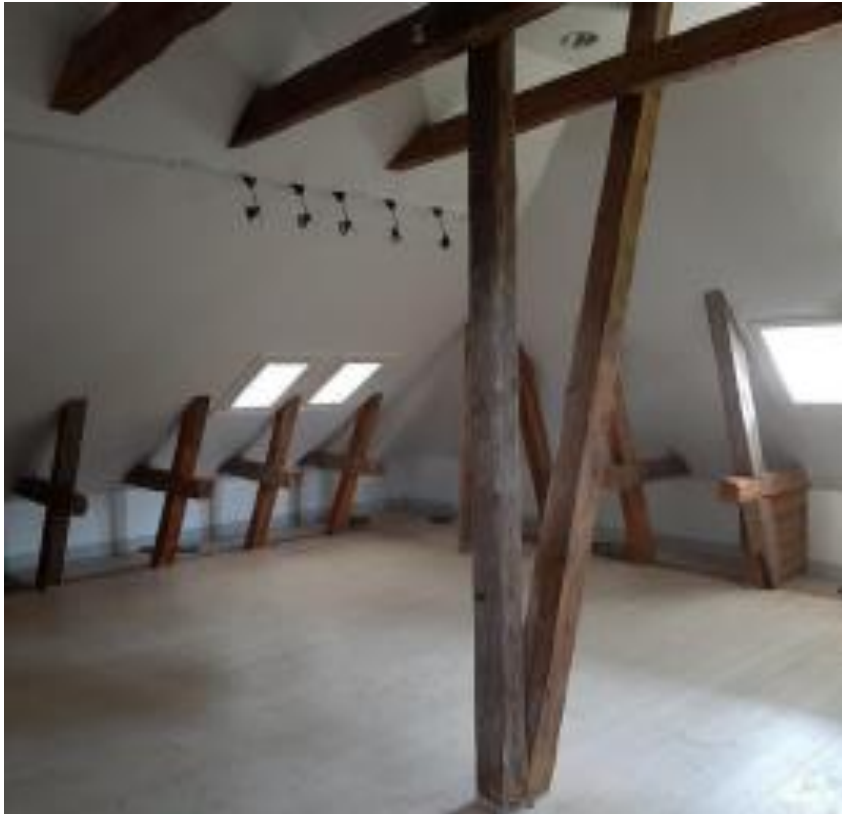
The large meeting room on the second floor was impressive with its visible beams and pillars. Due to its high room height, the space was spacious and would allow for a wide range of uses in the future. (Figure 18.)

FIGURE 18. *Large meeting room on the second floor*

The rooms had various pendant and recessed luminaires and were old-fashioned. Replacing old energy-using luminaires with new ones that are more energy efficient would be a major factor in improving the energy efficiency of a building. As such, the existing lighting in the conference room would be well suited, for example, for performance lighting.
