MYROSS WOOD HOUSE, LEAP, COUNTY CORK

Retrofit Strategy

March 2020

Job Number: 020006

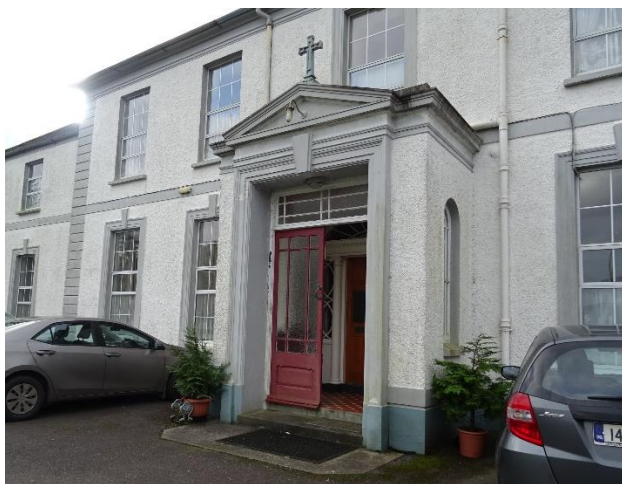
A variety of windows and doors exist in Myross Wood House of various ages, forms and stages of decay. The inner front door, fanlight, side windows and columns are likely original to the building, however the entrance portico has been changed significantly (Figure 17, see also Figure 5). The mouldings of the portico have cracked in places and the paint on the timber window frames is peeling.

Figure 16. The pedimented portico is not original to the building, however the interior door, fanlight and side windows likely are.

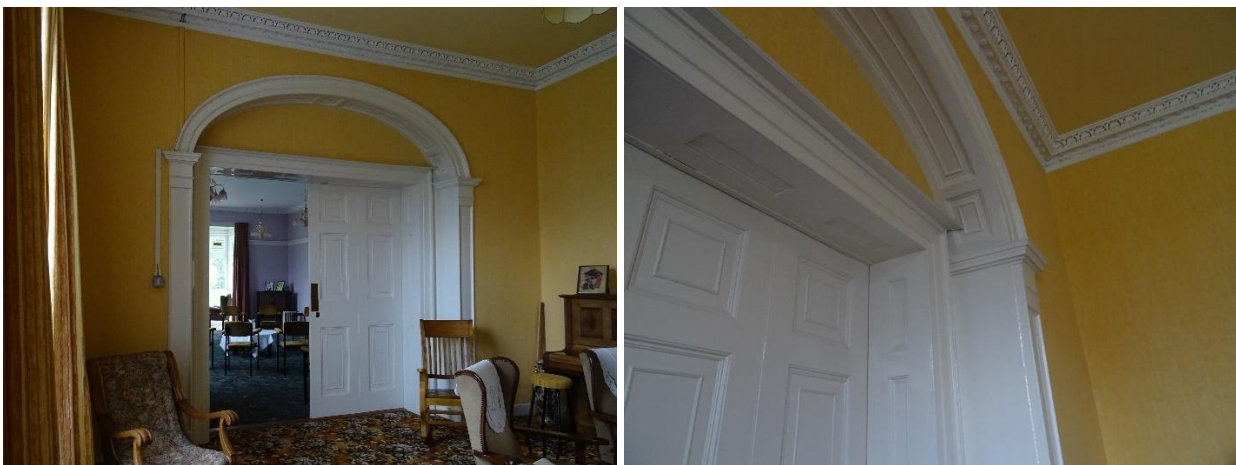
The parlour and library to the south of the entrance hall are in good condition and are not showing any worrying signs of excess moisture or deterioration. A fireplace has been blocked up in the parlour and it is likely one has been blocked up in the library as well. If reinstated, these could be used as ventilation shafts for a centralised ventilation system. A unique archway with fine detailing connecting the library and parlour has been well maintained (Figure 22). The cornices within these rooms are in very good condition (Figure 23), although the panelling and shutters are in need of some repairs (Figure 24). The sunroom off the Library is in good condition (Figure 25).

Figure 22. The archway and panelling may have been installed while the building was occupied by the 3rd Earl of Kingston.
 Figure 23. The cornices in the Library and Parlour are in very good condition.

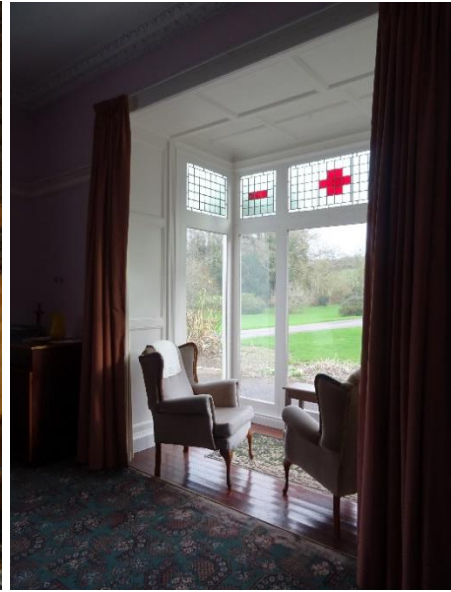
Figure 25. Sunroom within the Library.

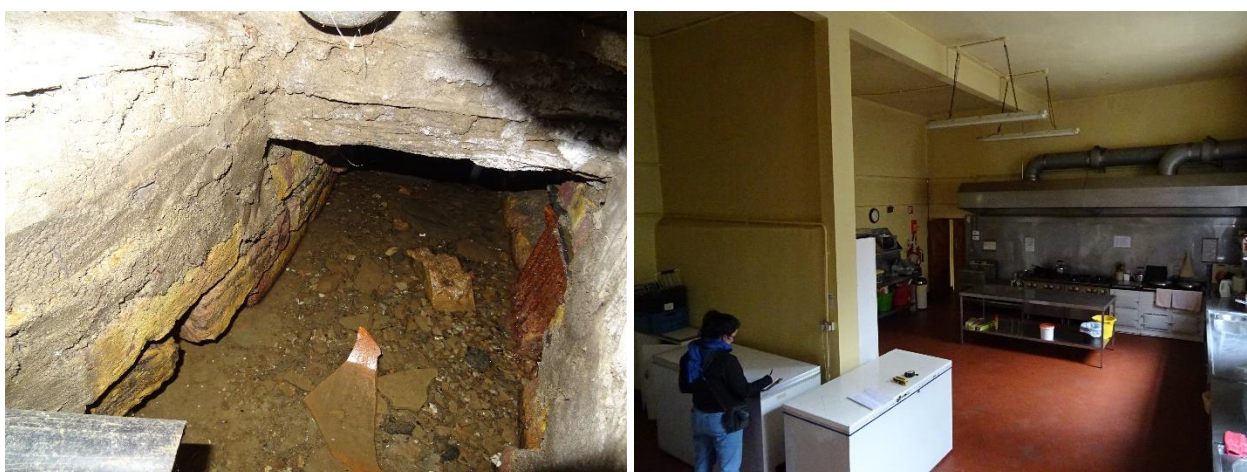
The Kitchen and Laundry in the north wing to the west of the Dining Room appear to be constructed of solid masonry for exterior walls (670 mm) and solid brick for internal walls (1000 mm). The floor of these rooms is approximately 1 metre lower than the Dining Room and is probably built upon the early level of the external ground floor. A drainage gallery was found underneath hallway outside the Laundry Room, which may indicate that this level is built upon sleeper walls with space for natural ventilation below (Figure 30). The underfloor area and drain are constructed of stone and rubble. The hallway floor is covered with 150 x 150 mm ceramic tiles.

A structural beam spanning east-west within the Kitchen may have been installed to support a later addition of upper floors to the existing building (Figure 31). The ceiling has some cracks and may be a painted concrete slab. Given that the wall depth and construction of the Kitchen corresponds with the oldest part of the house, it is possible that this portion was added by the 3rd Earl of Kingston during the early 19th century and that the roof structure was altered to add the upper floors in the 20th century.

Figure 30. Drainage gallery below the hallway floor outside of the Kitchen and Laundry Room.

Figure 31. The Kitchen within the North Wing was likely built by the 3rd Earl of Kingston when he extended the house during the early 19th century.

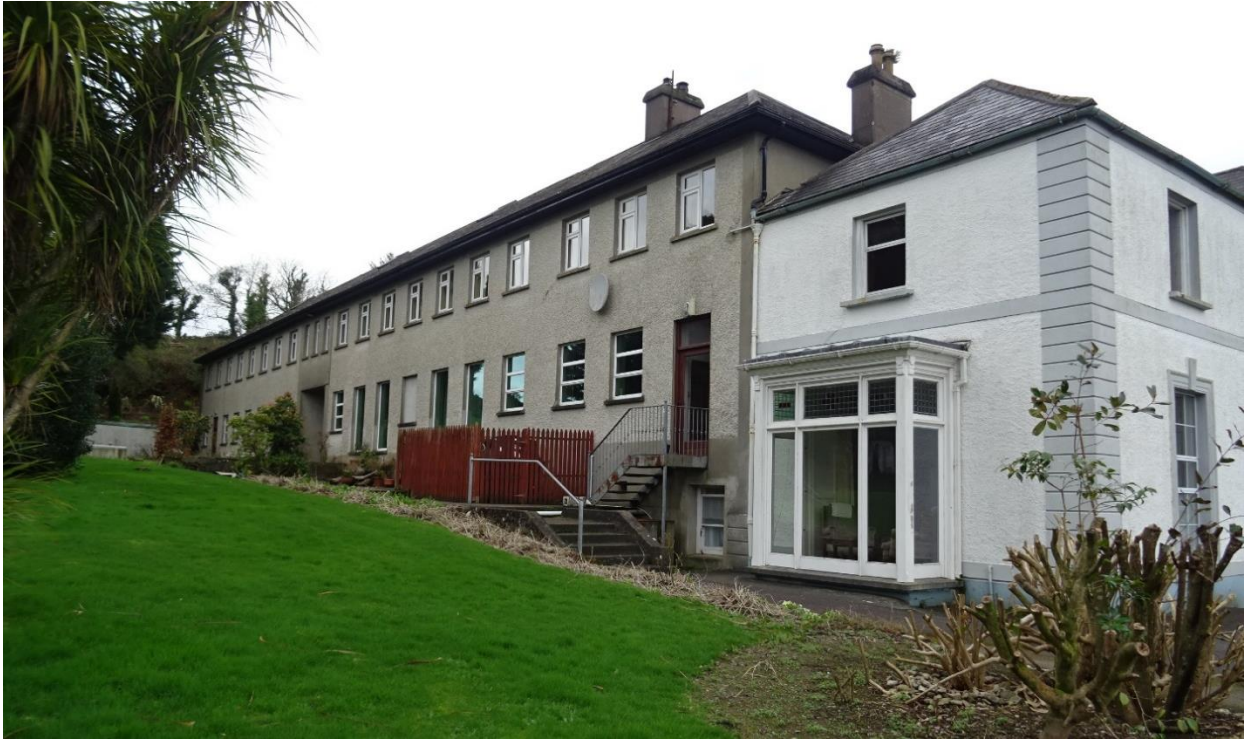
The Chapel and Conference Room were constructed in 1959 of concrete walls (480 mm) on a solid concrete floor (Figure 41). The Chapel appears in good condition except for the water ingress around the defunct chimney within the eastern wall which is damaging the timber wall panelling (Figure 42). The eastern wall of the Chapel is likely solid masonry (700 mm) and may have been an external wall to the original house. The Conference Room appears in good condition (Figure 43). The rooms are heated every morning and evening with conventional radiators.

Figure 41. South Wing (1959) abutting the southern portion of the original house (now East Wing).

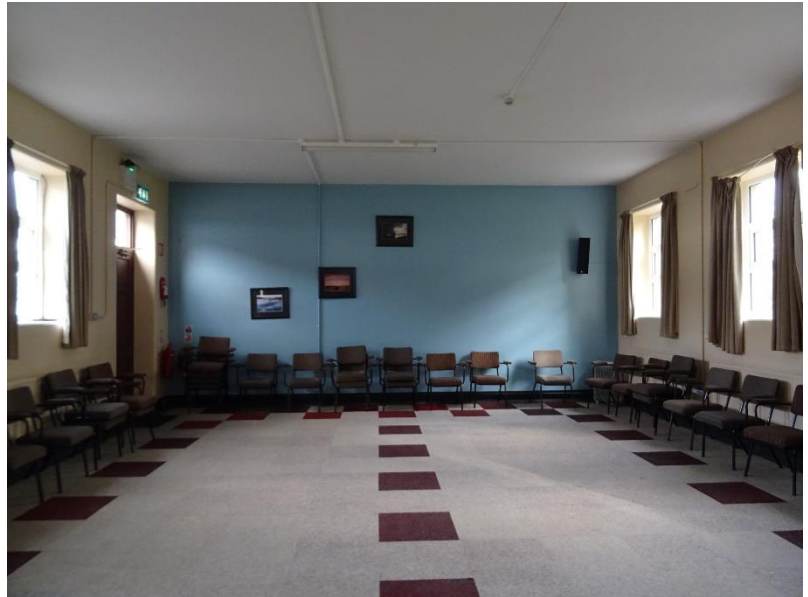
Figure 42. Rainwater ingress around the defunct chimney stack in the east wall of the Chapel in the South Wing.
Figure 43. Conference Room in the South Wing.
