Approaching Near Zero Energy in Historic Buildings

Deliverable No: T3.2.1

Deliverable Title: Initial Energy Performance Assessments

Deliverable Coordinator: Historic Environment Scotland

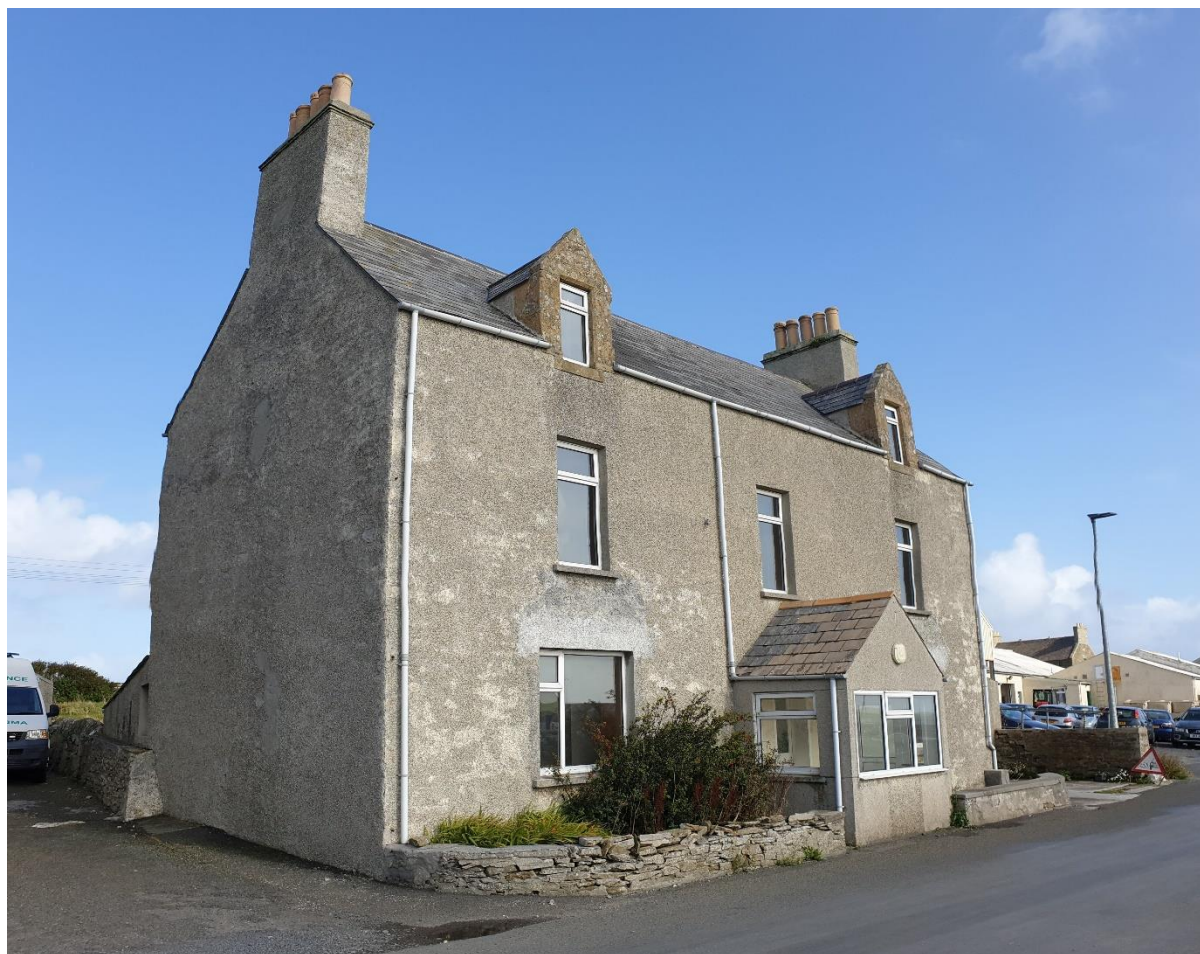
Figure 1: Bayview, pre-conversion in late 2019, seen from the southwest – Image © Historic Environment Scotland – Photographer: Carsten Hermann

Overall, the current thermal performance of building fabric at Bayview is poor, virtually the entire envelope is composed of elements with a likely thermal transmittance well in excess of $1\text{W/m}^2\text{K}$. The only likely exception to this is the insulated apex loft which will have limited benefit due to the uninsulated coomb ceilings to which it is immediately adjacent. Somewhat unexpectedly (based on the poor condition of the pre-existing cement render) contractors working on the building during the renovation works have reported that the masonry of the external walls is dry and in good condition.

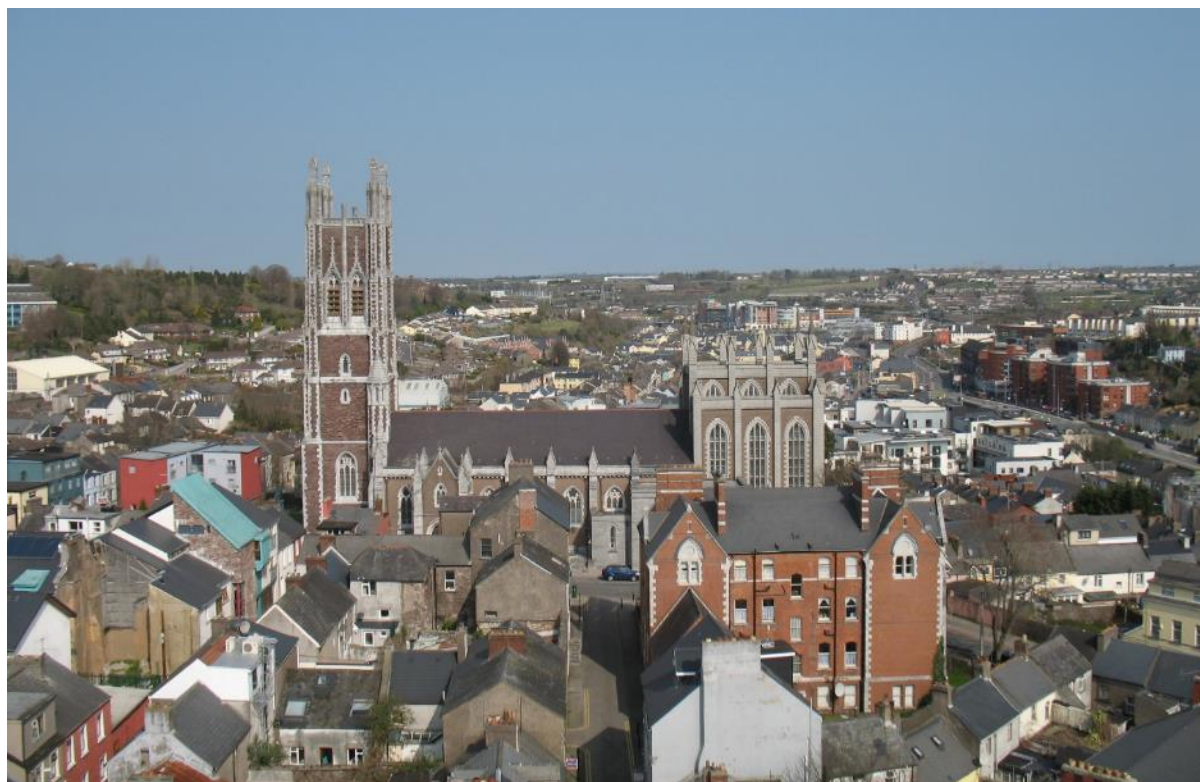
Figure 5: Cathedral of Saint Mary and Saint Anne in the city of Cork, Ireland, viewed from the south.

Typical of structures dating to the 19th century, the overall fabric performance of the cathedral is currently poor by modern standards. It should be noted however that air tightness has been identified as a key issue and fabric upgrades are unlikely to impart significant benefit without this first being addressed. This was recommended as a first step to improving overall performance by an outline feasibility study commissioned by NCE and completed by JCA Architects in early 2020. This study also identified a number of pressing maintenance issues of which the most urgent was repair of deteriorating flat roof membranes over the altar area which had exceeded their design life by a considerable margin. Replacement of these was completed by NCE during the course of 2020.

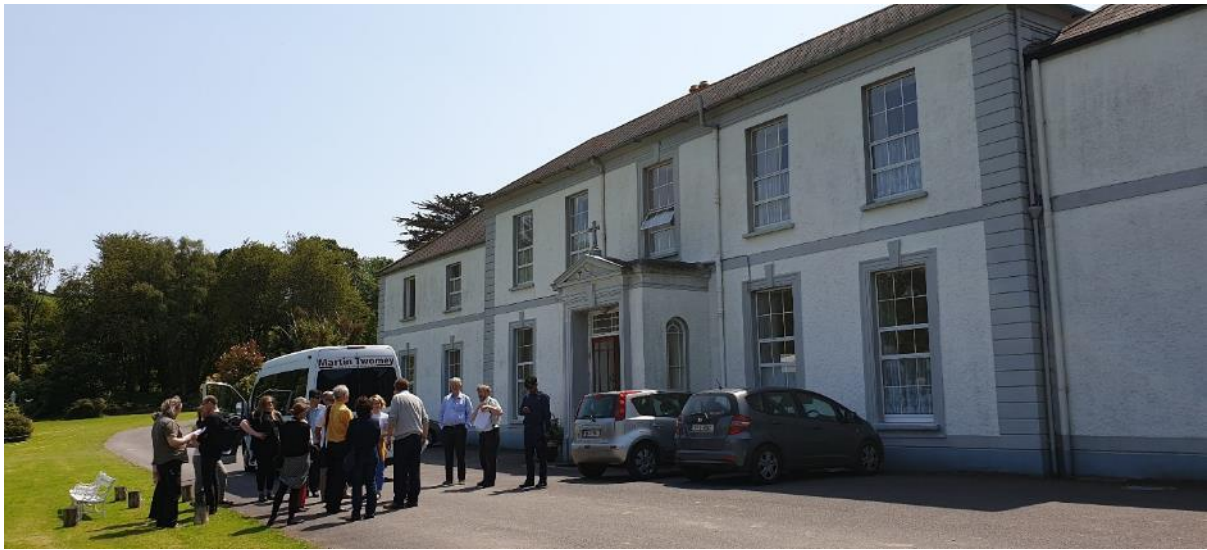
Figure 6: Myross Wood House, principal elevation of original Georgian house with early side extensions – Image © Historic Environment Scotland – photographer: Carsten Hermann

The condition of fabric elements is highly variable and prior to undertaking any upgrade works a number of outstanding maintenance issues will need to be addressed. Solid masonry walls in the older wings of the house are suffering dampness due to moisture within the building fabric becoming trapped behind the impermeable cement render, with lower parts of the north and west wing also suffering rising and laterally penetrating damp due to encroaching ground levels. It is also worth noting that the solid floors in the property derive little benefit from thermal inertia due to comparatively high perimeter to area ratios.

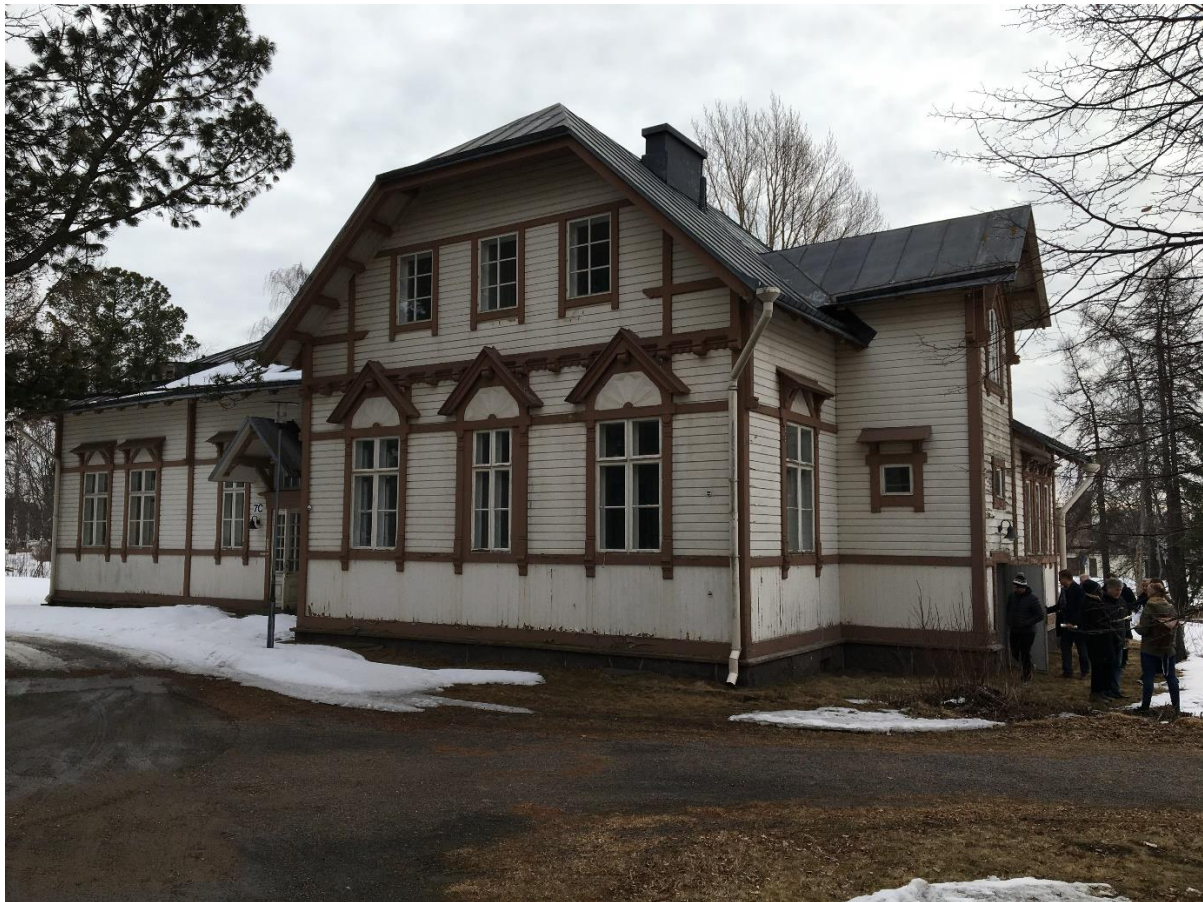
Figure 8: The Rector's House – Image © Historic Environment Scotland – photographer: Kenneth Easson

The windows are also timber, and largely original, with only windows on the upper storey having been replaced during the 1990s renovation. There is an urgent need for maintenance however and the windows are in need of stripping, fronting, and weatherproofing. There is also some water damage to ceilings internally and it was noted during an inspection that the internal environment is noticeably humid but further investigation of the extent of any water damage has not yet been undertaken.

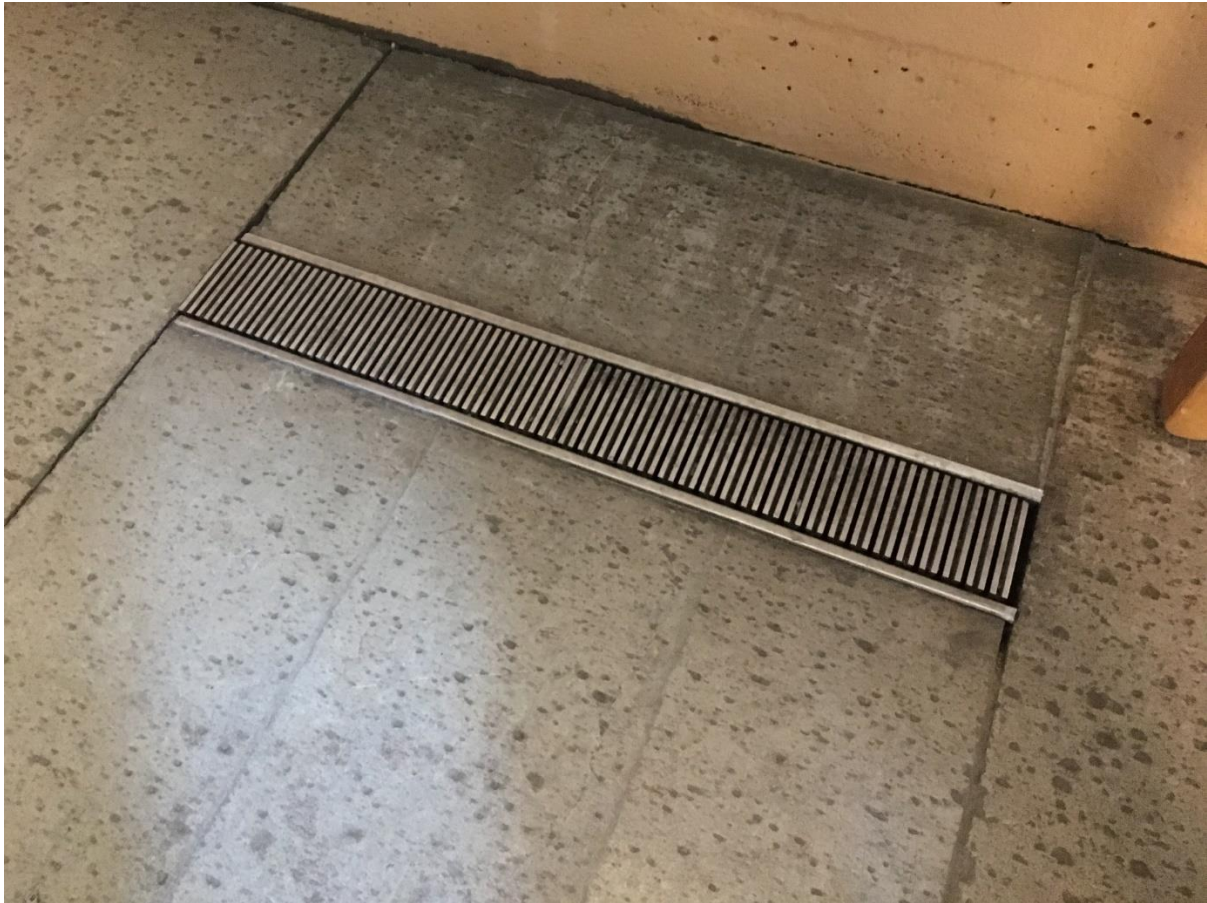
*Figure 15: Input vent from the mechanical ventilation system adjacent to the northeastern external wall –
Image © Historic Environment Scotland – Photographer: Kenneth Easson*
