Approaching Near Zero Energy in Historic Buildings

Deliverable No: T3.3.1/T4.2.1

Deliverable Title: Energy Assessment Results and Retrofit Outcomes

Deliverable Coordinator: Historic Environment Scotland

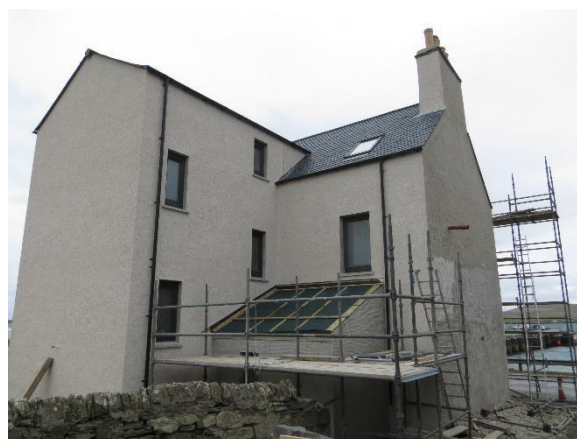
Figure 5: Bayview, mid-conversion, viewed from the northwest – Image © Historic Environment Scotland – Photographer: Yasser Battikha

Figure 4 shows the new common stair at the rear of the building which replaces a demolished two-storey rear section which was also smaller in footprint, this actually represent a reduction of the overall heated volume however as the new stair is unheated, and also introduces a sheltered wall. In Figure 5 a new extension is visible at the north-west corner forming a shower and WC for flat 2, this replaces a small lean-to shed which has been removed. Also visible in the above images above are new skylights in flat 4 which sit within an entirely new roof structure which has been slightly raised.

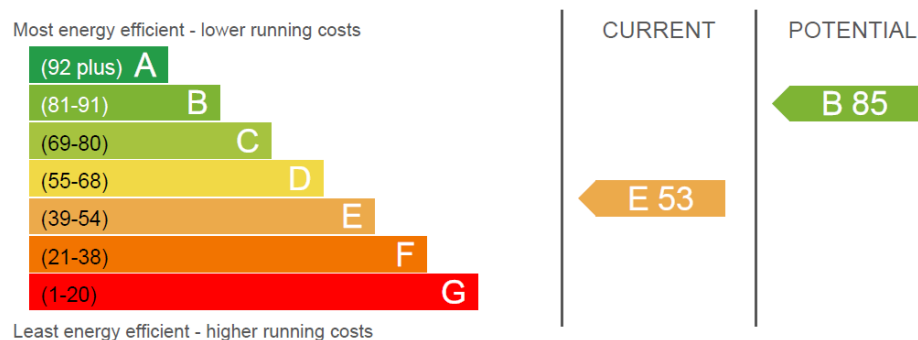
based on a scenario which assumed the prior configuration of the main heating system was restored to working order. The results for the two cottages of the southeast block are shown above and below (Figure 13 and Figure 14). Note the small but significant variation in the SAP rating which results from the slightly smaller footprint of Cottage 2, and the presence of a party wall separating it from the public toilet to which it is attached and which is not present in the case of Cottage 1. This may be considered essentially a quirk of the methodology as the likelihood that much real benefit is derived from this party wall is very limited.

Figure 14: Cottage 2, estimated SAP rating at time of survey assuming a functional main heating system. Assessment by HES member of staff 15/03/2022.

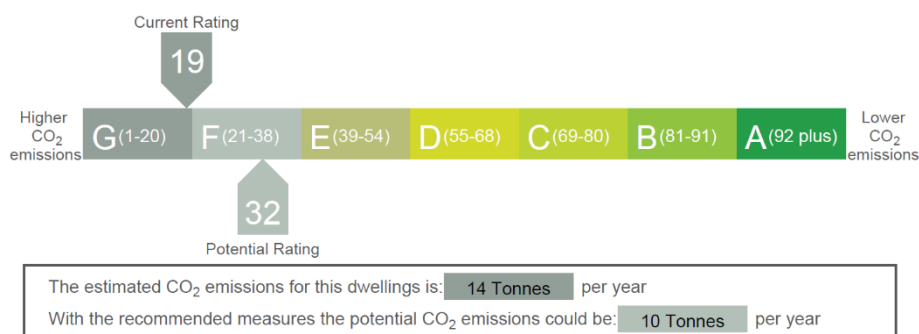
Figure 18: Cottage 3, estimated environmental rating at time of survey assuming a functional main heating system. Assessment by HES member of staff 16/03/2022.

Overall, Cottage 3 is the worst performer in environmental terms due to a larger footprint, lesser degree of attachment (meaning a shorter party wall) and because the wall type is considered to be of lower thermal performance which in this case is likely to be correct. Again, as with the other units on site, the potential rating is not a true reflection because a change of fuel type is not considered as an option, and additionally in this case because wall insulation has not been considered as an option.

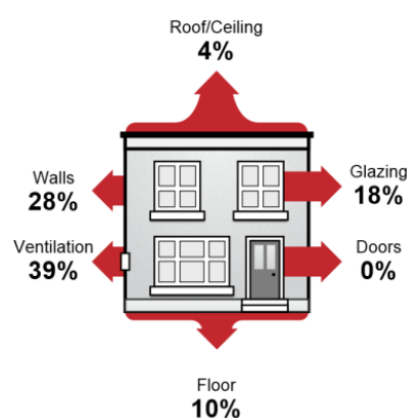
Figure 20: Simple graphic produced by DE HRA as an output of its "best estimate" model, in this case providing an overview of heat loss from Cottage 2.

The most notable difference between the output of RdSAP and DE HRA is that the breakdown of energy use in the building is far more granular, as illustrated by Figure 20 and Figure 21 above. This is designed to support the ambitions of a building owners which may be oriented towards financial, energy efficiency, or environmental goals. This reflects DE HRA's primary function, which is to

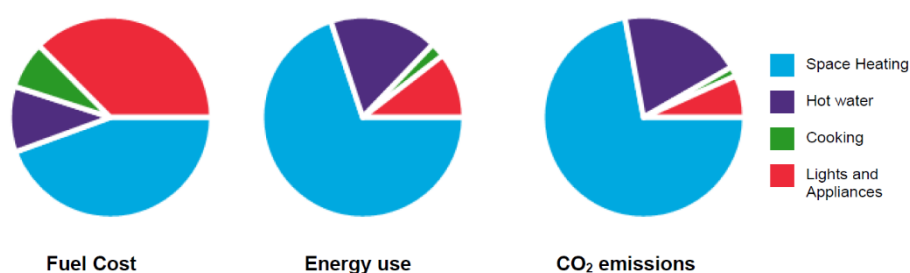
Figure 21: Simple graphic output by DE HRA providing an estimated breakdown of operational costs, energy use, and emissions at Cottage 2.

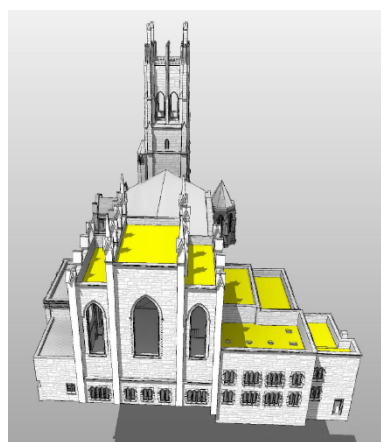
Figure 30: 3D visualisation of the cathedral showing flat roofs identified as in need of maintenance – Source: (JCA Architects, 2020)

JCA's (2020) feasibility study also identified an urgent need for maintenance work on a number of flat roofs at the eastern end of the cathedral, this was completed during summer of 2020. Whilst this does not represent retrofit work per se it is relevant to note as poor maintenance of building fabric is an ongoing problem for traditional buildings in many contexts. This can directly impact energy efficiency as the thermal performance of traditional fabric materials declines dramatically with increasing moisture content (Banfill, 2021). A legacy of inadequate maintenance can also be an indirect drag on improving energy efficiency as it often results in a backlog of issues which must be addressed before retrofit work can take place.

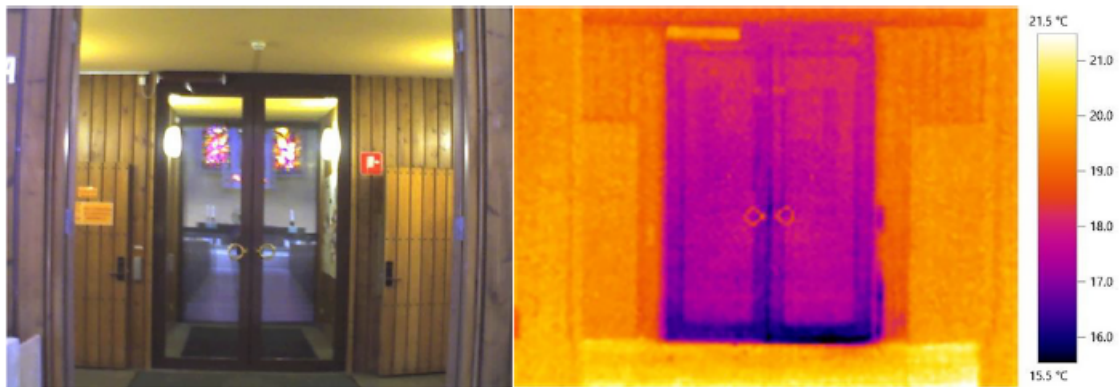
A thermal imaging survey was also incorporated in support of the principal energy modelling exercise (see Figure 47 and Figure 48 below).

Figure 47: Thermal image showing vestibule and internal doors – Source: (Zhang et al., 2022)

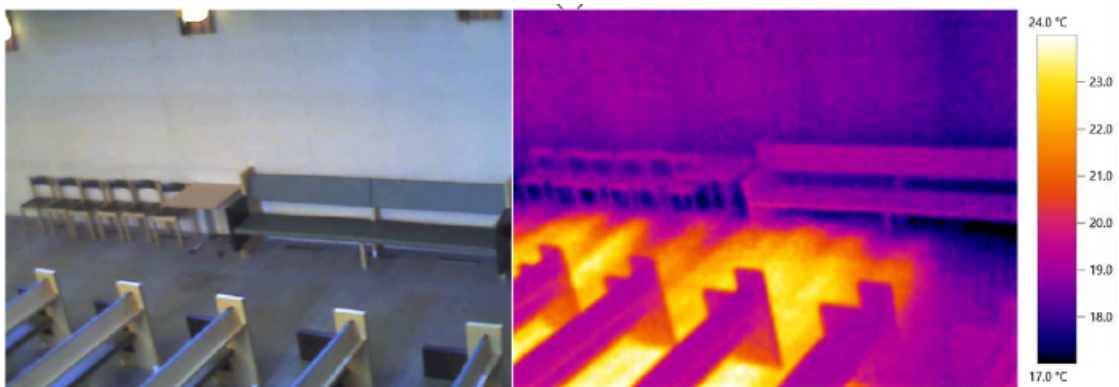
Figure 48: Thermal image showing underfloor heating in operation – Source: (Zhang et al., 2022)

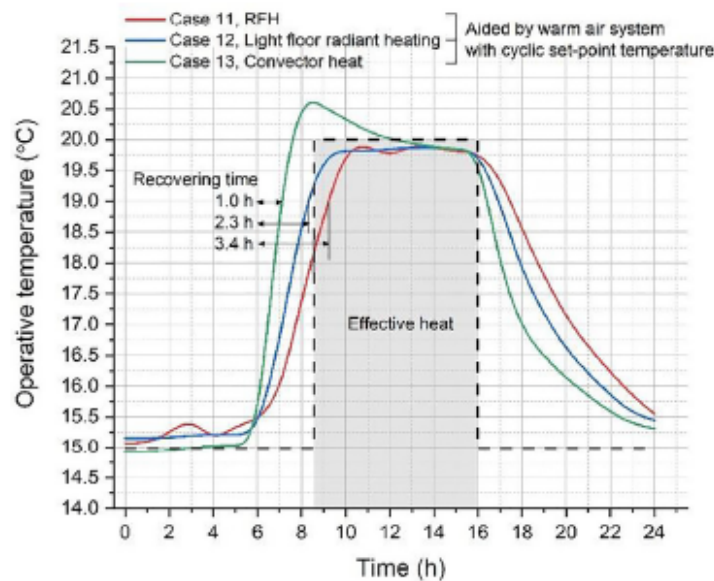
For Tegs Kyrka, the authors propose that the most effective heating strategy is likely to be one of the cyclic setpoint strategies, cases 11, 12, and 13, as shown in Figure 49 below.

Figure 49: Recovering time and operative temperature (simulated) on the coldest day of the year – Source: (Zhang et al., 2022)

The final key finding of the research was that the main difference between these three operating modes which used a cyclic setpoint was recovery time to the higher setpoint, determined by the thermal inertia of the heating system being used. The authors therefore propose that heating systems with lower thermal inertia should be preferred for this function in order to minimise recovery time to setpoint. They further suggest that the appropriate temperature for the lower setpoint should be selected on the basis of avoiding condensation based on prevailing local conditions, in the case of Tegn Kyrka this meant a lower setpoint of 15°C.

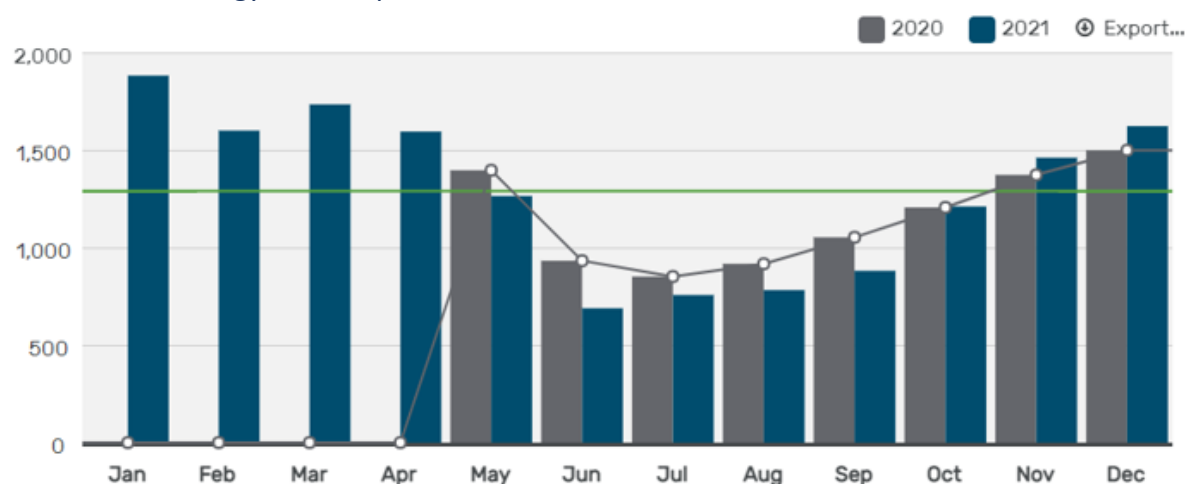
Figure 55: Electrical consumption of the building, kWh/month for 2020 and 2021 – Source: Landsverk

Shortly after the completion of the retrofit, a Danish monitoring system called Energy Key²¹ was installed to provide accurate monitoring of electrical consumption by the building (Figure 55) and the newly installed heat pump (Figure 56). Headline results from this monitoring are also summarised below in Table 23.

The results of this monitoring indicate that electrical demand for both the heat pump and other use follows a seasonal pattern. Both peak in January and nadir in June, which is the expected norm for a northern European climate. Total electrical consumption of the building amounts to ~48kWh/m²/yr, with space heating demand amounting to ~200kWh/m²/yr, reflecting a relatively good seasonal coefficient of performance (SCoP) for the heat pump of around 4. For a detached traditional building in a high exposure location this is a relatively good value, especially considering the limited scope for fabric interventions due to heritage and practical constraints.

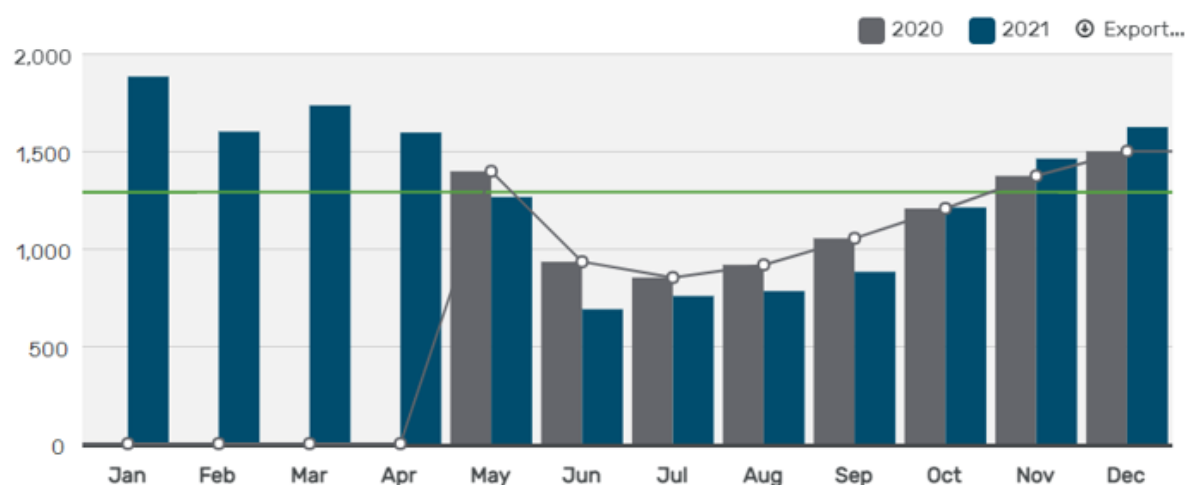
Figure 56: Electrical consumption of the GSHP, kWh/month for 2020 and 2021 – Source: Landsverk

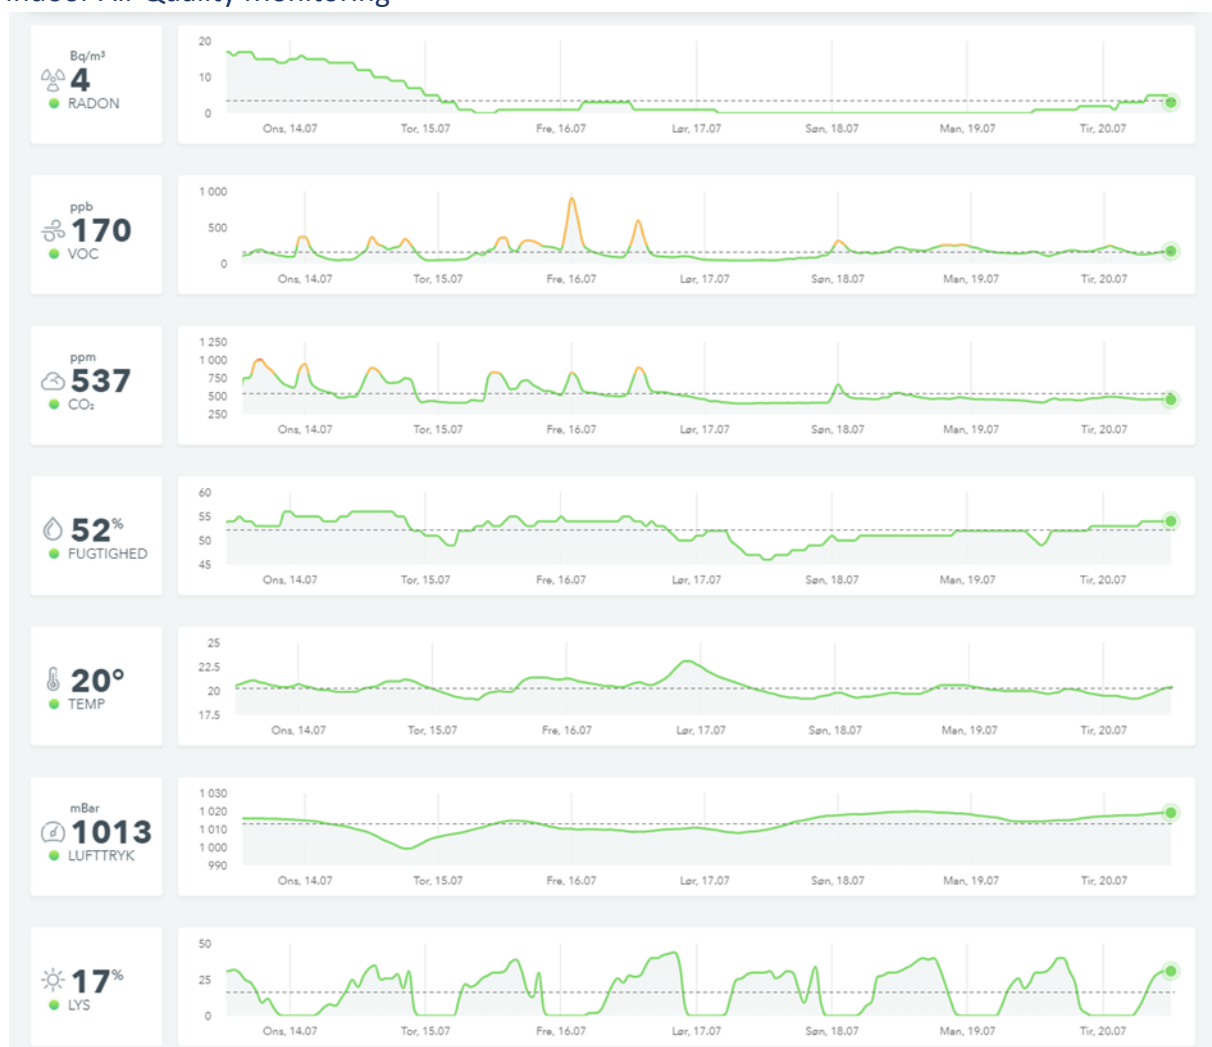
Figure 61: IAQ monitoring data, 13/07/2021 to 21/07/2021 – Source: Landsverk

A very positive sign in the higher resolution data (Figure 61) above is the stable humidity level indicating that the building is shedding moisture effectively as a result of fabric permeability and ventilation. It should be noted though that this is not difficult to achieve in summer. Data covering the winter months will offer a more robust indication and Landsverk are continuing to monitor on an ongoing basis.

It's also worth noting that VOC and CO₂ concentrations tend to rise together, indicating that VOCs within the building are principally resulting from the day-to-day activities of the occupants such as cooking, cleaning, burning candles, and the use of aerosol products, rather than persistent off-gassing by any synthetic products introduced during the retrofit and redecoration works. Occupants themselves also off-gas VOCs though generally not at a rate sufficient to meaningfully raise concentrations in the indoor environment.

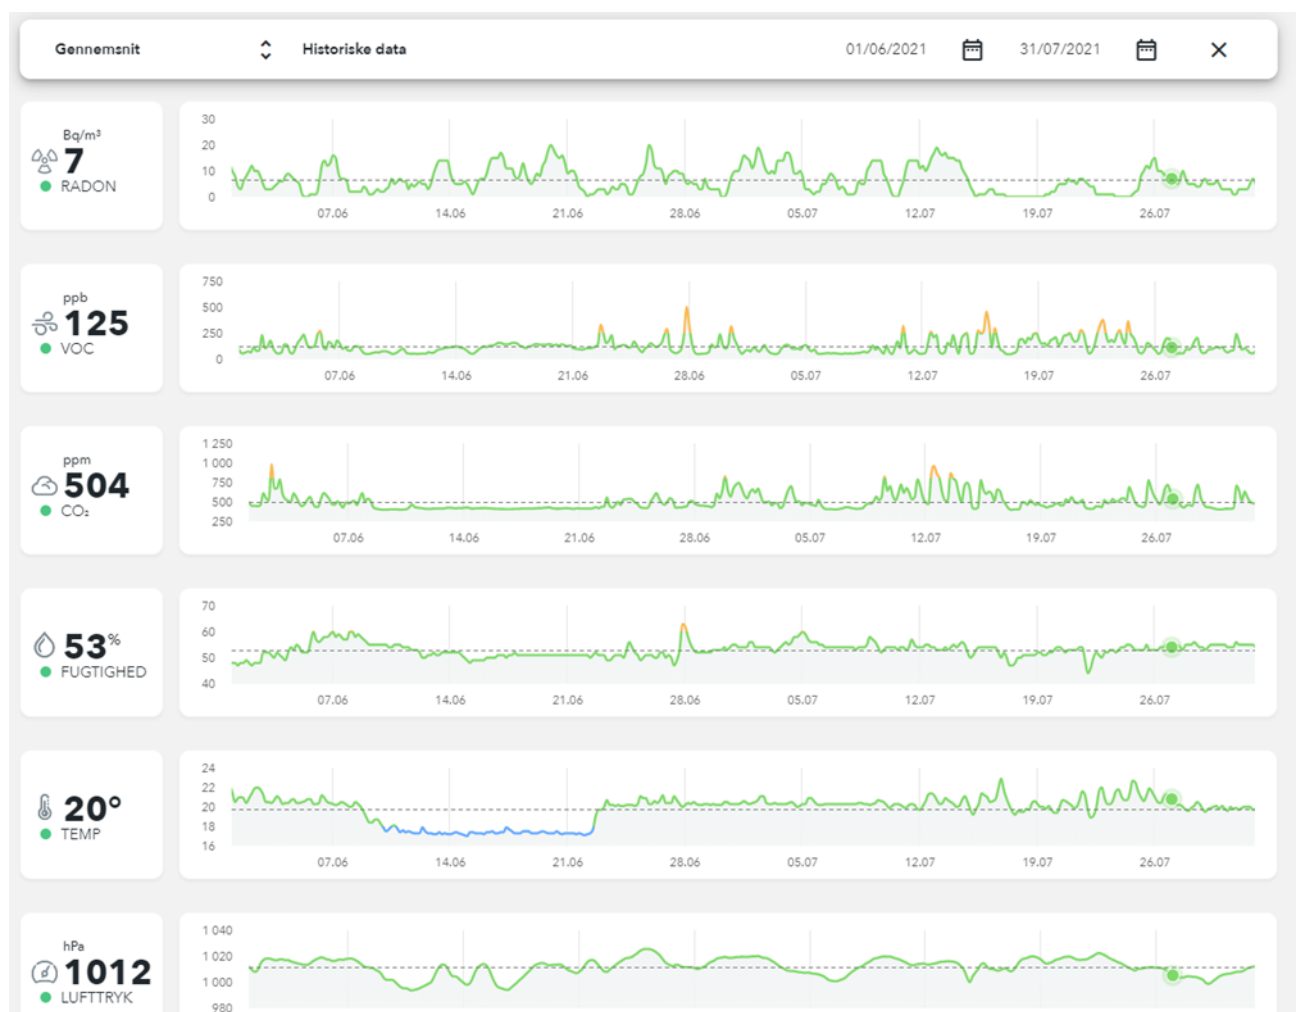
Figure 62: IAQ monitoring data, 01/06/2021 to 31/07/2021 – Source: Landsverk

In the lower resolution data above, values broadly remain almost entirely within the “good” range, reflecting a good balance between energy efficiency and ventilation. It is worth noting once again, however, that this is not difficult to achieve during the summer months and that data during the winter months will offer a better indication when available.
