# Approaching Near Zero Energy in Historic Buildings

# Deliverable No: T3.1.1

# Deliverable Title: Demonstrator Buildings and Energy Assessment Strategies

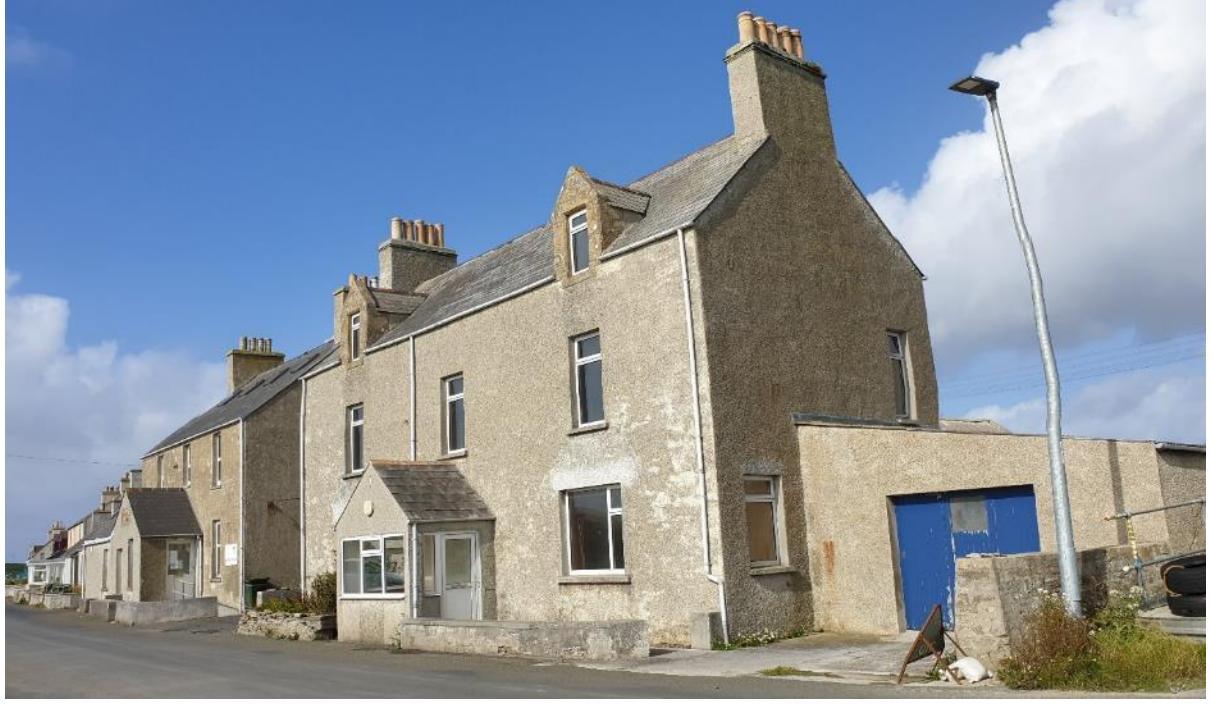
Figure 1: Bayview, pre-conversion in late 2019, seen from the southeast – Image © Historic Environment Scotland – Photographer: Carsten Hermann

Overlooking the harbour of Pierowall, the largest settlement on the island of Westray, Bayview is a two-and-a-half storey detached house constructed in the late 19th century. Originally the building was the house of the Pierowall harbourmaster before being used more recently as a family home and guest house. Unoccupied since 2018, the Westray Development Trust has since purchased the building with the aim of converting the building to house four flats which are to be let by the Trust to residents of the island. It is hoped this will contribute to resolving a longstanding shortage of affordable housing. These works are ongoing at time of writing and are expected to be completed during summer of 2022. Energy efficiency upgrades specified as part of this are described in detail in our subsequent report.

The external walls at Bayview are mass masonry built from a mixture of local stone types, chiefly sandstone with some whinstone<sup>1</sup>, and cement-based harling<sup>2</sup> on the exterior face. This harling was in poor condition and has been replaced like-for-like during the conversion. The existing roof in 2019 was of timber construction finished in slate and has also since been replaced like-for-like. The existing windows were of relatively modern PVC-framed double-glazing but have also been replaced with similar units as the existing ones were in very poor condition. The gross internal floor area of the building prior to conversion works was 222m<sup>2</sup> of which the ground floor was mixed solid and suspended timber construction, and internal floors were all of suspended timber. This internal floor area has been increased during the conversion by the expansion of the building envelope to the rear, chiefly to accommodate a common stairwell. The external walls and ground floor were previously uninsulated, as was most of the roof structure with the exception of a small apex loft insulated with mineral wool to a depth of approximately 150mm. The building does not carry any statutory heritage

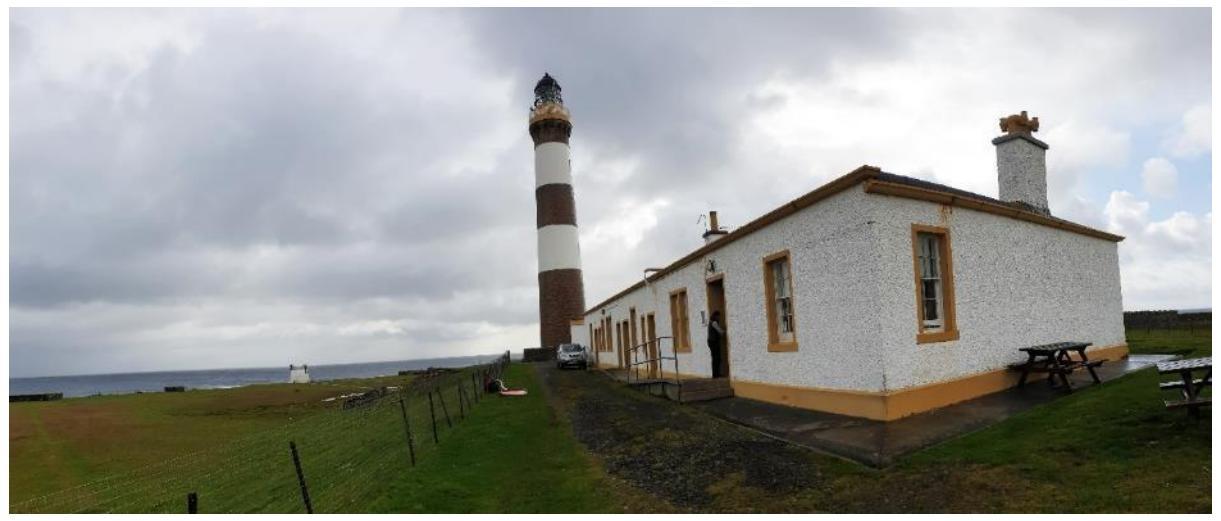
*Figure 2: Lighthouse with north-western block, housing the café/visitor centre and woollen mill – Image © Historic Environment Scotland – Photographer: Carsten Hermann*

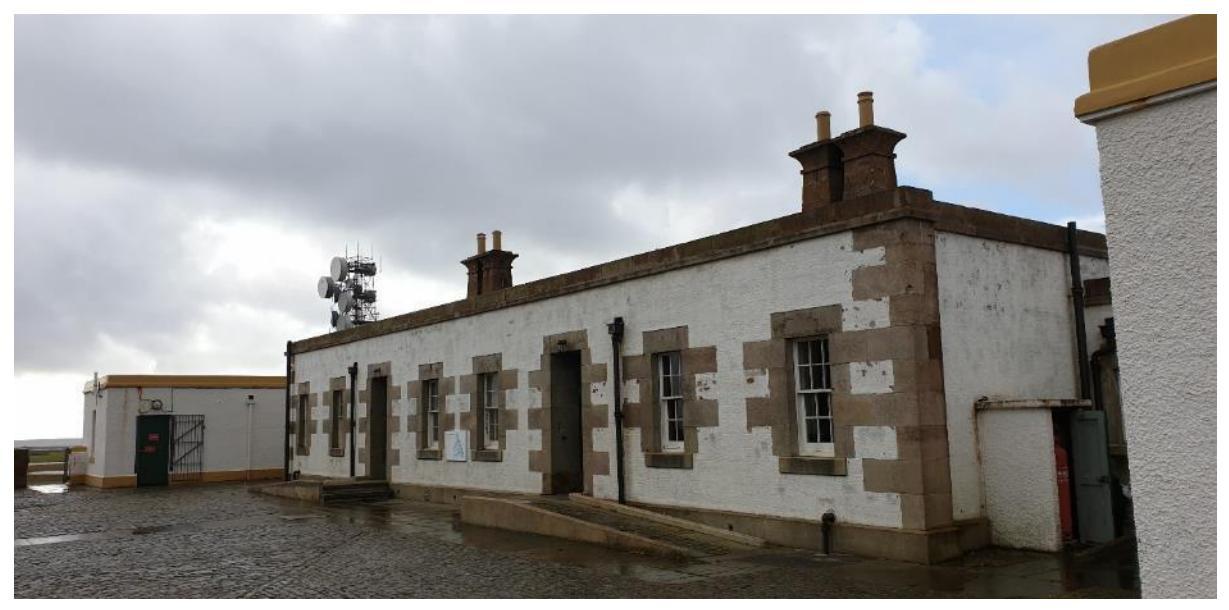
Figure 3: South-eastern block, housing two holiday apartments – Image © Historic Environment Scotland – Photographer: Carsten Hermann

Standing on a rectangular plan, the symmetrical southeast keepers' accommodation block is of solid brick construction with sandstone quoins at corners and windows. This block houses two cottages originally built for the lighthouse keepers' and which are now holiday lets operated by the North Ronaldsay Trust. The northwest block, of poured concrete construction, was originally built to provide a third keepers' cottage and a machine workshop for the complex. The third cottage currently serves as a café and exhibition centre while the workshop hosts a woollen mill processing locally produced fleece from the North Ronaldsay herd. The Energy Pathfinder demonstrator buildings are the two accommodation blocks which are owned by the North Ronaldsay Trust. The UK's Northern Lighthouse Board continues to own, operate, and maintain the lighthouse itself which is consequently outside the scope of Energy Pathfinder.

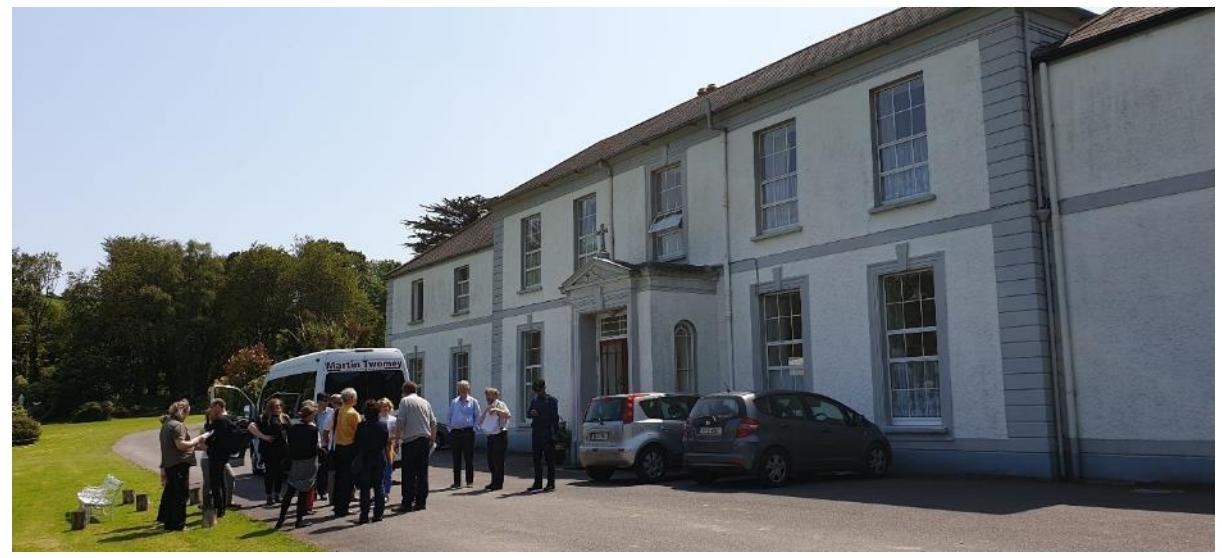
Figure 5: Myross Wood House, principal elevation of original Georgian house with early side extensions – Image © Historic Environment Scotland – photographer: Carsten Hermann

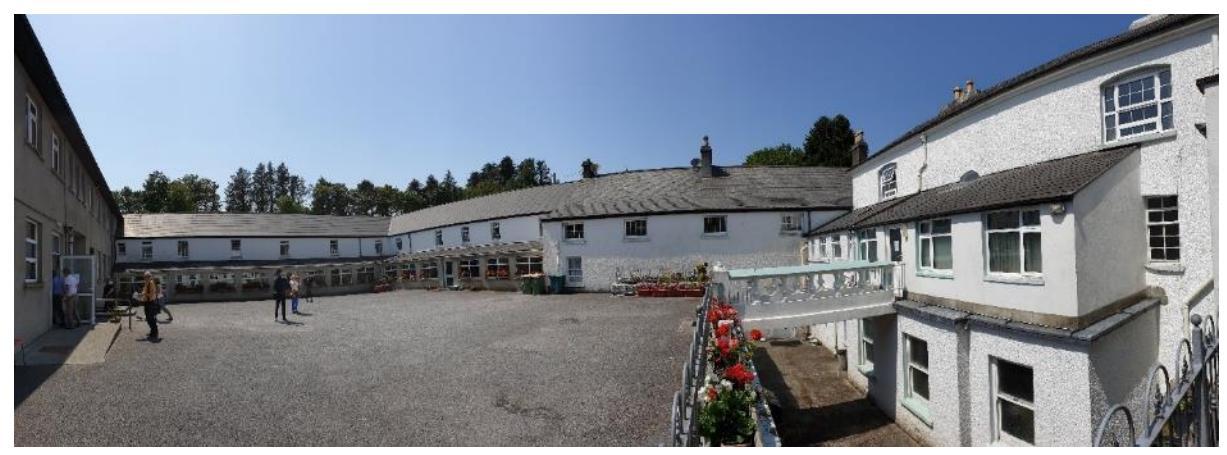
*Figure 6: Courtyard with 20<sup>th</sup> century extension left of centre; the original building with older extensions right of centre – Image © Historic Environment Scotland – photographer: Carsten Hermann*

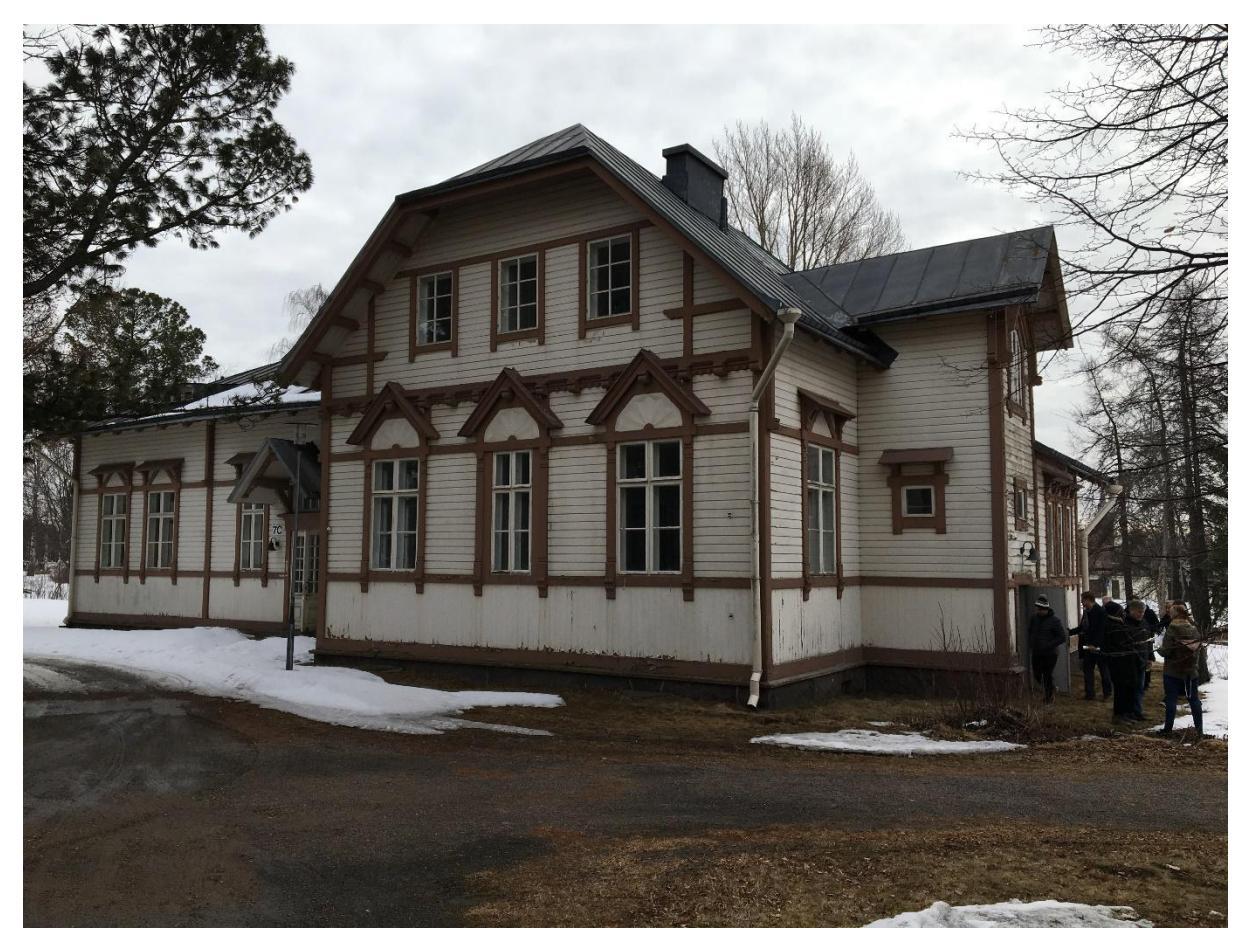
Figure 7: The Rector's House – Image © Historic Environment Scotland – photographer: Kenneth Easson

The Raahe Rector's House is a building of moderate cultural significance on Raahe's university campus. This traditionally constructed, timber-boarded log structure is currently unoccupied due to chronic dampness issues which have caused considerable mould growth. Fungal investigations have been commenced to inform the planning of a suitable renovation journey which can restore the building to active use. This process has been delayed considerably however due to staff changes at Oulu University and due to the ongoing coronavirus pandemic. Current plans for the building intend it to become a residence for visiting artists following renovation.

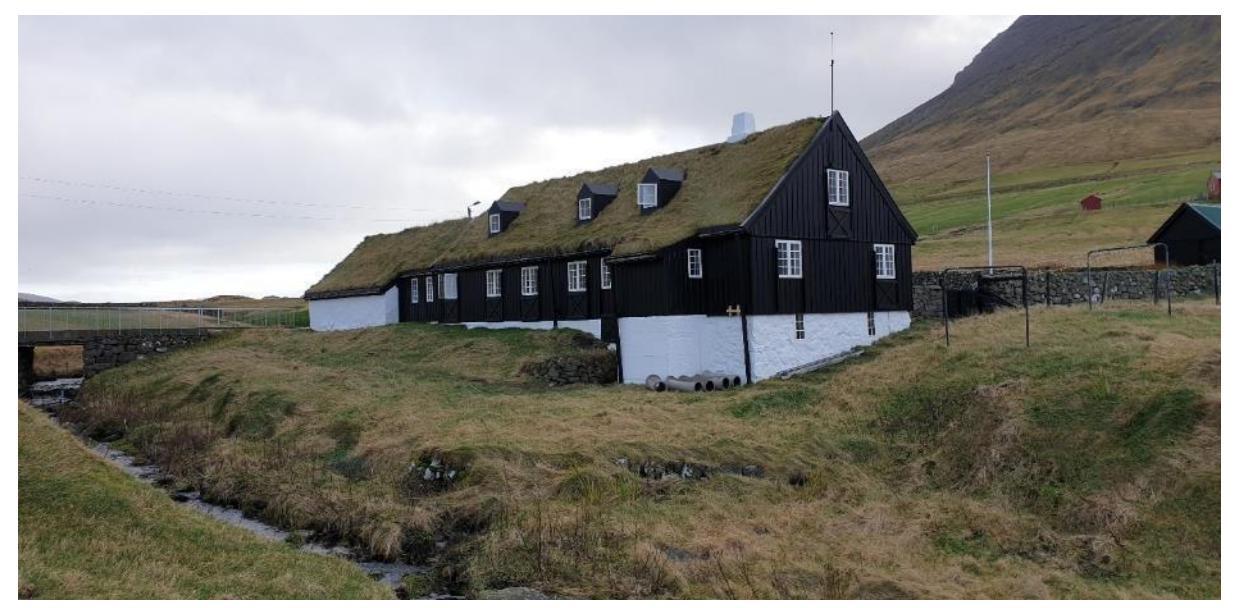
Figure 9: Viðareiði Vicarage seen from the immediate northwest – Image © Historic Environment Scotland – photographer: Carsten Hermann

Built in 1854 in the village Viðareiði, this wooden vicarage building is an ongoing pilot project of Landsverk, the Faroes department of public works and a partner organisation in Energy Pathfinder. The building is being renovated by Landsverk which will include removal of most modern materials, installation of Optoglas windows, extensive insulation works, and replacement of the existing fossil fuel heating system with a ground source heat pump. These renovation works will be completed by the end of 2019.
